Inspection Report

Sample Report

Property Address:
12345 S Sample Road
Jupiter Florida 33478

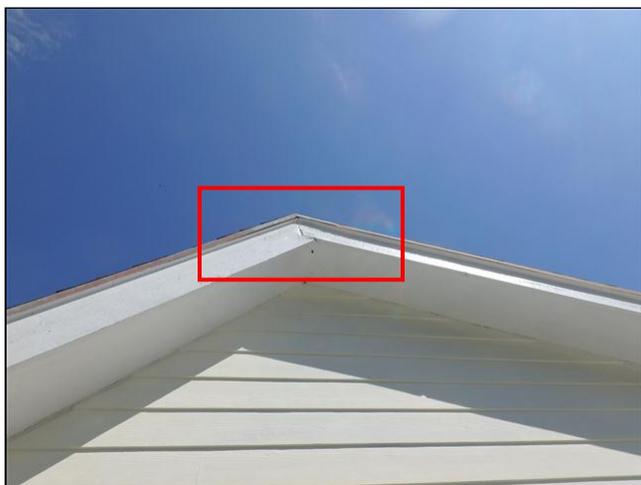
1.2 Fascia requiring sealant/painting. Observed section which could have some deterioration/moisture damage. Not accessible due to pitch of roof. This should be monitored and any deteriorated sections of fascia should be replaced as necessary. Other areas of possible fascia repair but not definitive due to being painted over. Note: This section of the house has a high pitched roof with no attic access. The conditions behind and under this roofing section is not accessible and conditions are unknown.

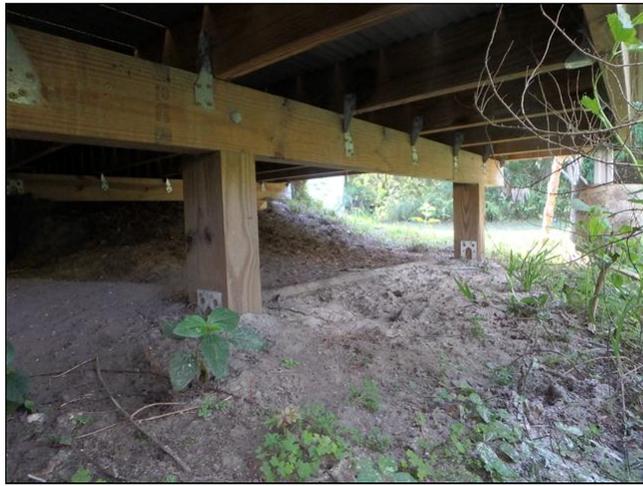
1.5 (1) Decking appears in good overall condition. Visible areas underneath the decking appear in good overall condition.

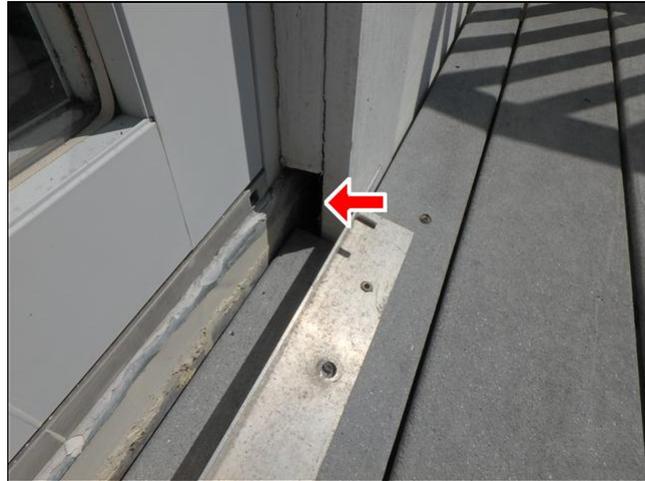
🏠 1.5 (4) There are open gaps at the lower sides of the rear deck/patio doors. This can allow water to intrude behind the siding. Recommend sealing.

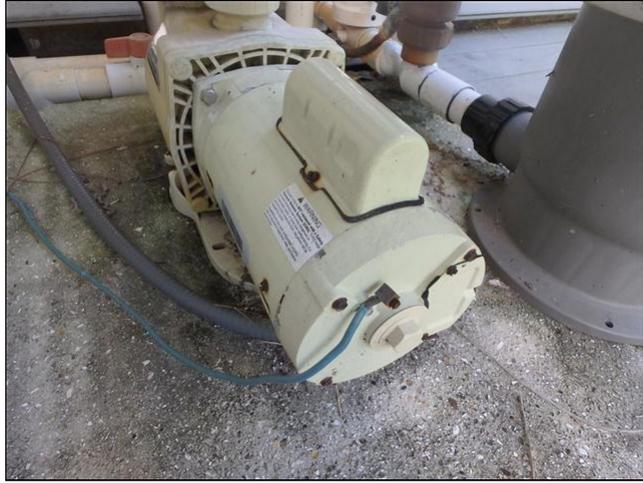
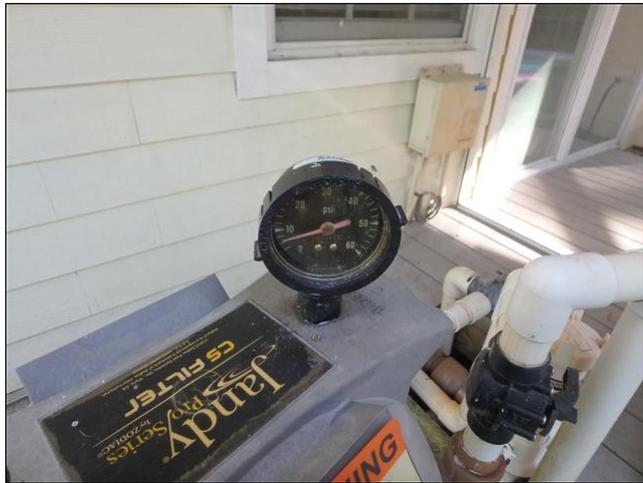
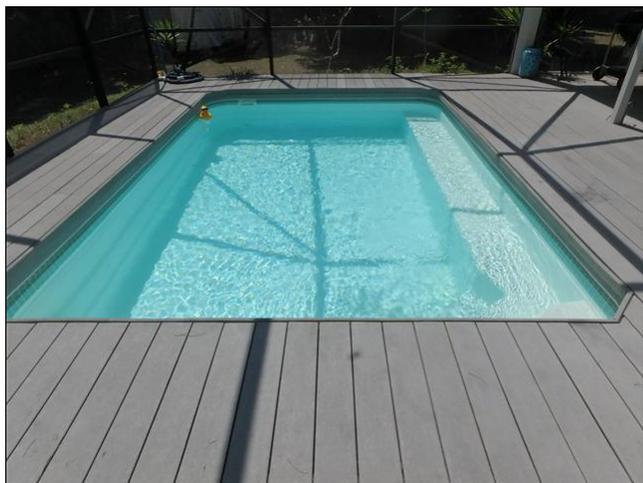
1.7 (1) There is an above-ground pool installed at the rear of the property. Pool inspection is not part of a home inspection. Only a courtesy visual for overall condition is offered. The pool, pool surface, pump, filter and visible piping appear in overall good condition. The pump is operational and water is flowing through the system as designed. The filter is not opened for inspection. As a matter of general maintenance, recommend having the pool serviced. The filter should be checked and replaced if necessary, and the water should be tested for ph and chlorine levels. As a new owner, it is recommended to have the pool serviced and put on a maintenance program.

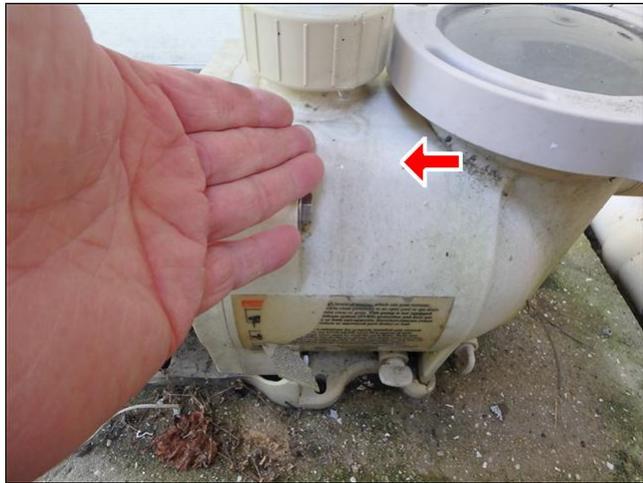
1.7 (2) Area of filter with a leak

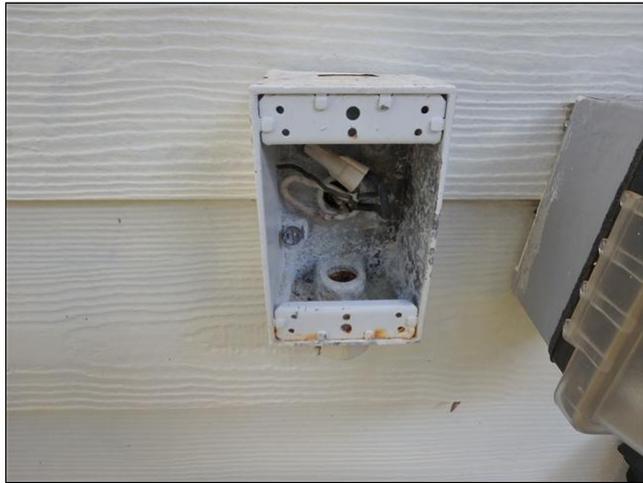
📍 1.10 (1) Uncovered box with live wiring

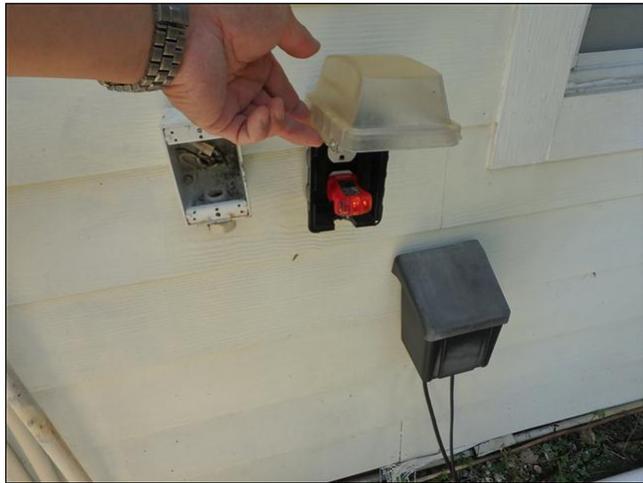
🏠 1.10 (3) The exterior electrical receptacle did not have GFCI protection. The GFCI receptacle should be replaced.

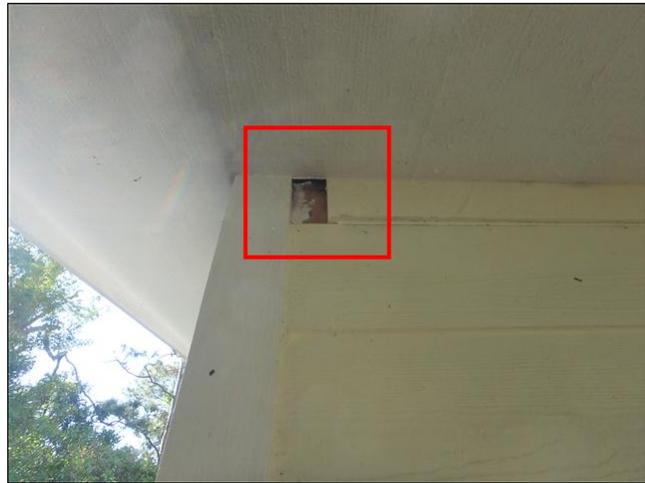
🏠 1.12 Open gaps in exterior walls should be sealed and finished to prevent moisture and pest entry.

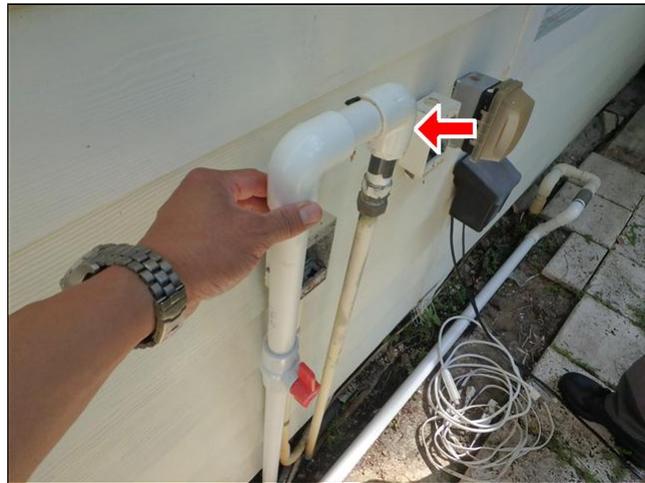
🏠 1.13 (1) Unsecured water line

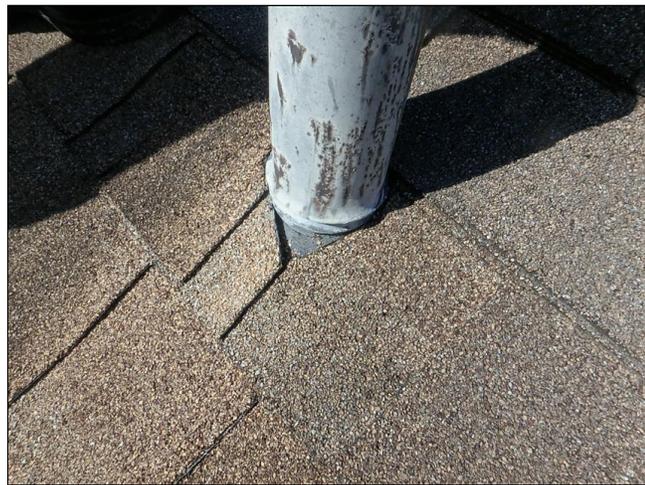
2.2 (2) Damaged shingle/flashing at a roof penetration. This could be an area of potential leakage

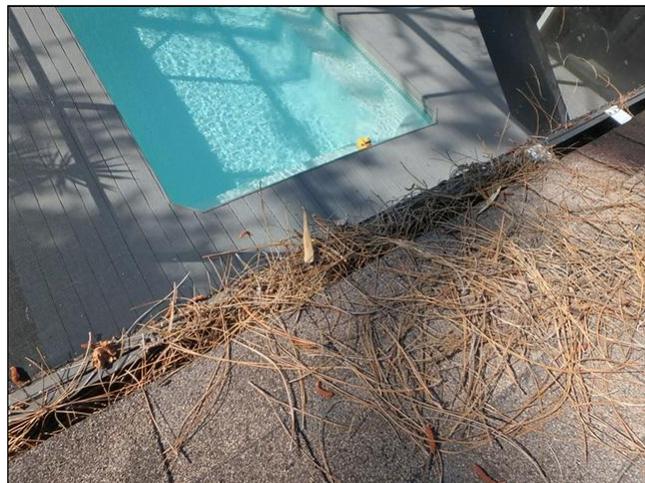
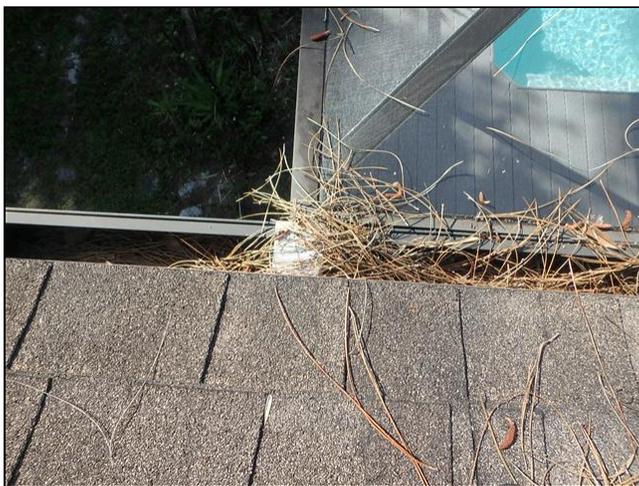
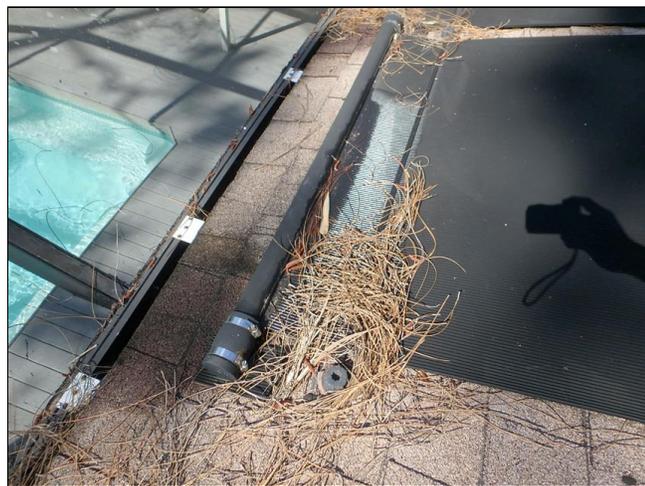
2.3 The gutters should be serviced and cleaned to prevent buildup of debris and obstruction of downspouts

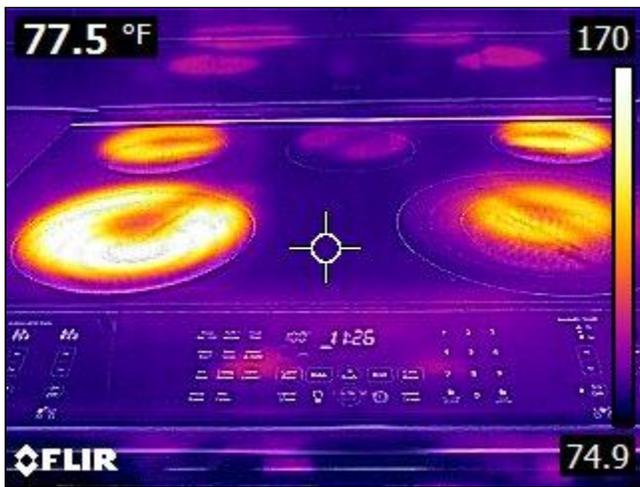
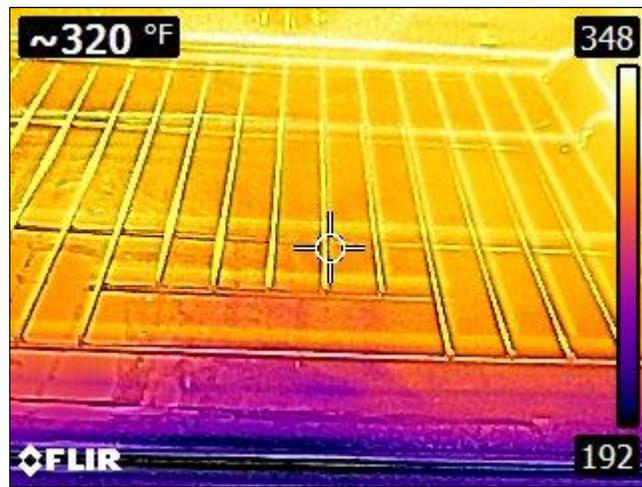
3.1 (1) Range burners all worked as expected. The oven operated normally and as expected with satisfactory temperatures

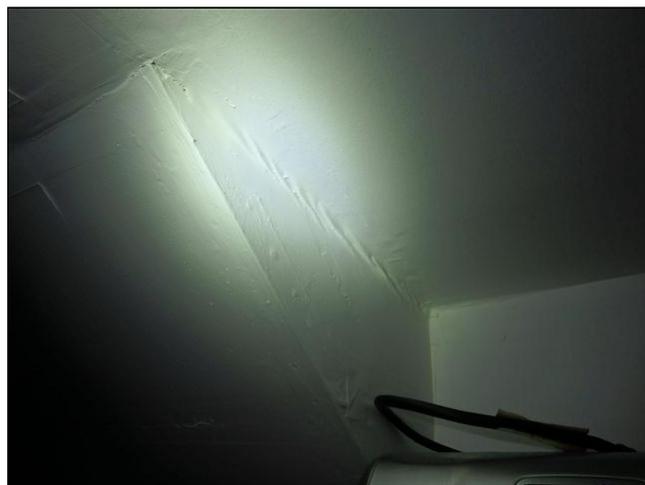
**4.0** (2) There are minor surface type imperfections to the finished drywall of the walls or ceilings. These are considered cosmetic in nature but noteworthy since they were not originally designed that way. They should be repaired and finished.

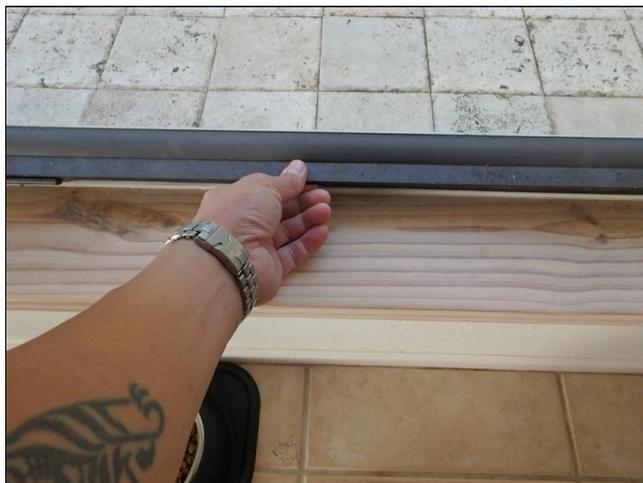
4.6 Numerous windows are difficult to operate. Recommend service to all windows for proper and efficient operation.

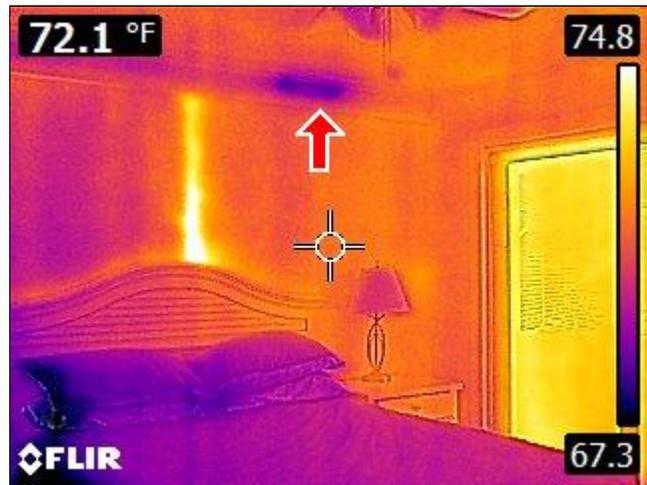
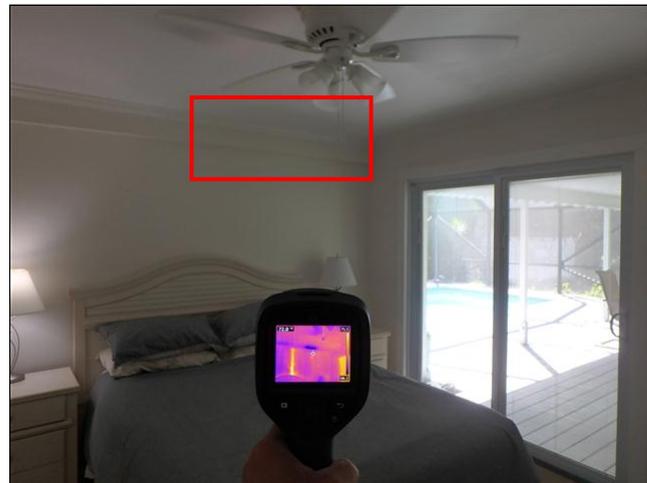
4.7 (1) Area in the first floor bedroom identified to have elevated moisture levels. These areas should not have elevated moisture levels. These areas should be monitored. If the moisture level continues or increases, then invasive measure must be taken in order to identify the origin and correct the issues.

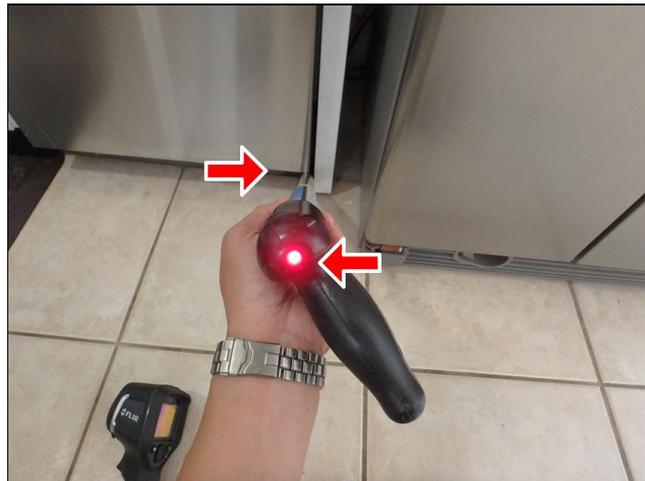
4.7 (3) Dishwasher has a leak at the lower, right corner

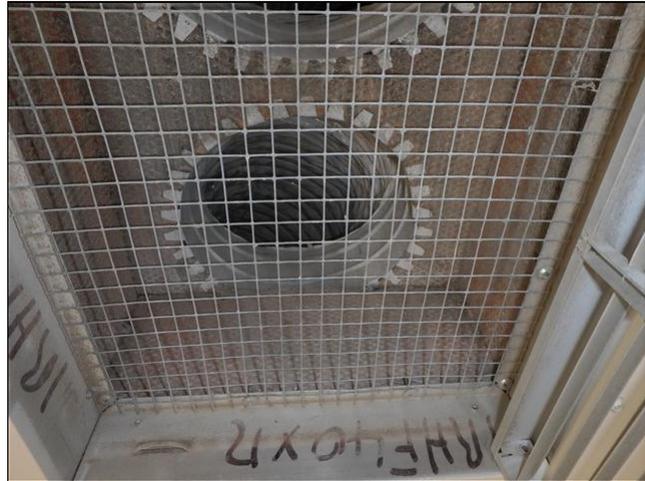
7.6 (2) The return plenum is in good overall condition. There are no condensation leaks or other moisture issues at the time of the inspection,

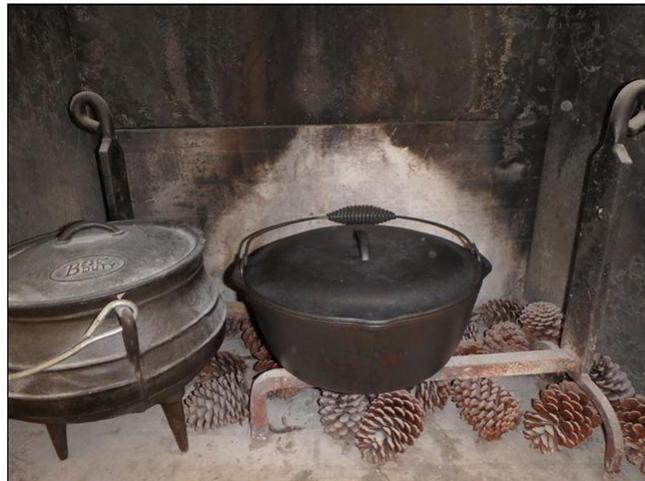
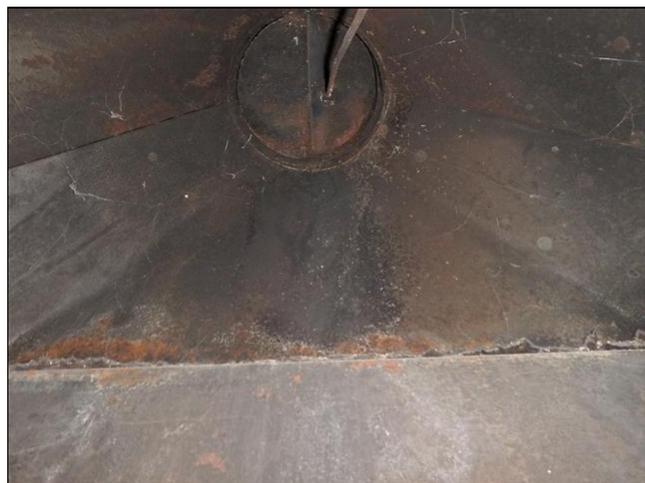
7.8 The fireplace is in good overall condition. However, before attempting to use it, it is recommended that a qualified chimney contractor perform a specific chimney inspection and evaluate the flue and other aspects to ensure it is safe to use.

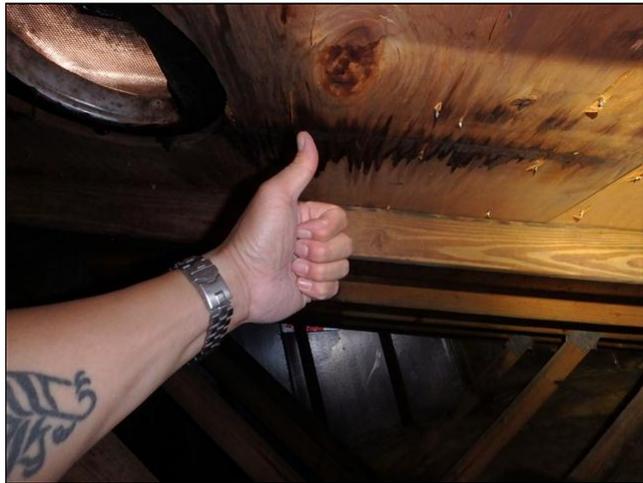
9.6 There is evidence of previous water leaks/water intrusion found in the attic at areas underneath the roof sheathing. These water stains appear to be from previous leaks/water intrusion. They are located near the edge of the roof and are not currently moist. But this should be monitored because the age of the previous staining is not known. This area could potentially leak during a rain event.

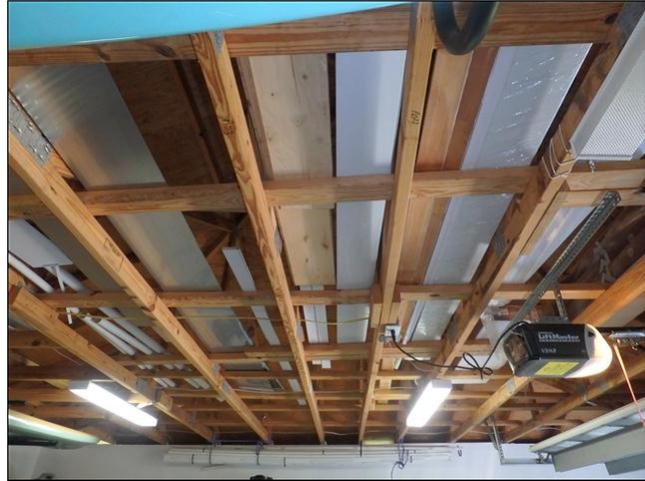
10.0 The garage was built on site in 2012 according to permits on file. The ceiling/roofing structure is manufactured wood truss and is open.

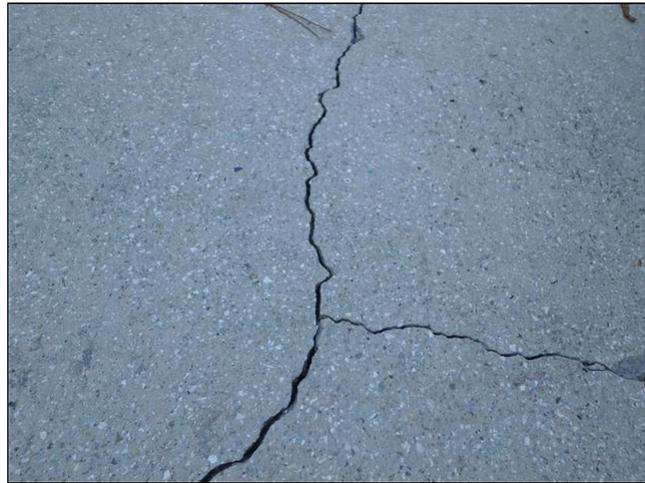
10.1 Noted cracking in the garage floor which are typical expansion/settlement type cracks.
