Inspection Report

Sample Report

12345 Sample Hwy
Stuart Florida 34994

Date: 3/21/2019	Time: 10:00 AM	Report ID: Sample Report #9
Property: 12345 Sample Hwy Stuart Florida 34994	Customer: Sample Report	Real Estate Professional:

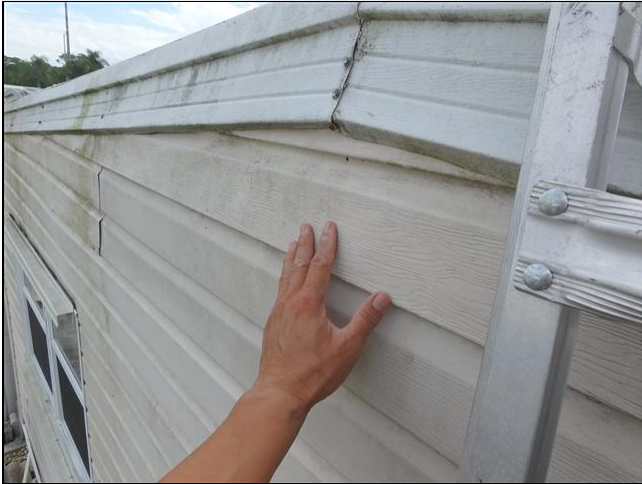
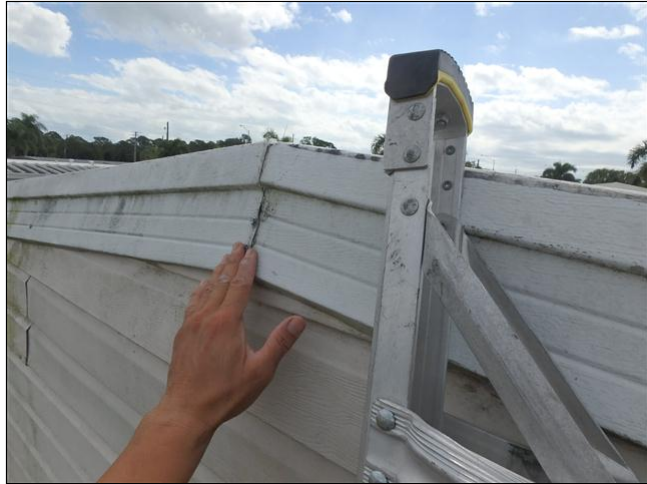
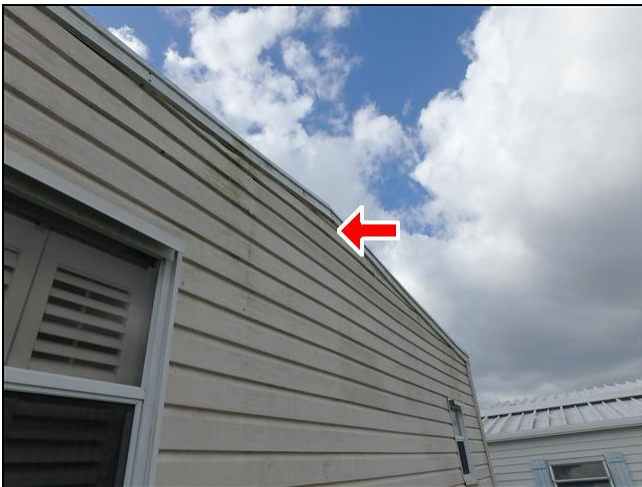
1.0 (2) Rear of the building has a slight tilt inwards. The siding is not flush against the wall. Reasons unknown

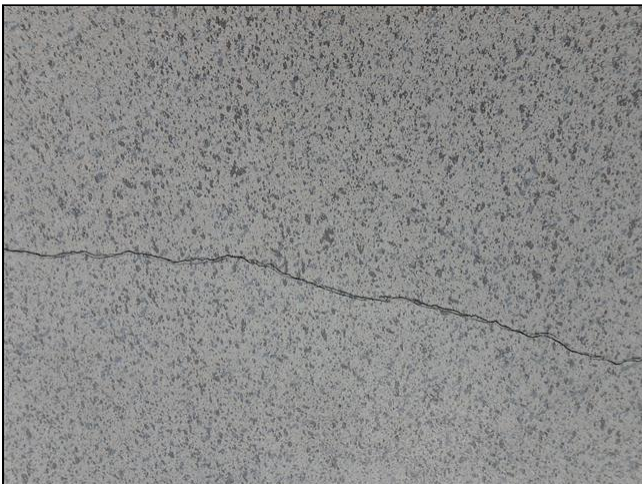
1.6 Noted area of cracking in the driveway, these appear to be settlement/expansion cracks

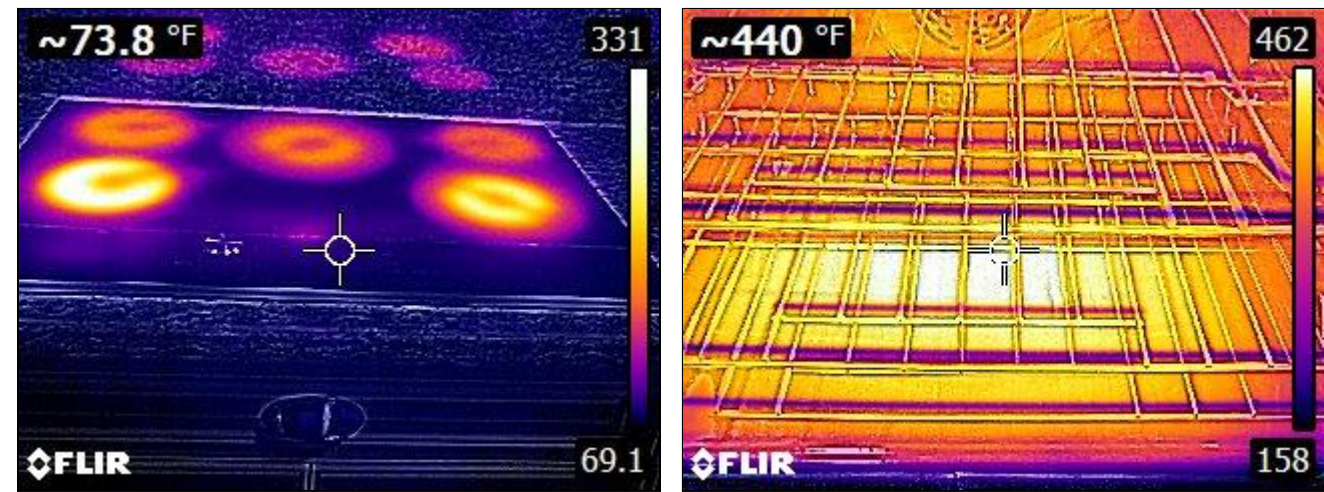
- 3.0 The dishwasher operated and cycled through to the end with no visible leaking or other obvious defect
- 3.1 Range burners all worked as expected. The oven operated normally and as expected with satisfactory temperatures

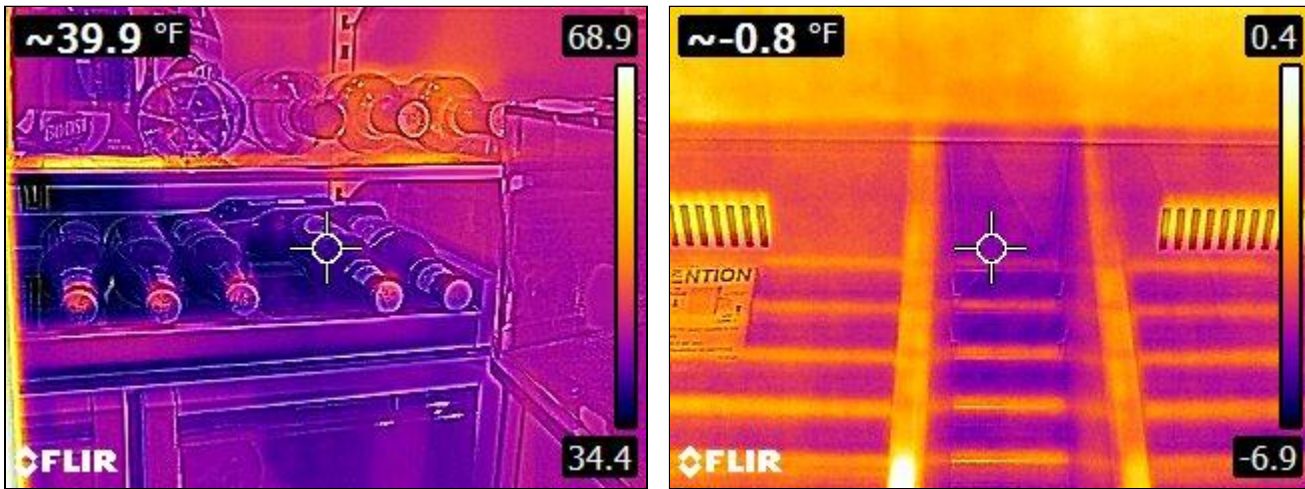
3.4 The refrigerator and freezer were operating at expected temperatures as set by the built-in temperature controls.

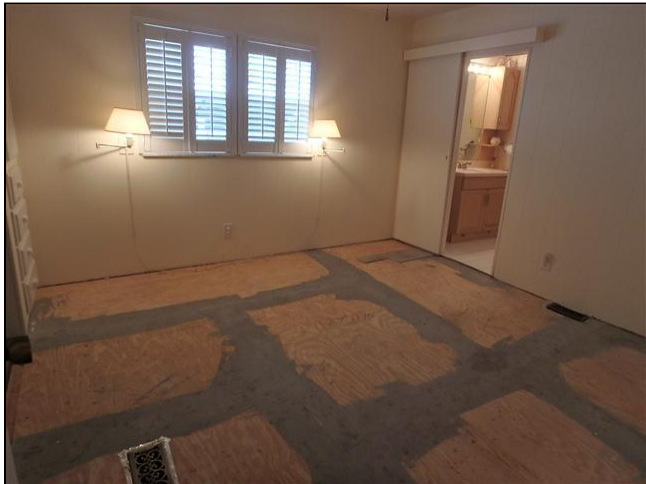
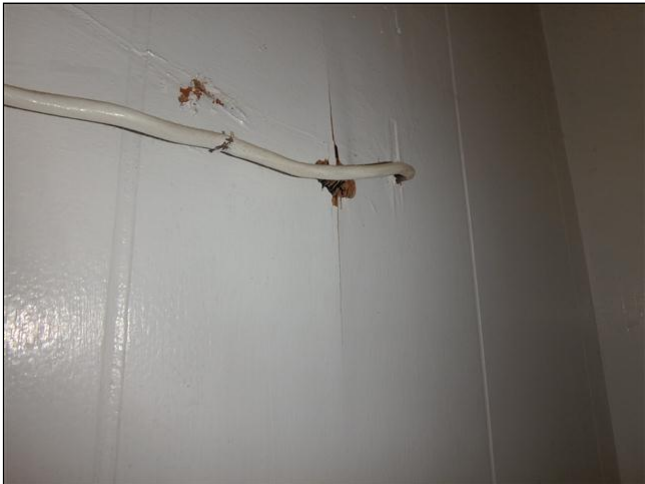
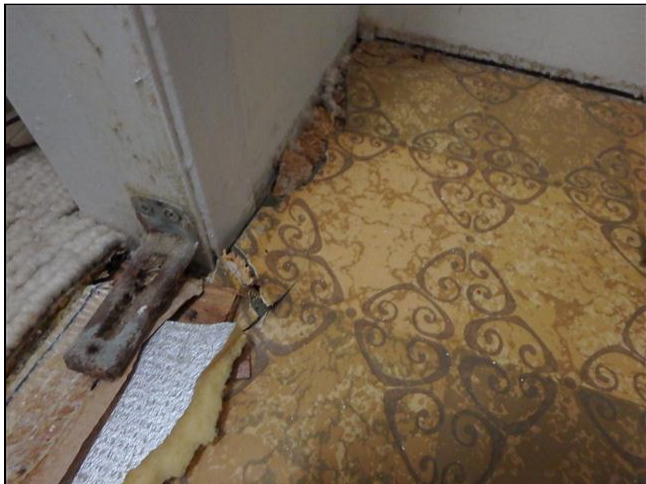
**4.0** (2) There are rooms with the carpeting removed. There are minor surface type imperfections to the finished walls or ceilings. These are considered cosmetic in nature but noteworthy since they were not originally designed that way. They should be repaired and finished.

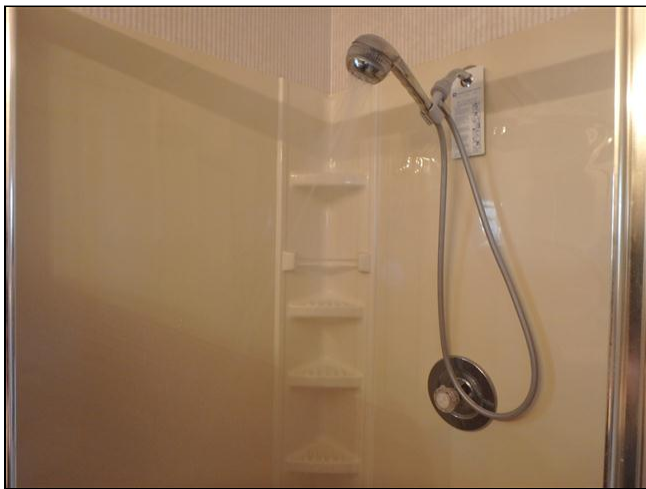
4.4 Note: There are one-piece plastic tub and shower enclosure units in the bathrooms. The condition of the wall and floors behind and under these enclosures are unknown. These types of shower retrofit enclosures tend to be a "quick fix" for bathrooms. They could potentially be covering previous issues which are now unknown.

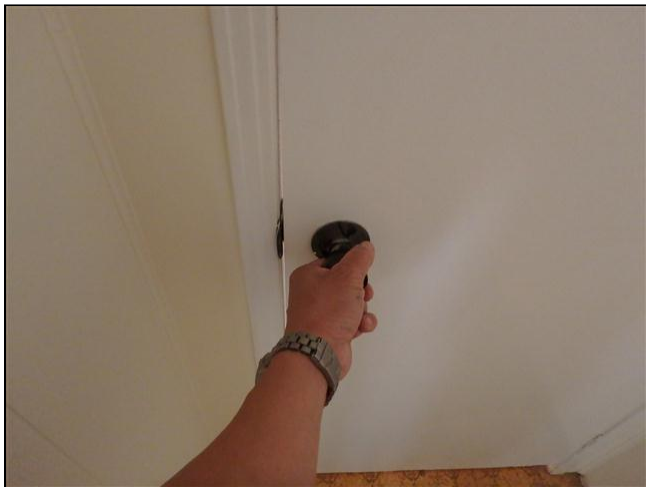
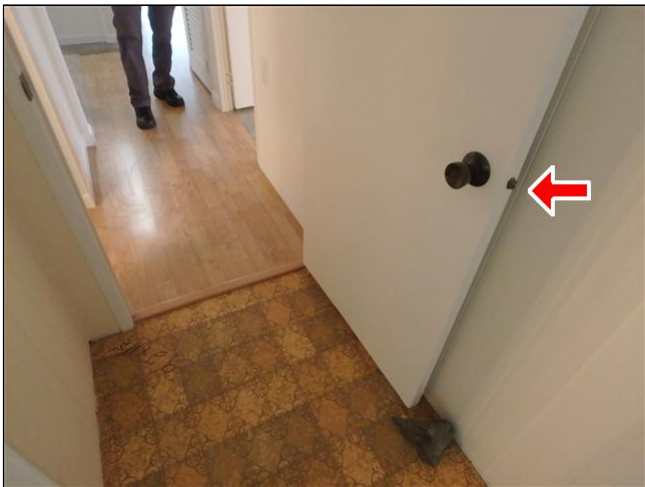
4.5 Interior door does not latch properly when in the closed position. Could be due to alignment of shift from settlement over time

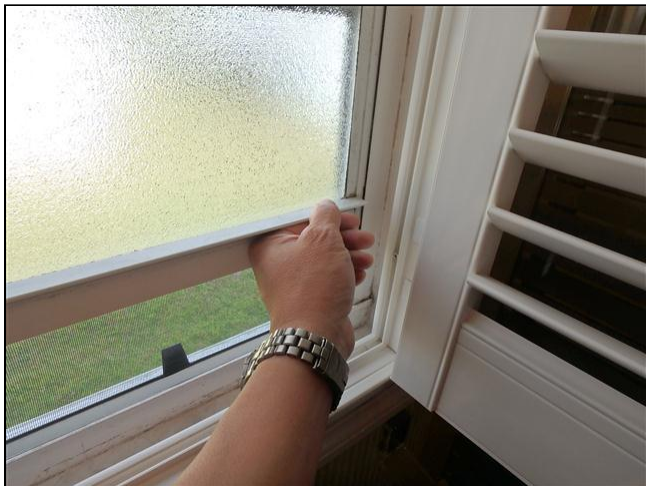
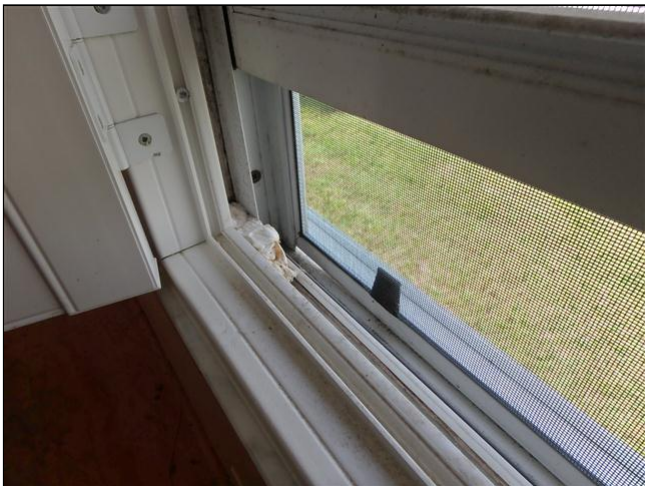
4.6 Window counter balance return springs were noted to be damaged, recommend repair and maintenance of all additional windows with a wax based lubricant.

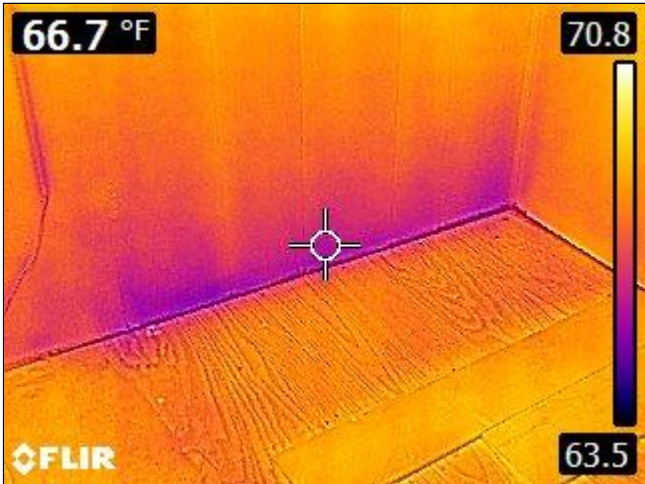
4.7 (1) Bedroom closet along the wall edges has elevated moisture levels. The carpeting was pulled back and the tack strip and underlying flooring has elevated moisture. The opposite side of the common wall is the shower in the other bathroom. There could be a potential issue behind the wall.

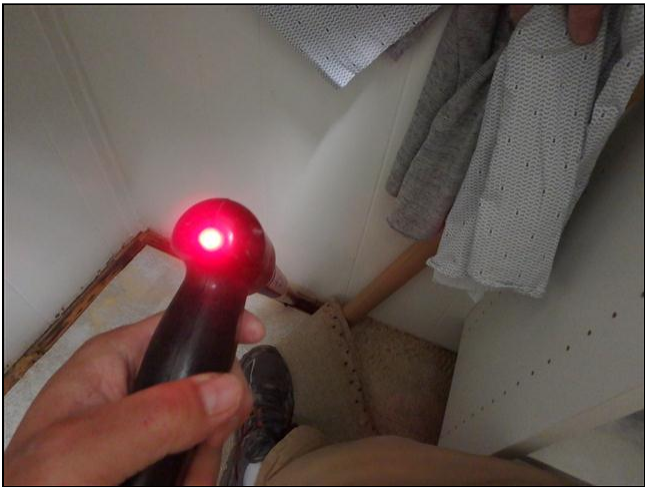
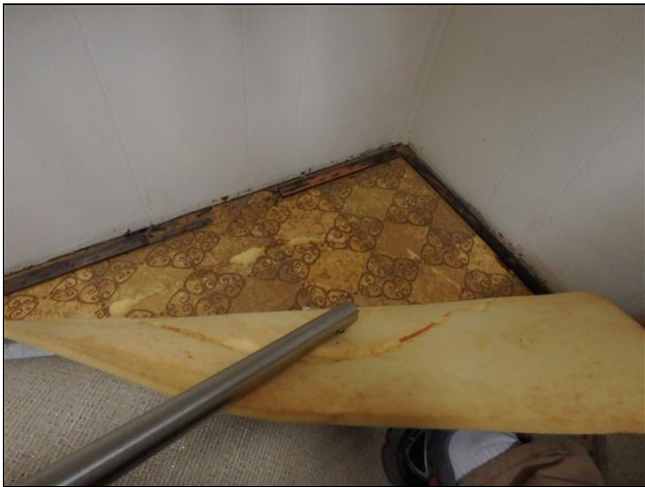
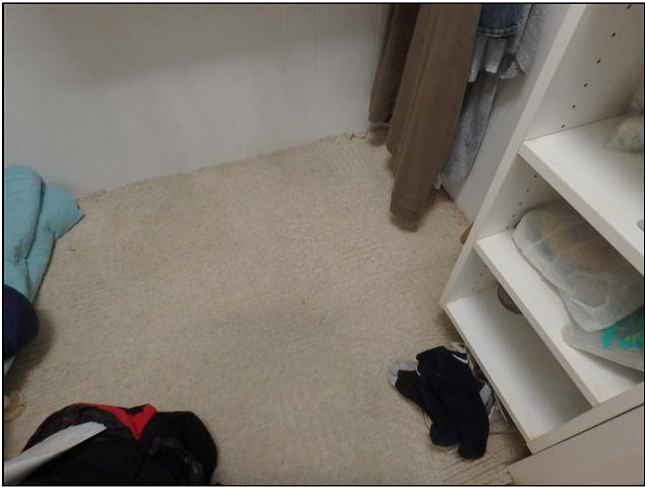
(1) Bedroom closet along the wall edges has elevated moisture levels. The carpeting was pulled back and the tack strip and underlying flooring has elevated moisture. The opposite side of the common wall is the shower in the other bathroom. There could be a potential issue behind the wall.

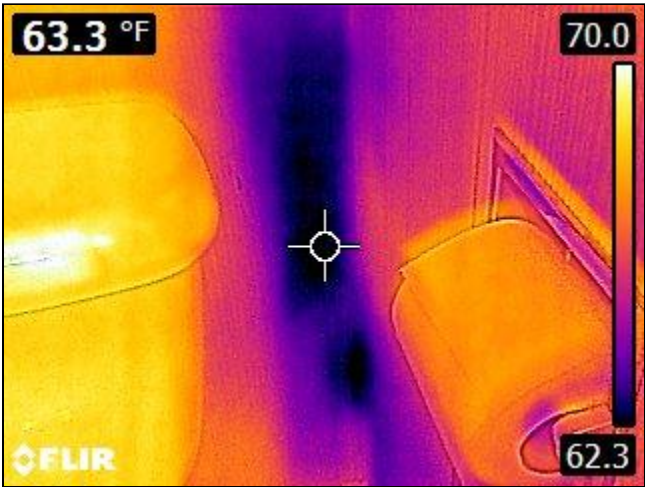
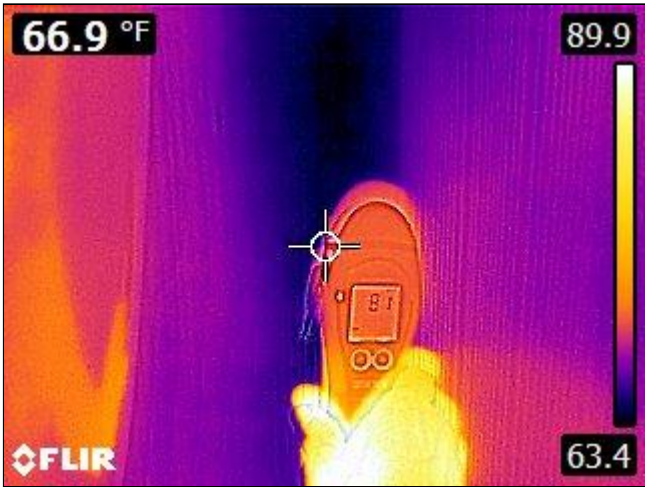
4.7 (2) There is a small area to the right and behind a toilet that appears to have elevated moisture levels but was tested with a moisture sensor and moisture meter and were not elevated. This could just be an anomaly.

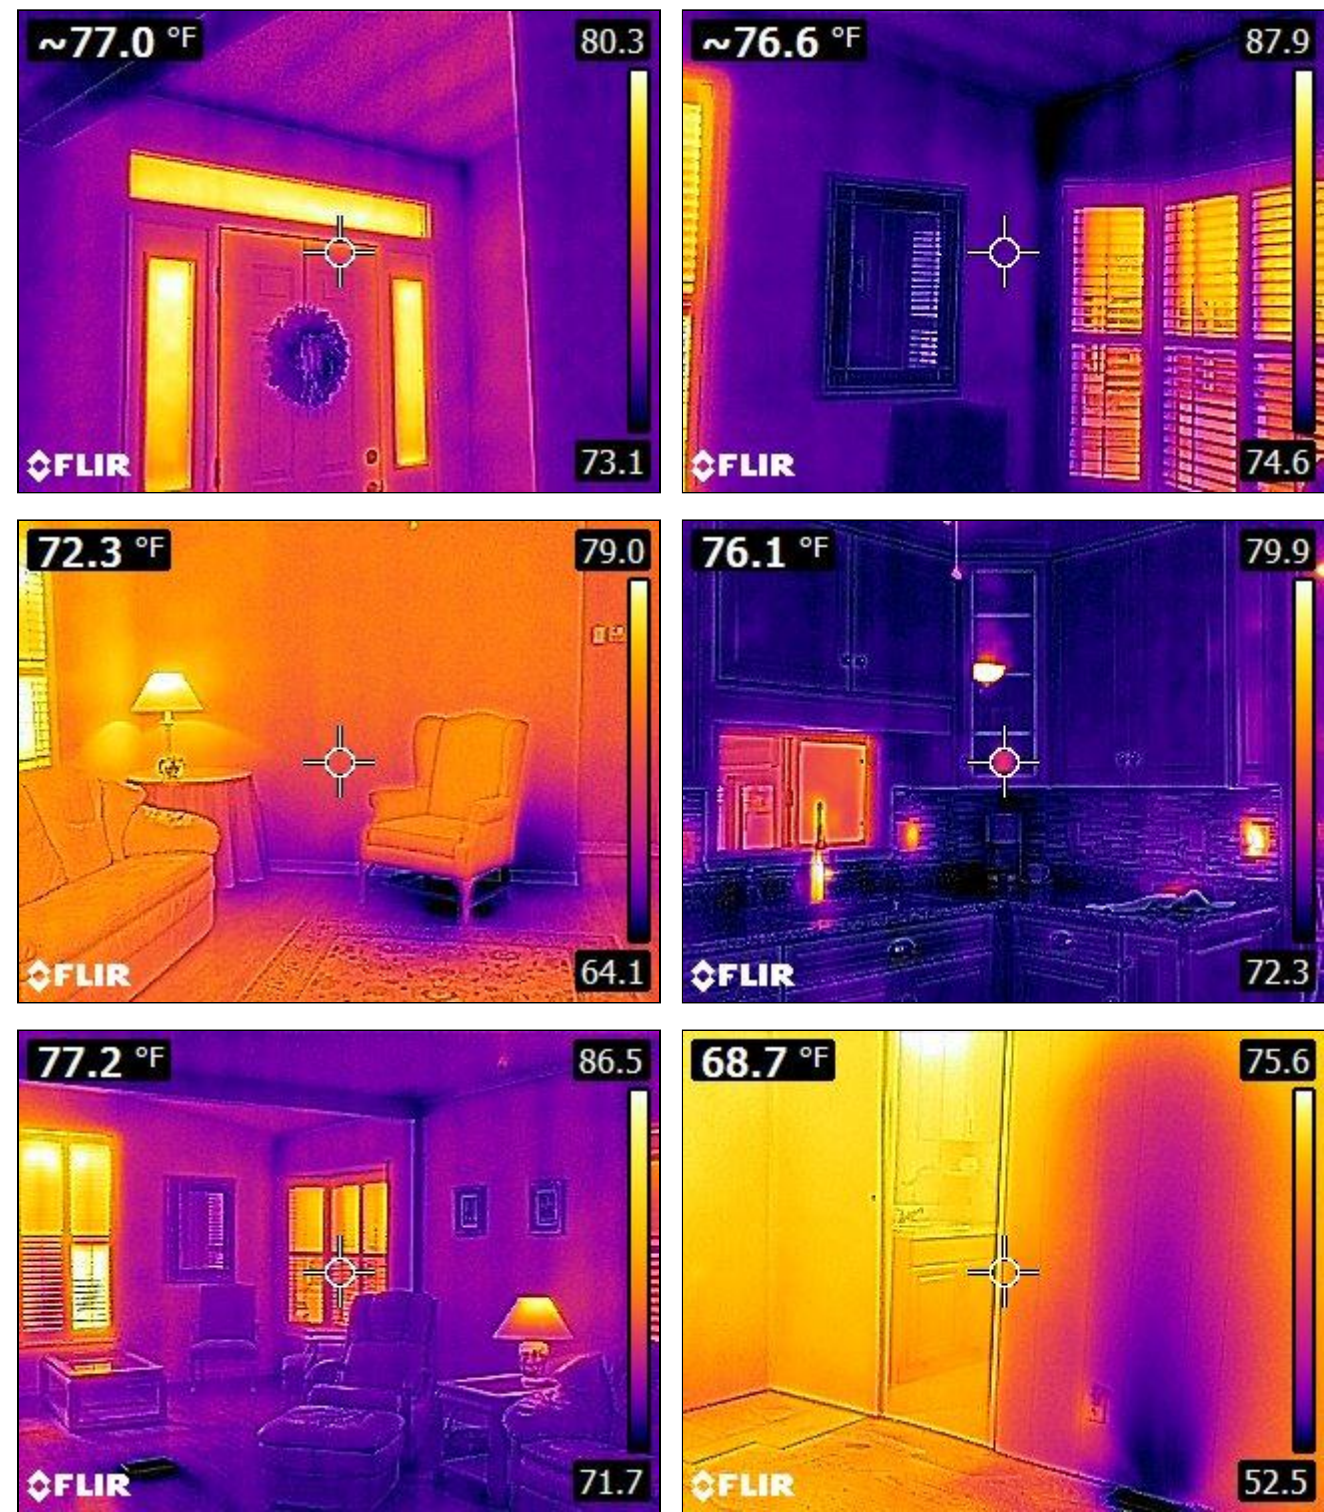
4.10 A second dedicated pass through the entire house was conducted using an infrared thermal camera and moisture meters solely to look for any signs of moisture or water intrusion. Every wall, ceiling and floor was scanned. Any indications of moisture will be reported in other sections of this report. Keep in mind that there is no way to see through walls and conditions behind walls are unknown, and outside the scope of a home inspection. The following thermal images show each room with no indications of moisture presence at the time of the inspection.

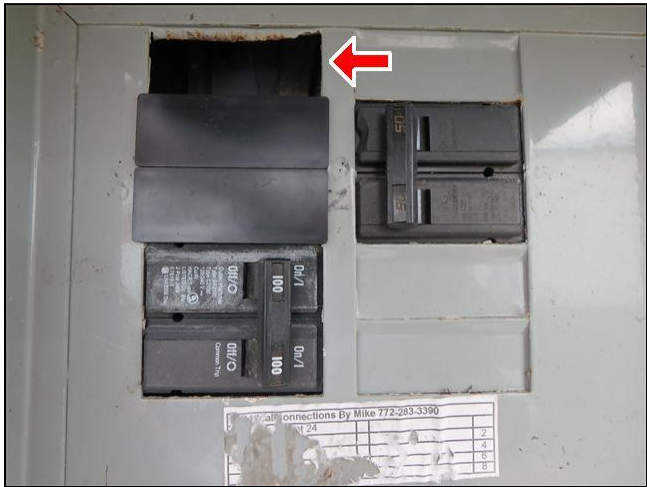
5.2 (2) Open breaker space/knockout. This can be a safety hazard and should be covered

(2) Open breaker space/knockout. This can be a safety hazard and should be covered

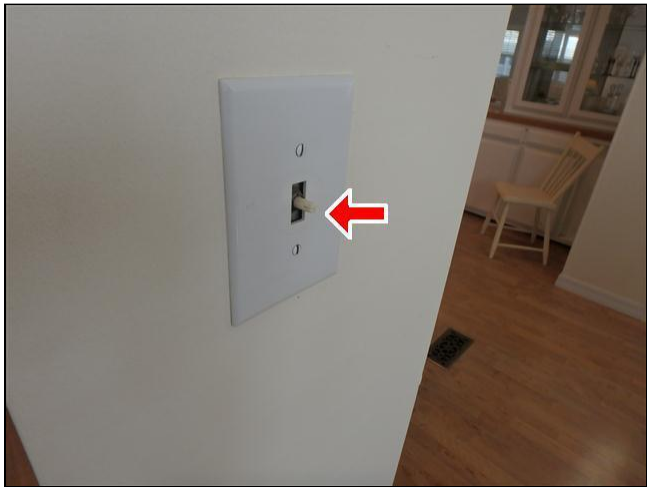
5.5 Missing switch knob

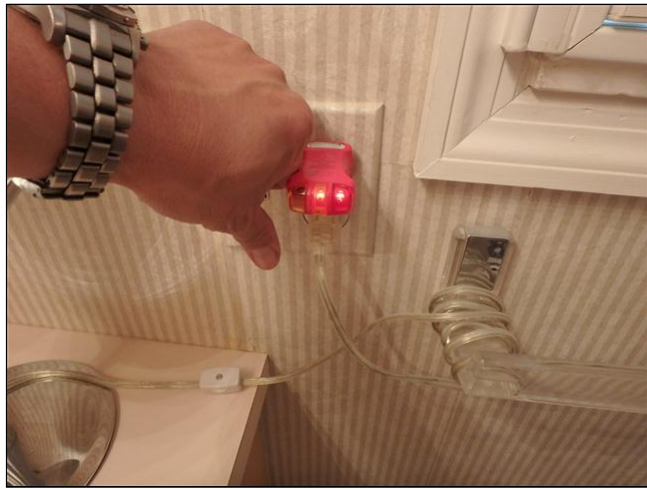
🏠 5.6 Noted an electrical receptacle that had reverse polarity. This should be corrected by a qualified electrical contractor

Noted an electrical receptacle that had reverse polarity. This should be corrected by a qualified electrical contractor

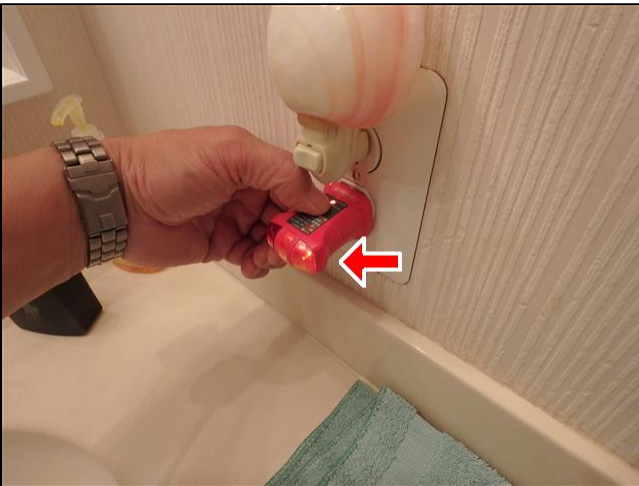
🏠 5.7 There are GFCI receptacle(s) that are not working. Recommend that any inoperative GFCI receptacles be replaced.

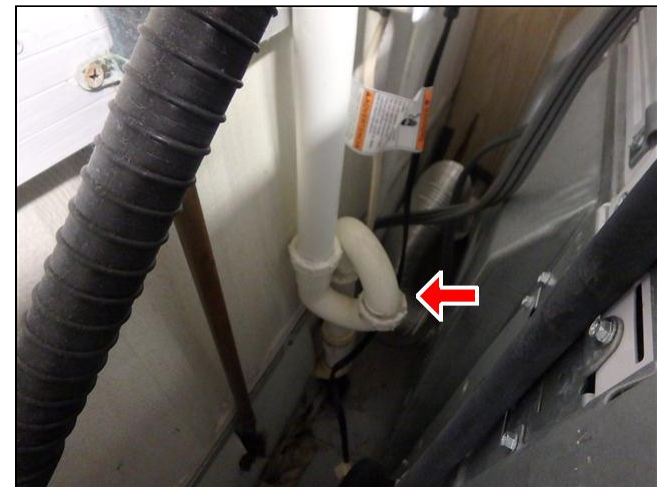
**6.1** “S” traps aren’t allowed because they have the potential to suck, or ‘siphon’, water out of the trap as the water flows down the drain. This should be corrected by a qualified plumbing contractor

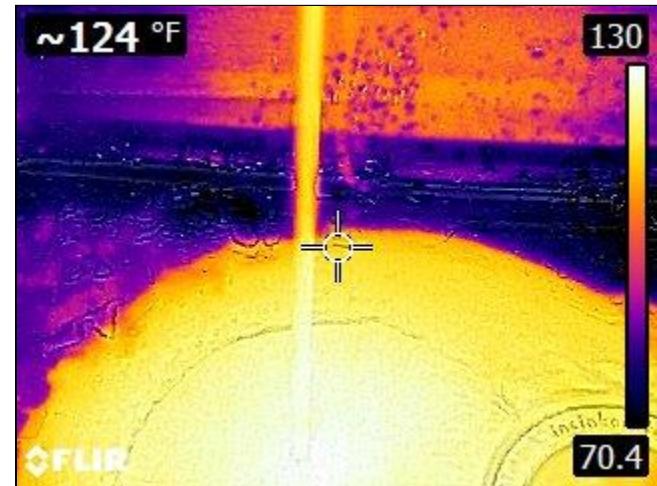
6.4 The hot water temperature was 124 degrees fahrenheit at the time of the inspection.

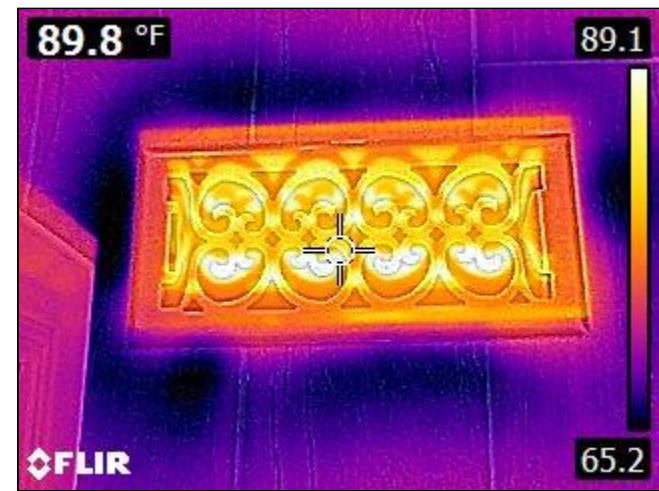
7.3 Heat was working as expected using normal controls

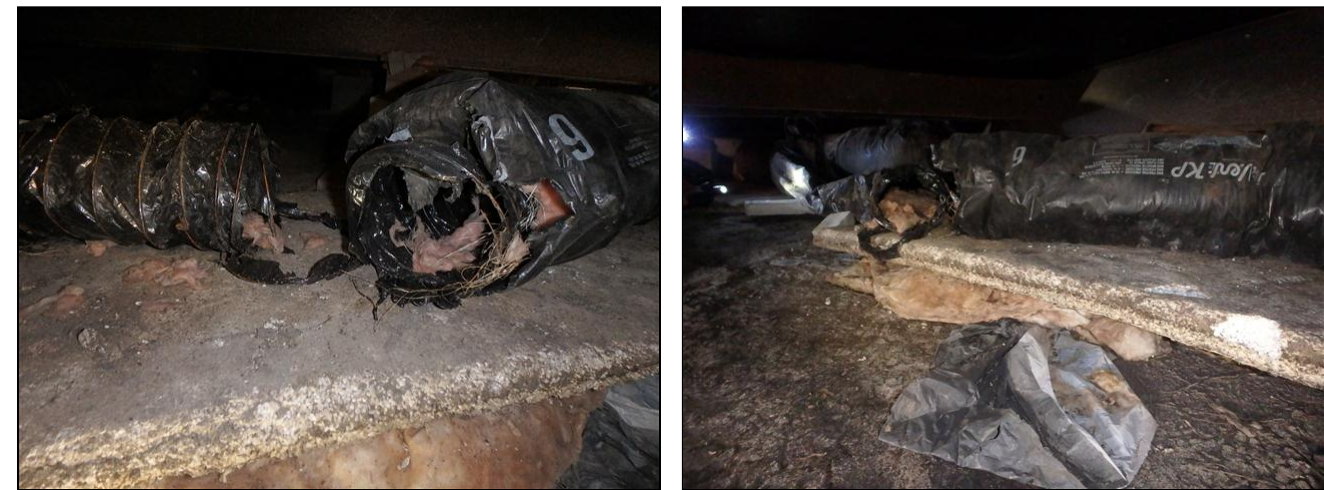
7.6 (1) In the crawlspace, there is a SUPPLY duct that is severed. It appears to have been damaged by rodent activity. Currently, the ducting is active and is allowing conditioned air to vent directly into the crawlspace area. This is affecting the efficiency of the HVAC system and of the cooling capacity of the interior of the home. This should be corrected as soon as possible.

(1) In the crawlspace, there is a SUPPLY duct that is severed. It appears to have been damaged by rodent activity. Currently, the ducting is active and is allowing conditioned air to vent directly into the crawlspace area. This is affecting the efficiency of the HVAC system and of the cooling capacity of the interior of the home. This should be corrected as soon as possible.

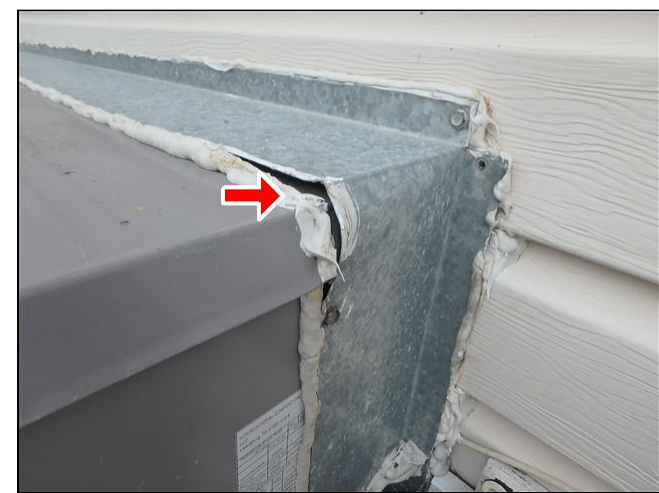
7.6 (3) Open gap at the HVAC should be sealed

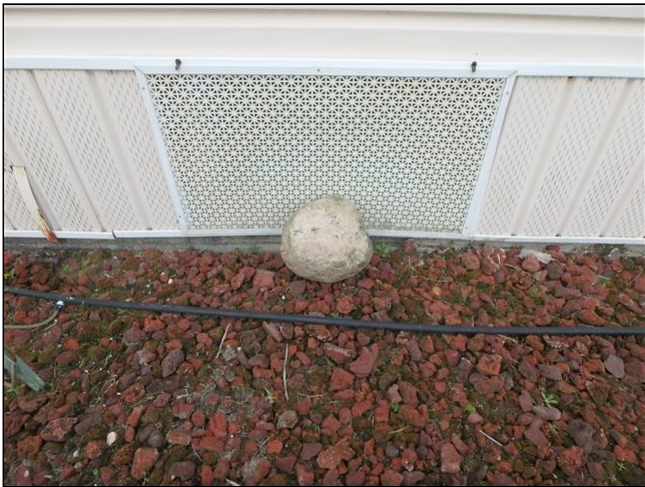
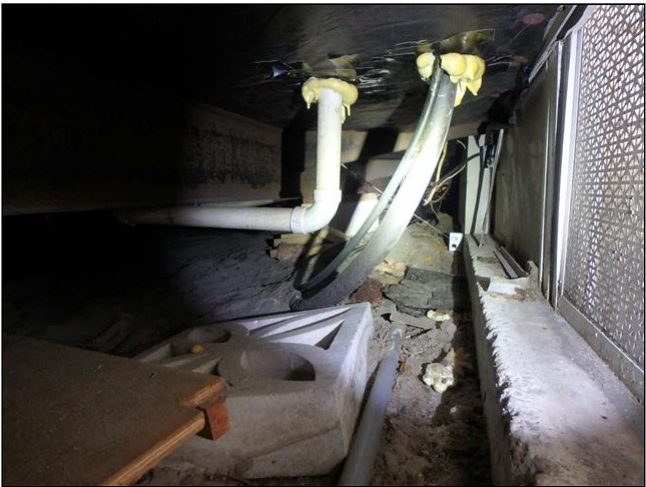
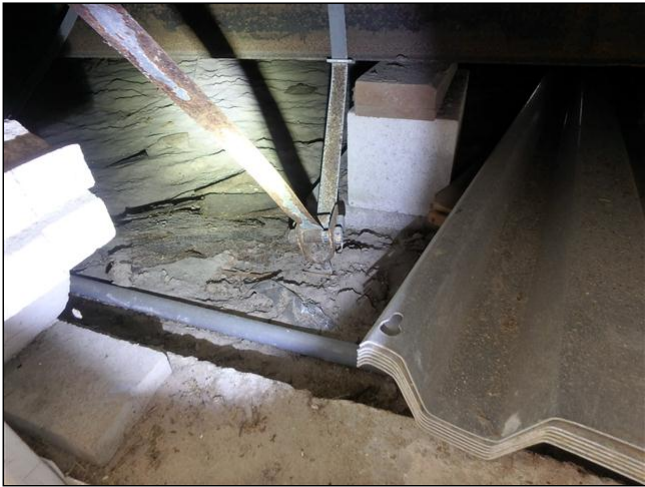
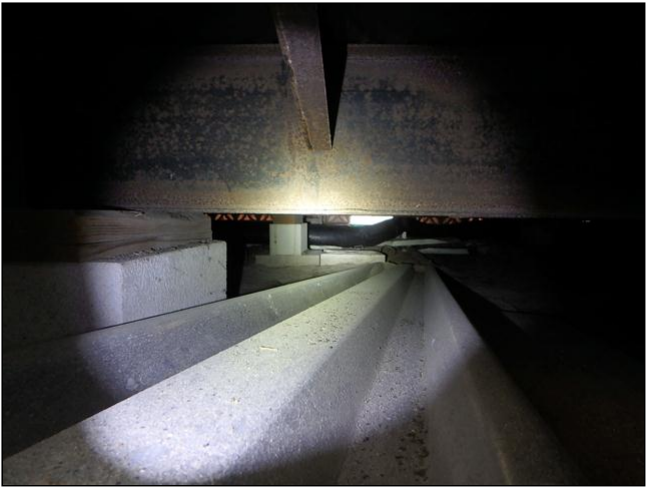
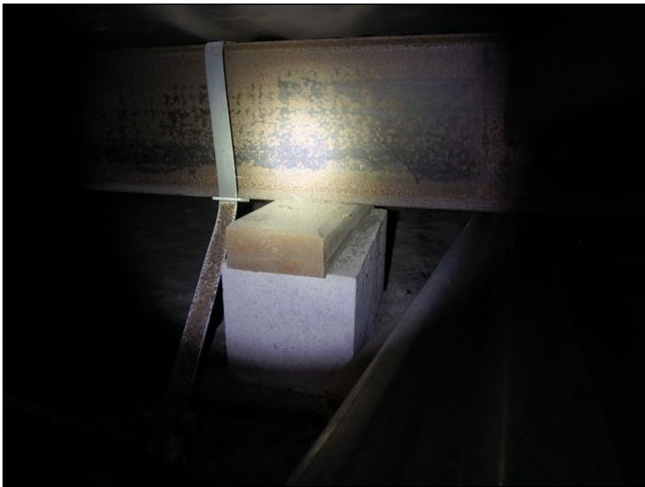
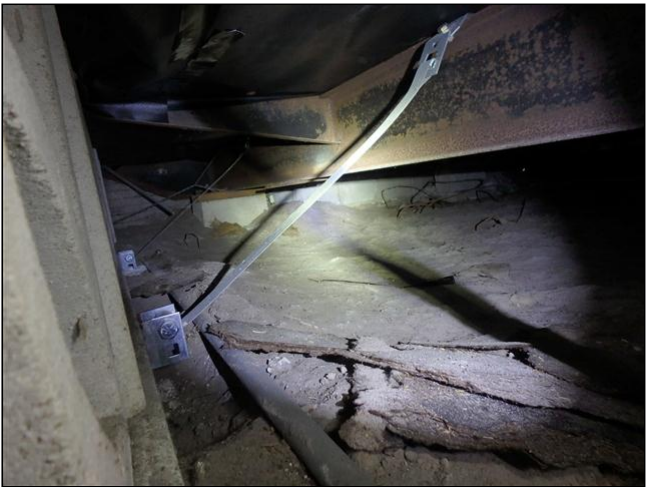
8.0 The crawlspace was accessed but not all areas were accessible due to debris and HVAC venting/ducting systems. There are no obvious water leaks and the overall condition of the components are good. There is some surface rusting to the chassis, but that is normal and expected. The supports are in good overall condition. There is a severed HVAC supply duct which was discussed in section 7 HVAC. There are insulation panels installed on the ceilings of the undercarriage of the home. There is no water/vapor barrier. One side of the home has had the hurricane storm straps replaced, but the other side does not. It was conveyed to me that those will be replaced in the near future, and a copy of an invoice/work order for the straps were available.

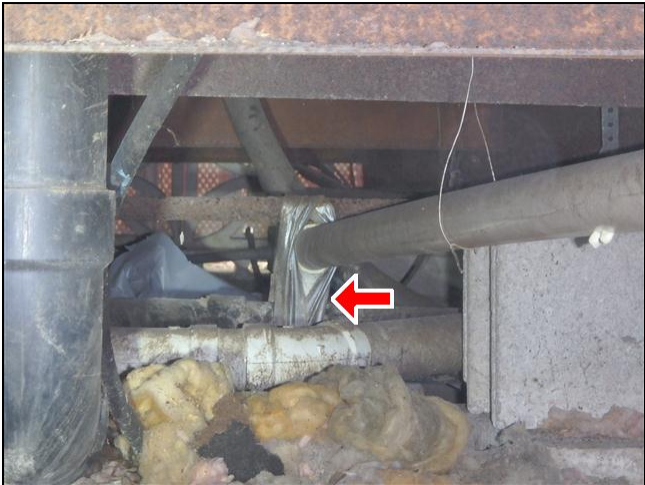
8.10 (2) View of new straps

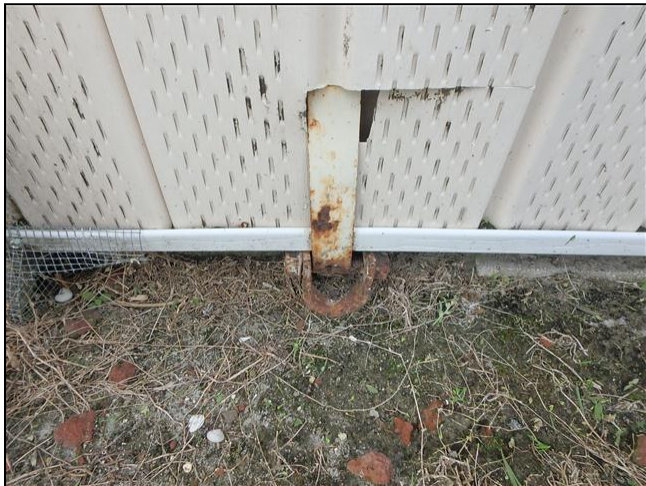
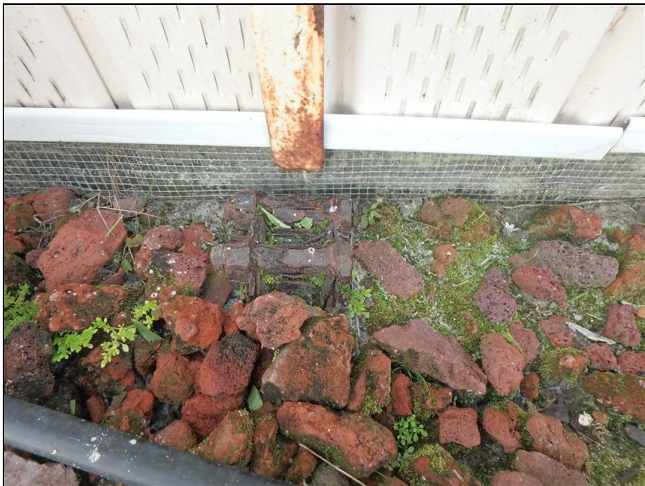
8.10 (3) Old decayed straps
