# Inspection Report

Property Address:  
5555 Sample Road  
Wellington FL 33414

<b>Date:</b> 6/8/2023	<b>Time:</b> 01:00 PM	<b>Report ID:</b>
<b>Property:</b> 5555 Sample Road Wellington FL 33414	<b>Customer:</b> Sample Report	<b>Real Estate Professional:</b>

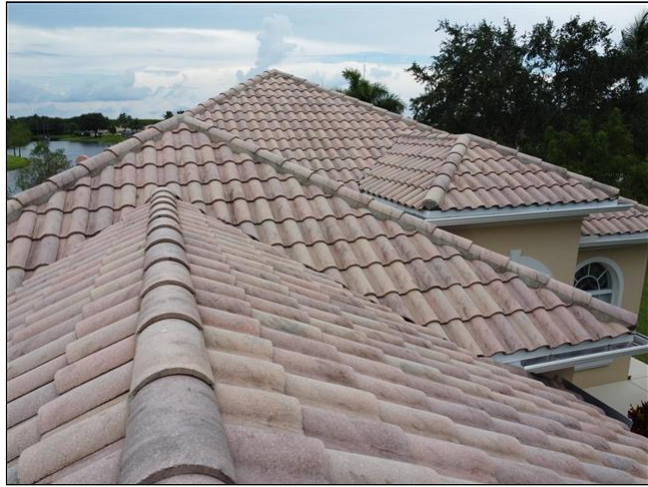
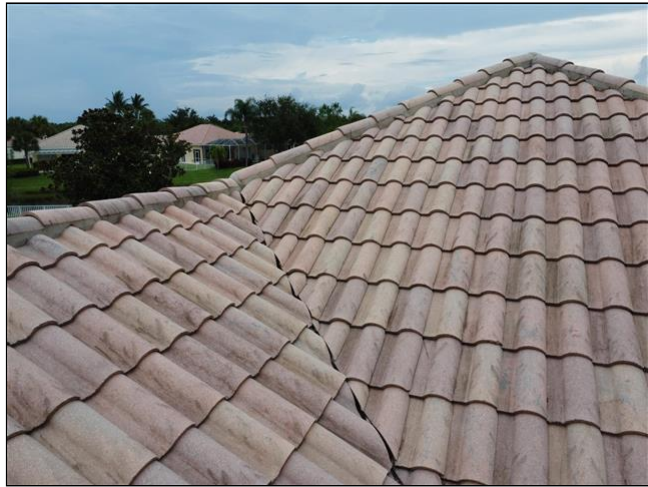
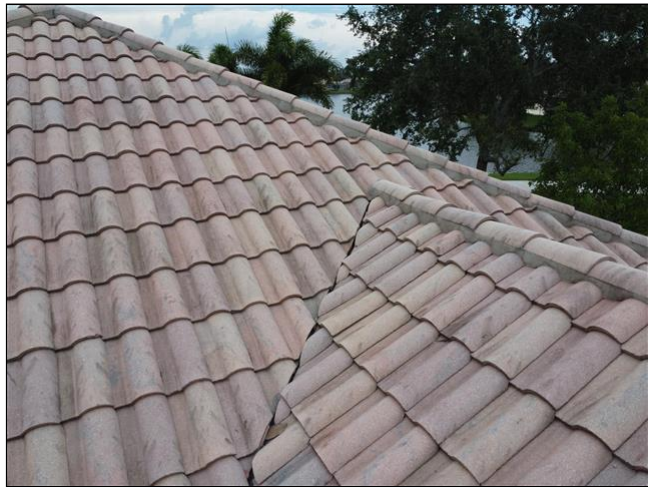
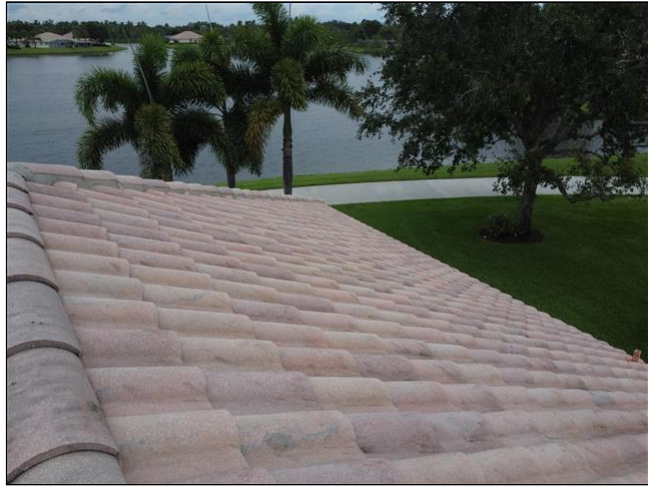
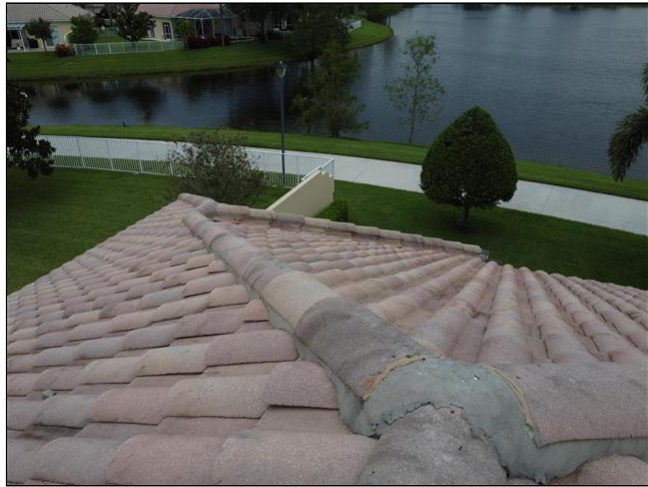
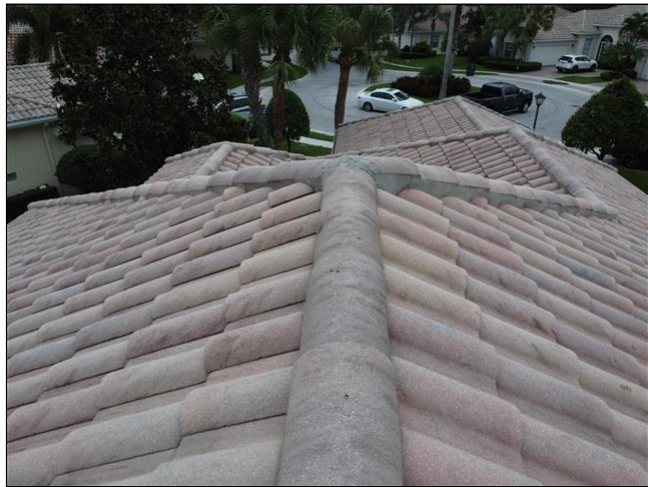
**2.0 (2) The roof appears to be in good overall condition. However, there are at least two areas where the roof is leaking.** Under harsh weather conditions and intense summer heat, the underlayment, which is the actual moisture barrier that lies beneath the concrete tiles, can become deteriorated and begin to fail without notice as it ages. Since the underlayment is underneath the tiles, it is not accessible or visible and its actual condition is not known.

2.4 There is visible water leaks at the attic. Please see section 10 for further information.

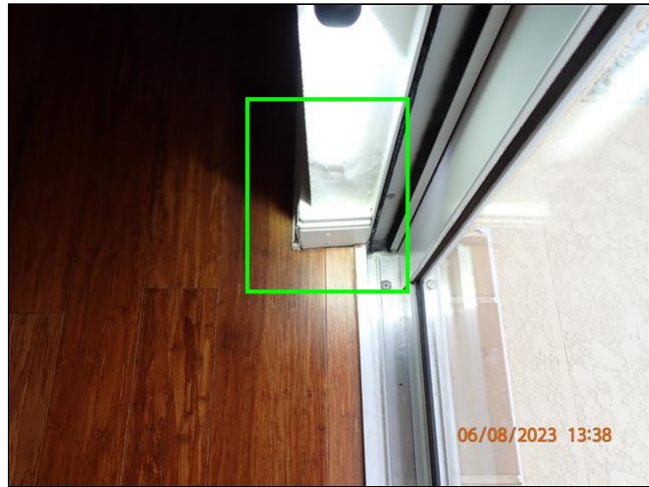
4.4 Staining, deterioration or previous repairs were found at one or more areas around the home. These types of stains/repairs appear to be from previous moisture intrusion issues such as roof and/or plumbing leaks. There could be concealed issues that may still result in active moisture intrusion at these or other areas which may not have staining. The extent of any moisture intrusion damage cannot be predicted without aggressive methods such as opening up ceilings or walls to expose these areas, which is beyond the scope of this home inspection. We recommend consulting with the seller/owner for any additional information such as invoices that can serve to document that those affected areas were properly corrected. We further recommend monitoring these area(s) especially after rain events. If elevated moisture is found, we recommend having a qualified contractor evaluate and repair as necessary.

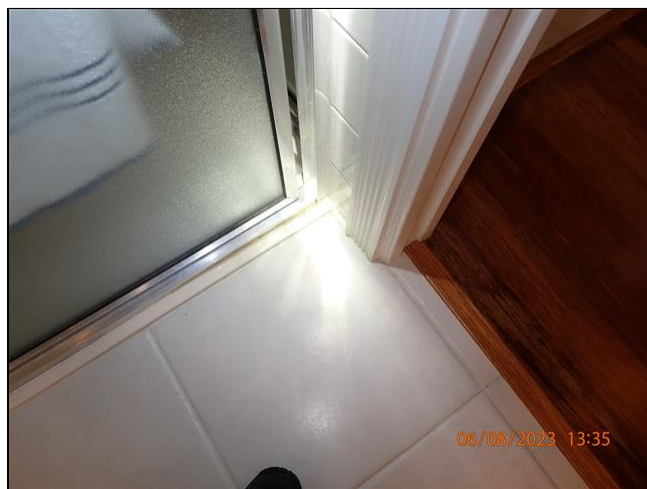
**4.7** The areas adjacent to showers on either side may have some moisture deterioration. These areas are very common for this as water from the shower can splash and cascade down along the walls and tubs. These areas can have different degrees of deterioration and may have affected the walls and possibly the inside of the walls and or floors depending on how much exposure to water and for the length of time they have been repeatedly subject to moisture.

Note: While these areas are likely moist due to shower water run-off, these areas should dry out if the shower has not been in use. Recommend having these areas rechecked to ensure they are not remaining moist or getting worse which would indicate a different water source such as a plumbing leak.

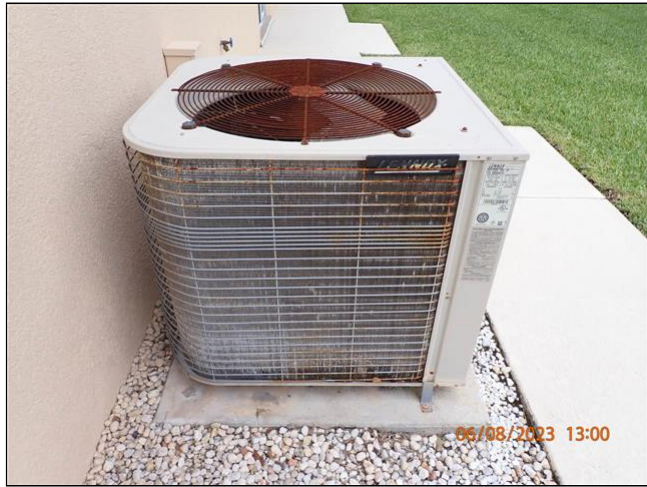
**8.0 (2)** Note there is visible corrosion at the condenser unit. It is the original unit and can fail at any time.

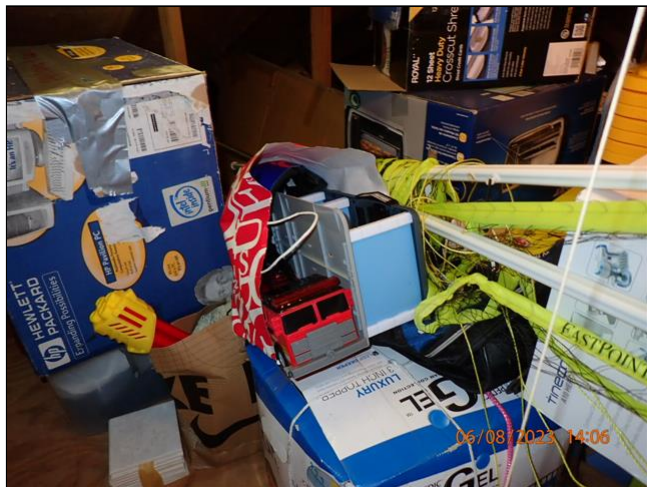
10.9 Note: there is stored personal items in the attic space above the garage. As a result areas of this part of the attic could not be properly inspected
