Inspection Report

Mr Sample Report

Property Address:
1234 Sample Report
Sample City FL 33444

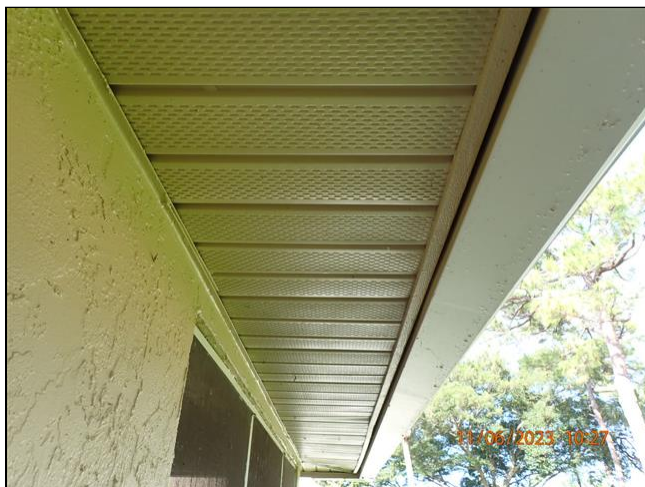
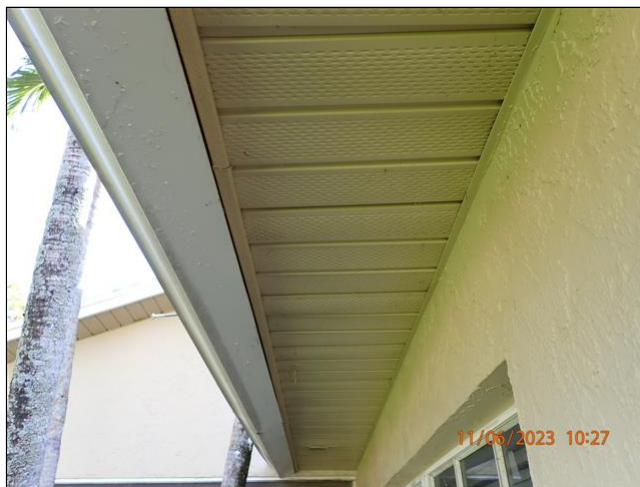
1.1 (2) There are one or more areas along the fascia that appear to have some degree of moisture deterioration. Recommend monitoring this area and replace if necessary. Presence of moisture or prolonged presence of moisture would indicate possible roof leaks in the affected areas. Note: When opening these affected areas up for repair/replacement, expect that there will be some degree of deterioration with the fascia, sheathing and or other concealed components.

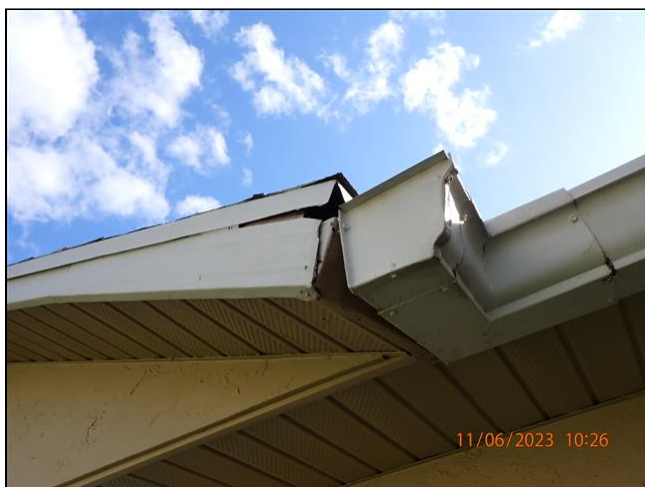
📍 1.2 (1) Entry door sidelight lower frame is water damaged.

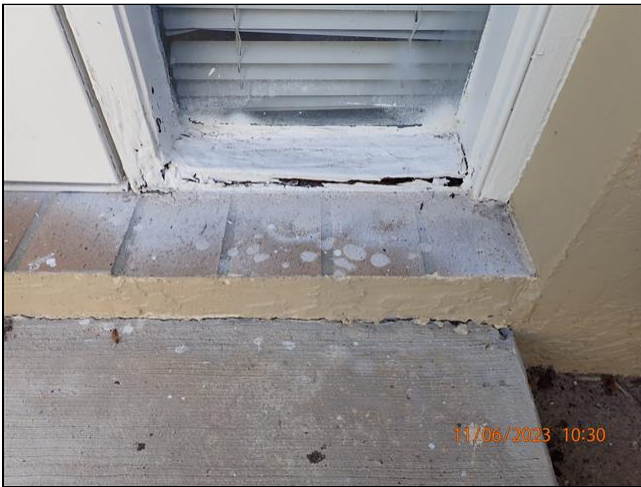
📍 1.2 (2) Wood rot is noted in the lower portions of the exterior door/door jamb areas.

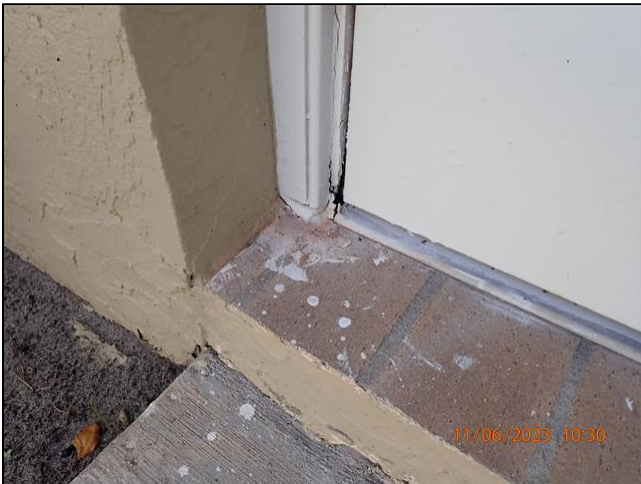
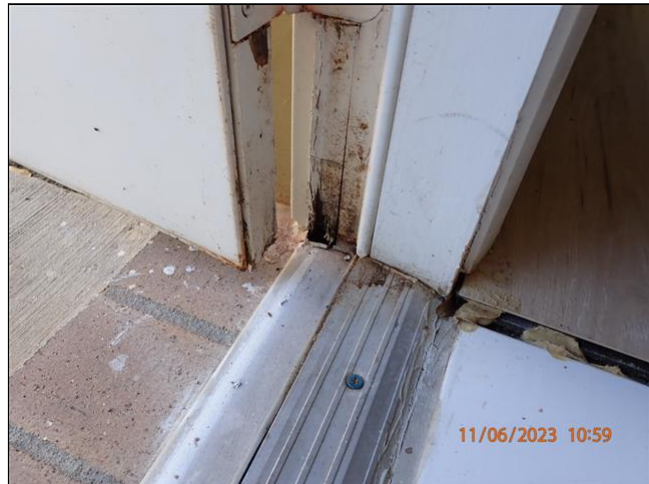
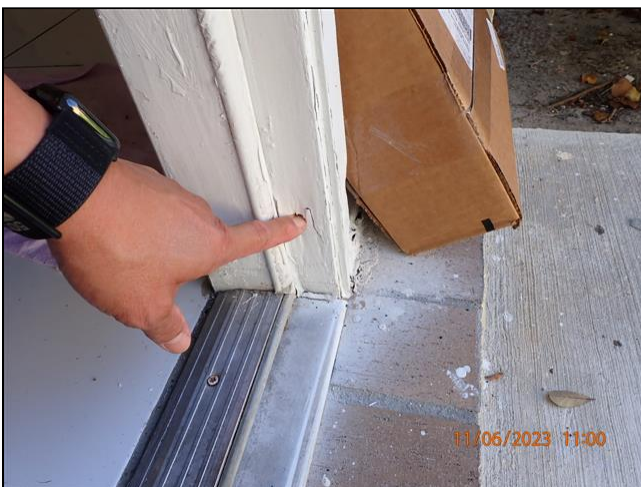
1.3 Detached window screen found on the ground.

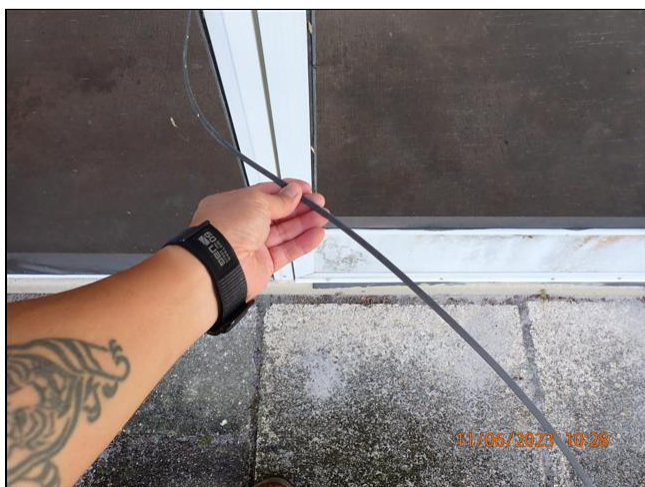
**📍 1.4 (3) Enclosure door mechanism should be serviced or replaced. It is corroded.**

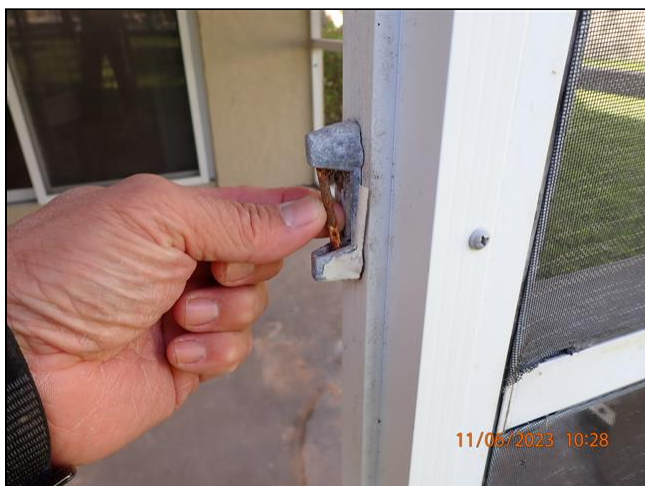
1.4 (4) Door closer does not close door fully.

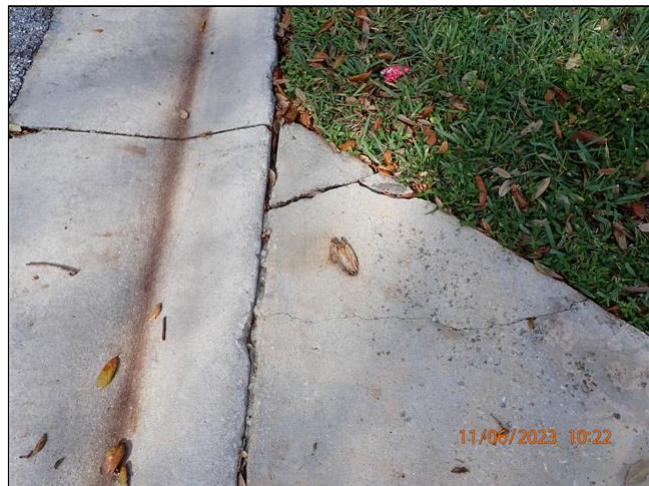
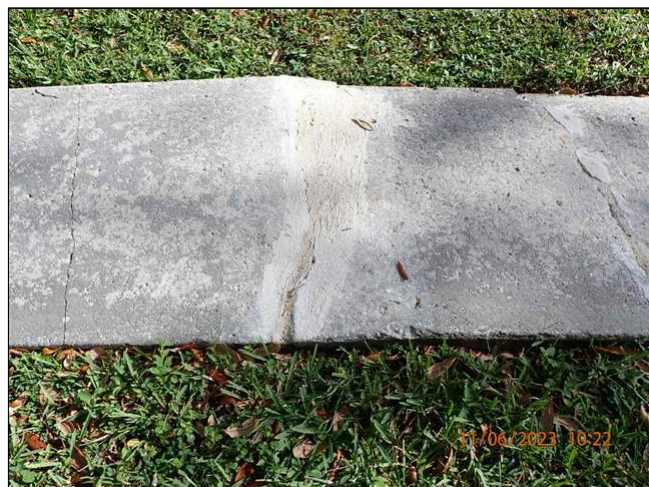
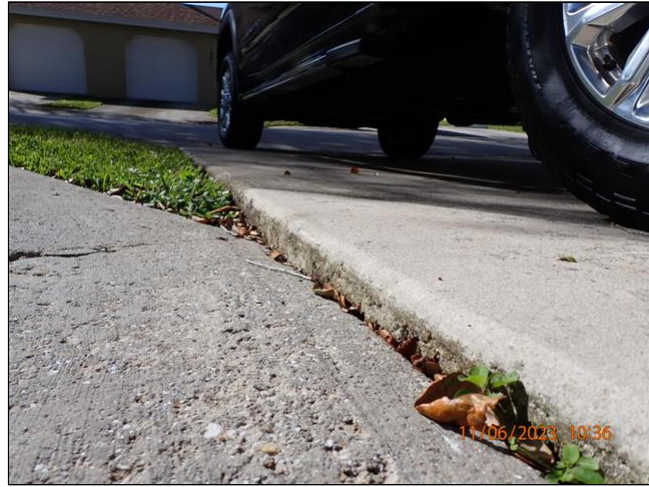
📍 1.5 (2) Walkways are sinking and causing a trip hazard. There is a large tree nearby and the root system can be affecting the walkways and driveway. This needs to be corrected as it is a tripping safety hazard.

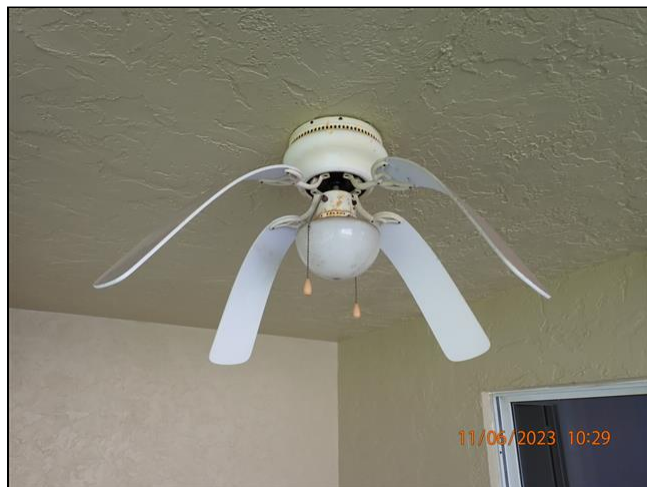
1.8 Exterior ceiling fan needs to be replaced.

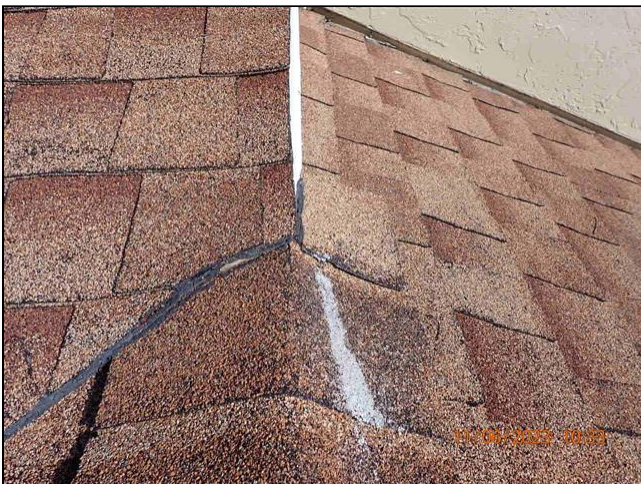
2.1 (2) There are one or more areas where flashing/kick out flashing is missing or may be inadequate to effectively divert water away from the house. Missing, inadequate or damaged flashing can cause leaks and water intrusion into the home.

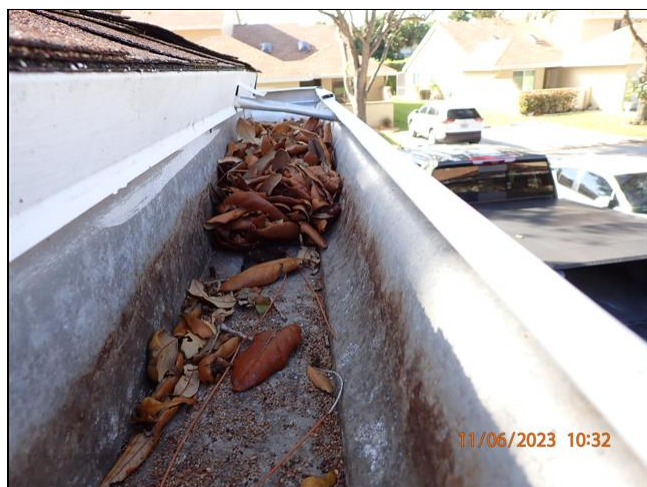
2.3 (2) There are seams in the gutter system that appear to be leaking. These seams should be properly sealed.

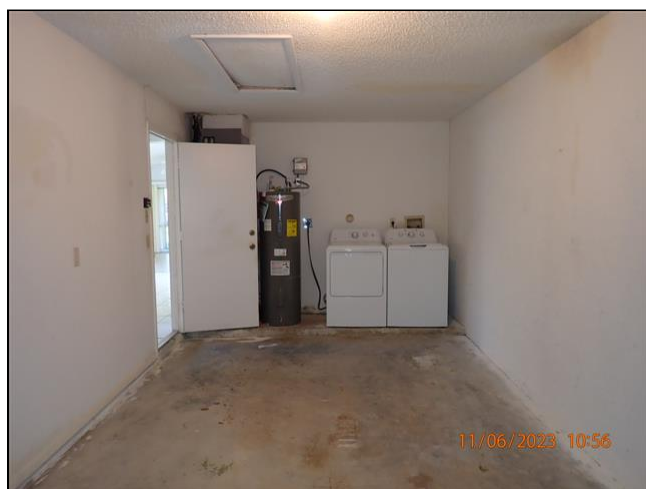
3.0 (2) Note: There is staining or discoloration at the walls and ceilings in the garage. These areas were scanned and tested with meters and were not moist at the time of the inspection.

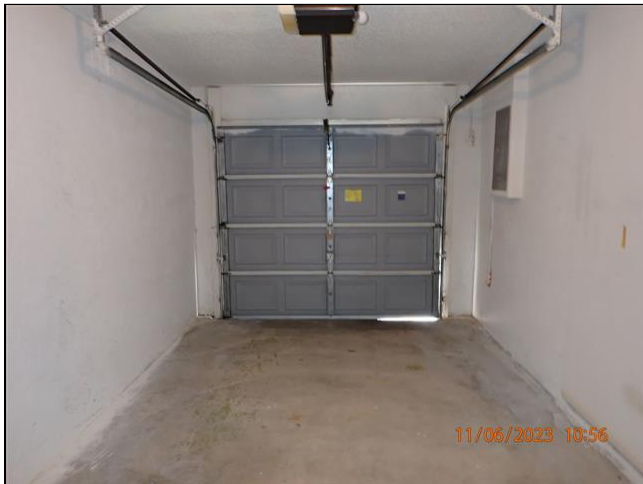
3.2 (1) The garage door and opening system needs to be replaced. It is damaged and the door does not open. It can only open partially manually.

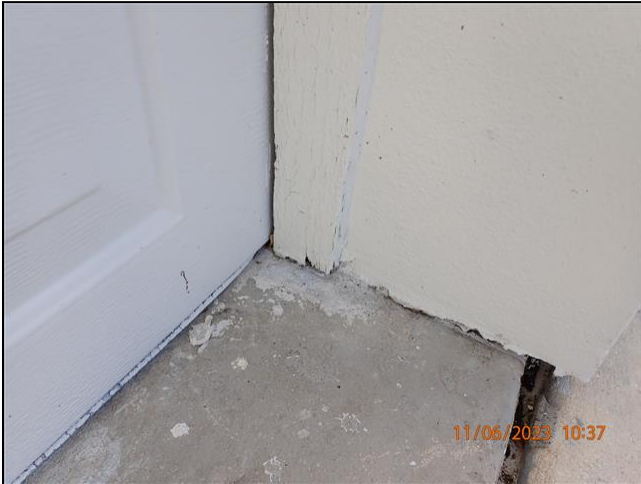
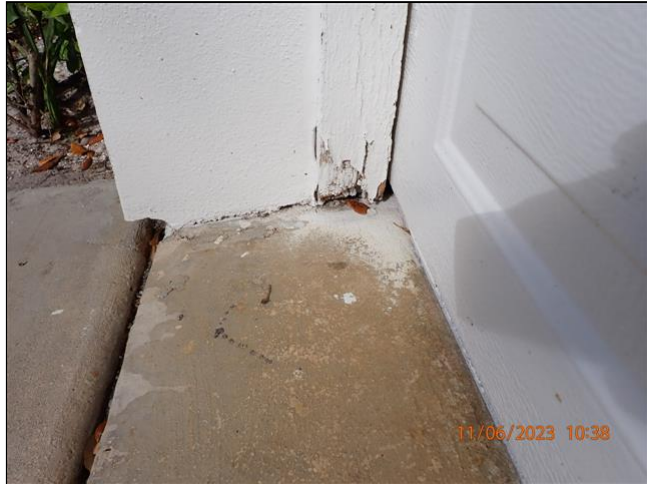
3.2 (2) The garage door framing has some wood rot at the base of the sides of the framing. This is typical with wood products and exterior locations due to the high moisture levels and rain water wicking to those areas

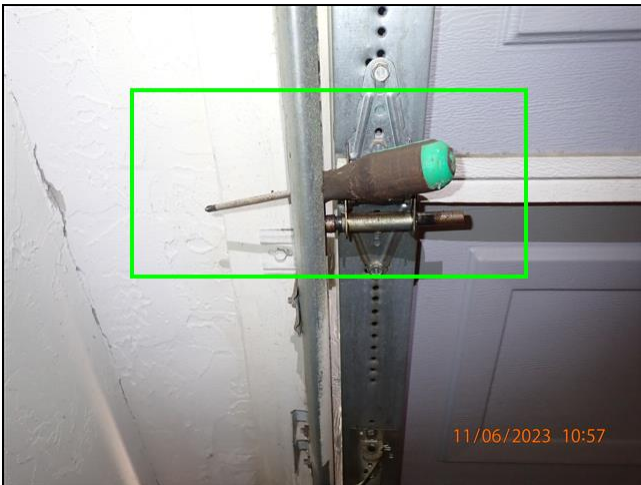
3.2 (3) Note: There is no deisgned method to keep the garage door locked, so a screwdriver is put into one side to prevent the door from beikng opened.

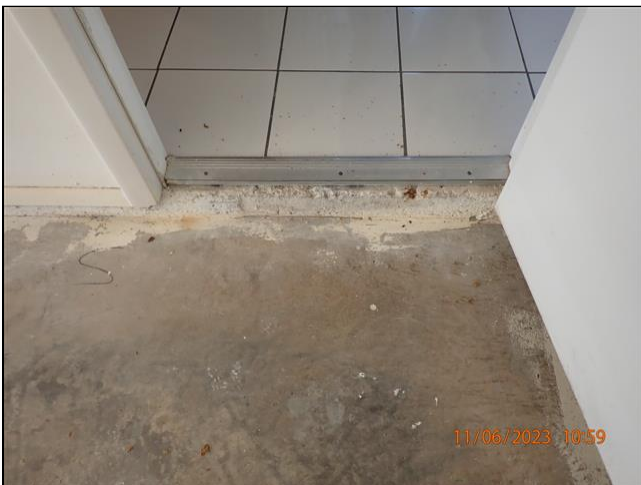
3.3 (1) The occupant door leading from the garage to the interior of the house should be not be less than 1-3/8" in thickness or fire-rated (for 20 minutes minimum), properly weather stripped and self closing. The intent is to isolate any carbon monoxide and fire/smoke from entering the living spaces of the home. This recommendation is a matter of safety, not a requirement to replace.

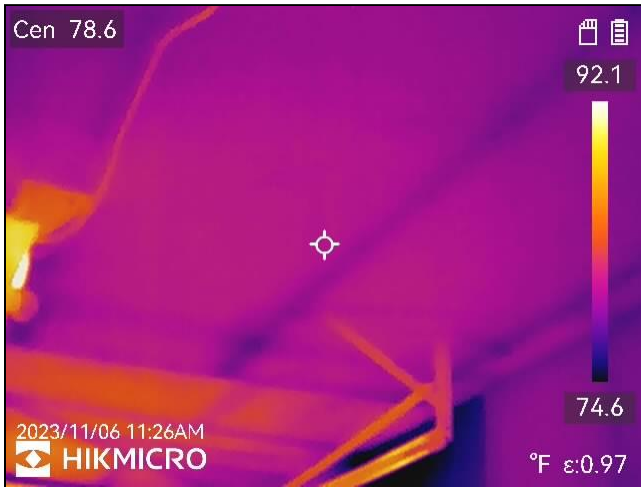
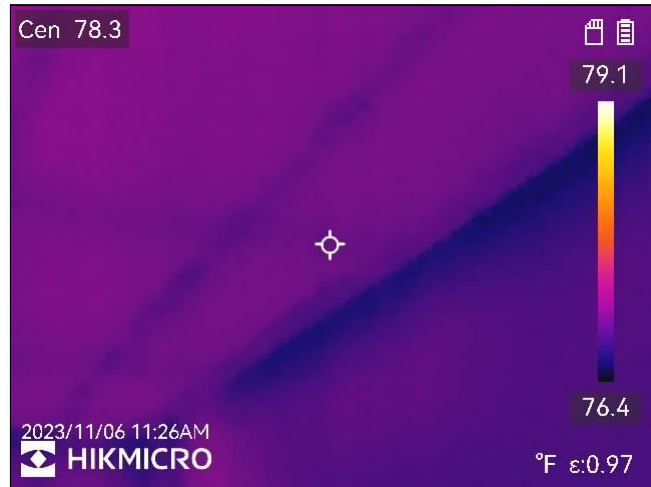
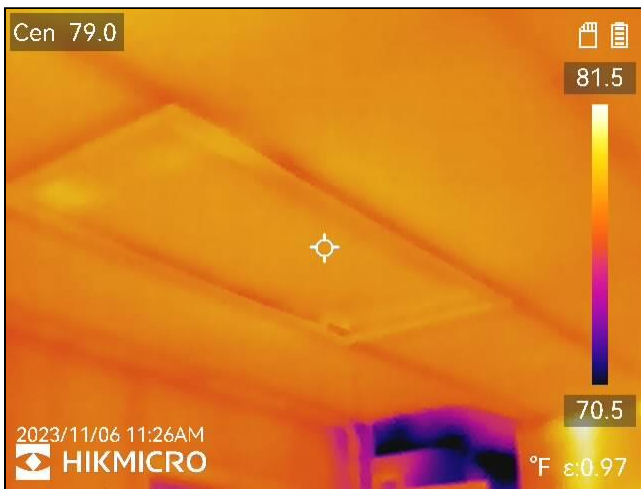
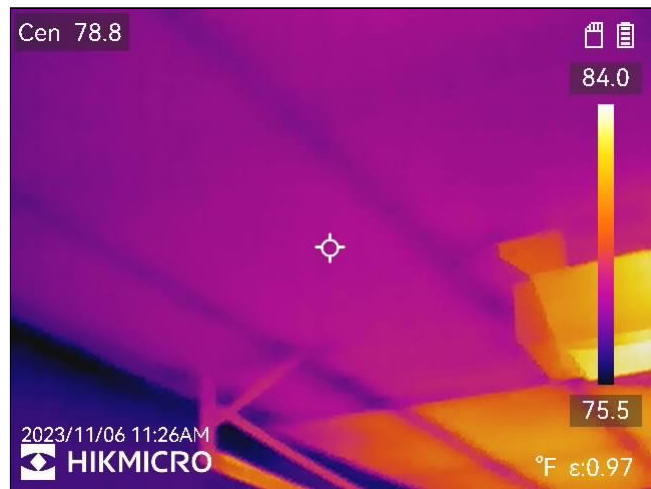
3.11 Garage walls and ceiling were scanned with an infrared thermal camera and were non resultant for elevated moisture at the time of the inspection.

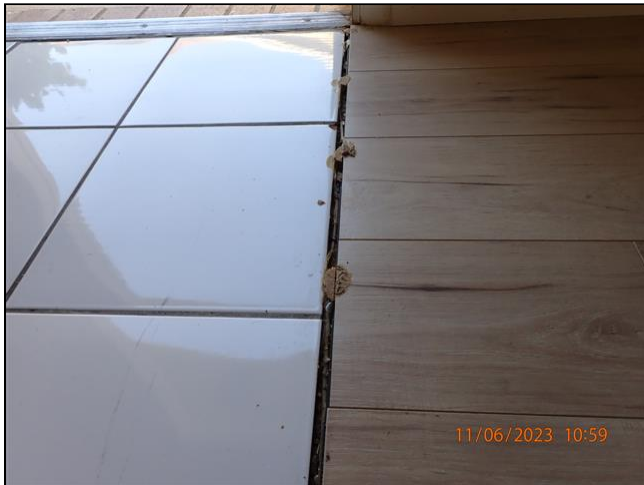
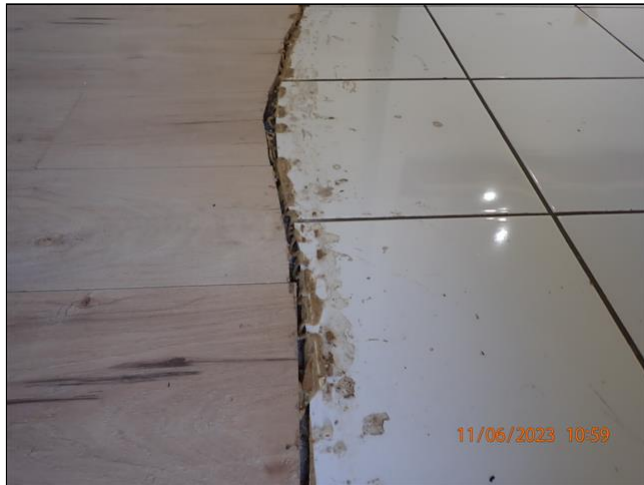
4.0 (1) Note on flooring: Interior finished flooring with materials such as but not limited to carpeting, linoleum, and laminate flooring can conceal damage, deterioration or other issues which are not accessible. This home inspection does not include any invasive actions in any manner, to attempt access to the sub flooring via removal, in whole or in part thereof. Additionally, wall to wall type carpeting will harbor dirt and conditions conducive to mold growth. When any finished flooring is removed, it can expected to find one or more areas of damage or deterioration including the presence of mold. We recommend discarding any carpeting and cleaning and sanitizing the remainder of the property. Unfinished areas. Uneven flooring.

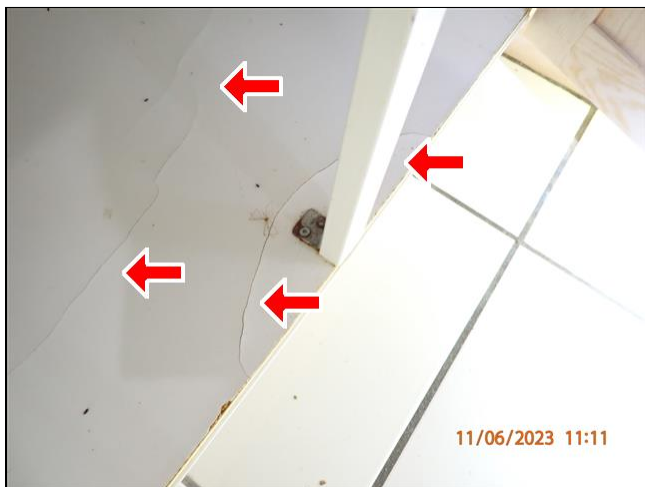
4.1 (2) Kitchen sink cabinet has damages to the floorboards and walls.

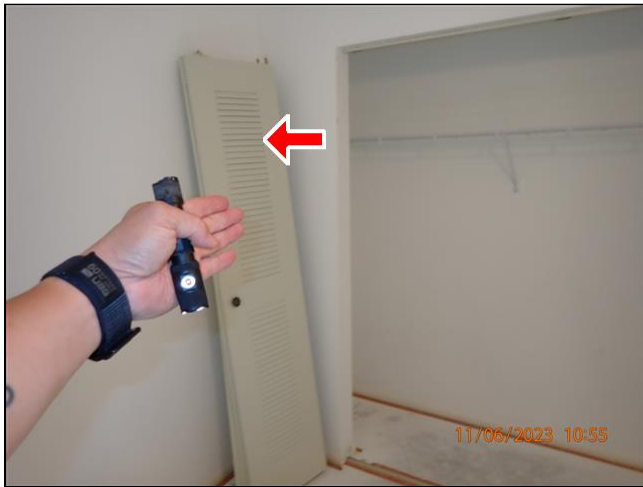
📍 4.2 Interior bifold closet door(s) are not in their tracks.

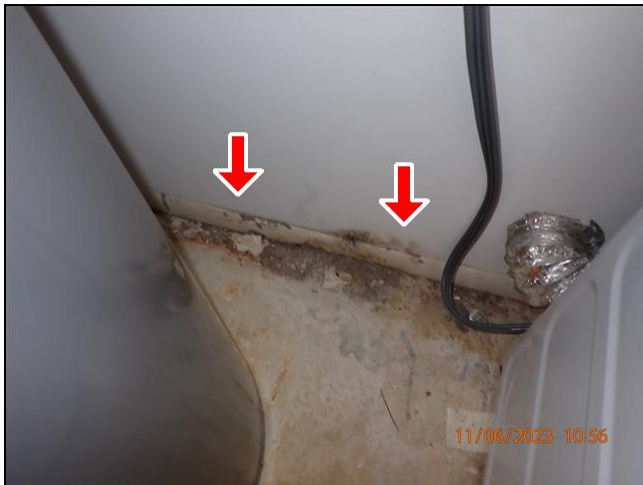
📍 4.3 There is visible mold present. There is also musty odors which are indicative of the presence of active mold. We recommend having a mold assessment conducted in order to confirm the presence of mold, the type of mold and mold spore counts to ascertain the level of danger in the structure. All visible mold and the sources of moisture will require remediation.

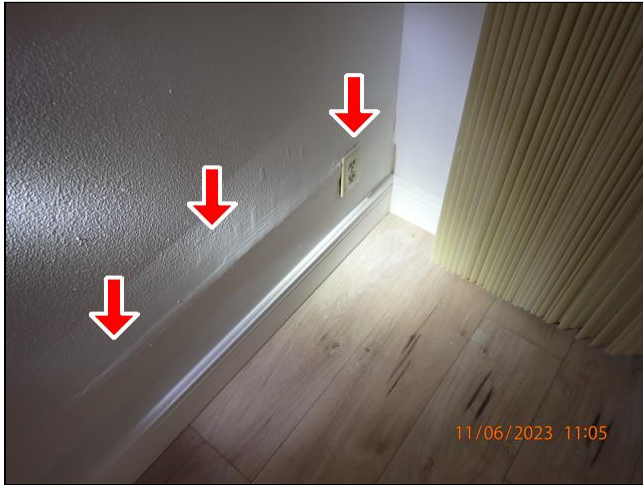
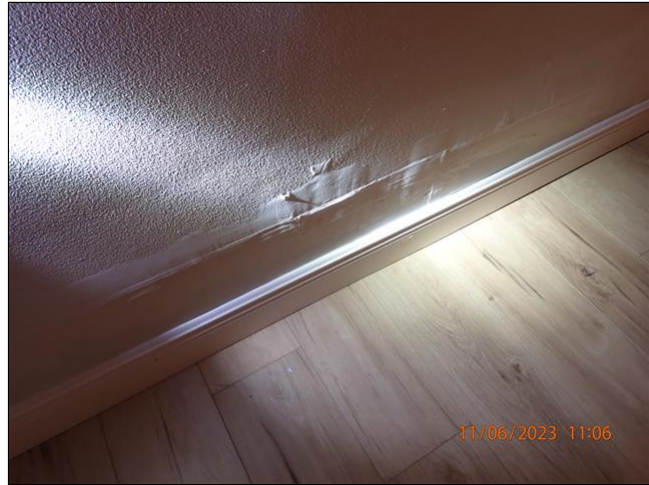
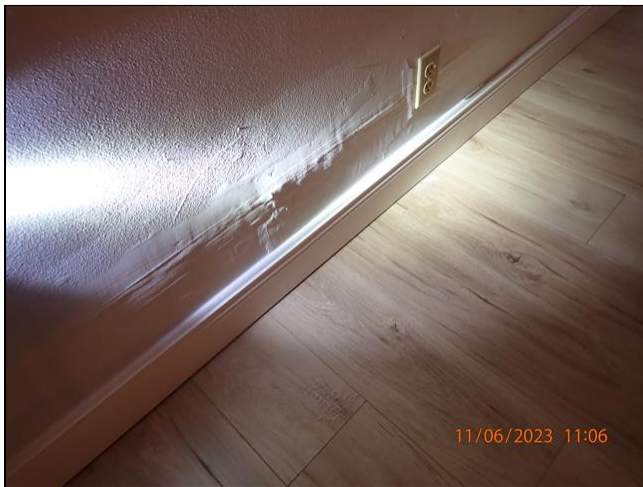
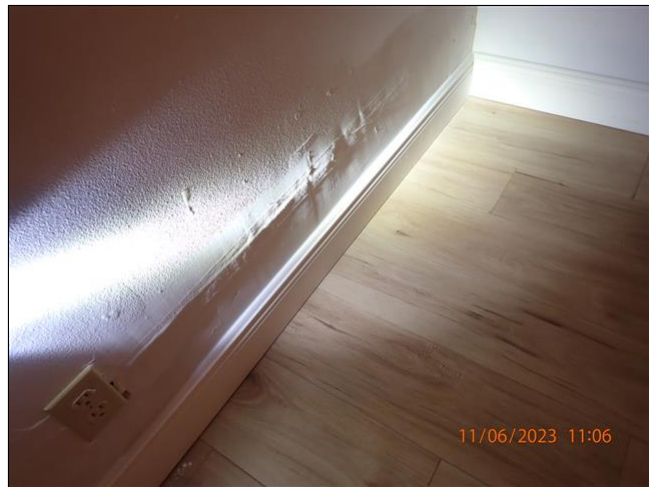
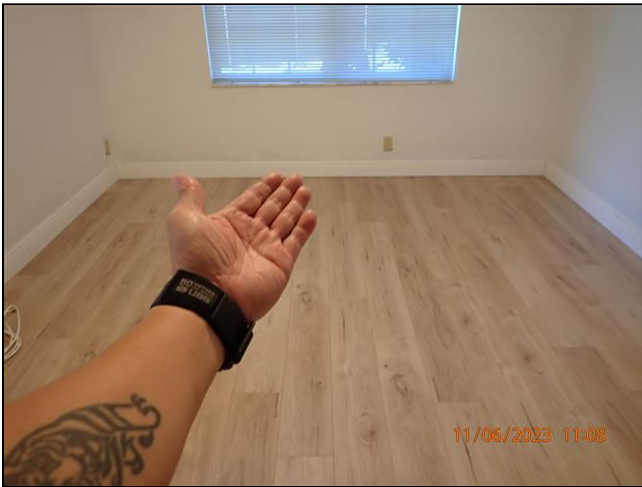
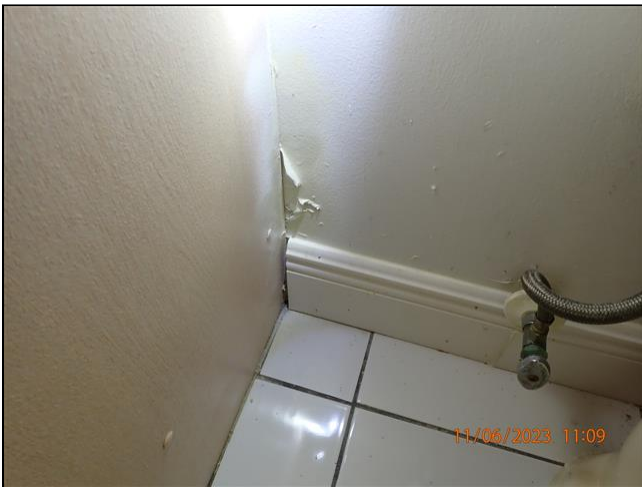
4.4 Note: The property has polybutylene piping. There was likely a leak which caused a flooding situation. That made it necessary to remove flooring and carpeting. It appears mold and water damage remediation was conducted. Whole sections of lower walls were removed to assess and remediate the water and mold damages. Total damages and teriary damages may have ocured but have been covered. The workmanship is subpar and there are no permits on file for flood repairs. Interior of walls, ceilings etc are not accessible. There could still be concealed damages and unprofesional repairs present.

Recommend consulting with the seller for the mold assessment and remediation reports.

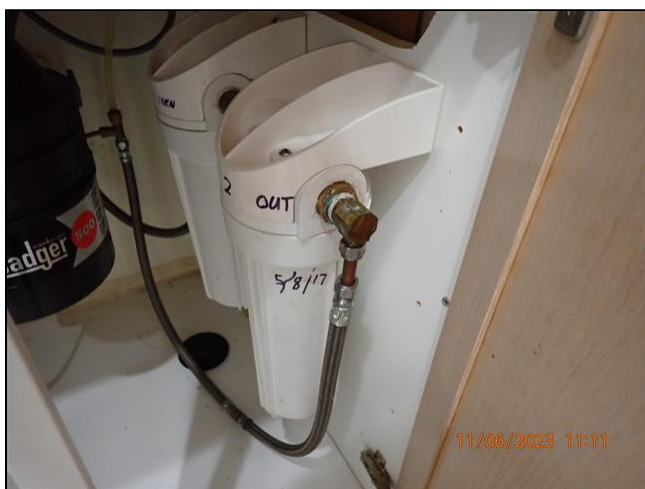
4.6 (2) Note: The cabinet under the kitchen sink felt excessively warm. The heat could be radiating from the dishwasher which is adjacent to it. This should be monitored and addressed if necessary.

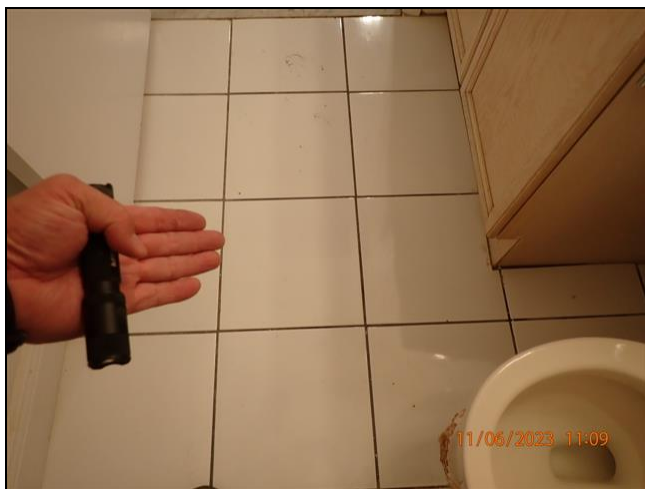
4.7 (2) The areas adjacent to showers on either side may have some moisture deterioration. These areas are very common for this as water from the shower can splash and cascade down along the walls and tubs. These areas can have different degrees of deterioration and may have affected the walls and possibly the inside of the walls and or floors depending on how much exposure to water and for the length of time they have been repeatedly subject to moisture.

4.7 (3) Note: The bathroom/shower floor tiles are glazed and smooth which will be slippery when they get wet. This can be a safety hazard. Recommend installing a safety type shower mat inside the shower and in the bathroom floor for safety traction.

Note: While these areas are likely moist due to shower water run-off, these areas should dry out if the shower has not been in use. Recommend having these areas rechecked to ensure they are not remaining moist or getting worse which would indicate a different water source such as a plumbing leak.

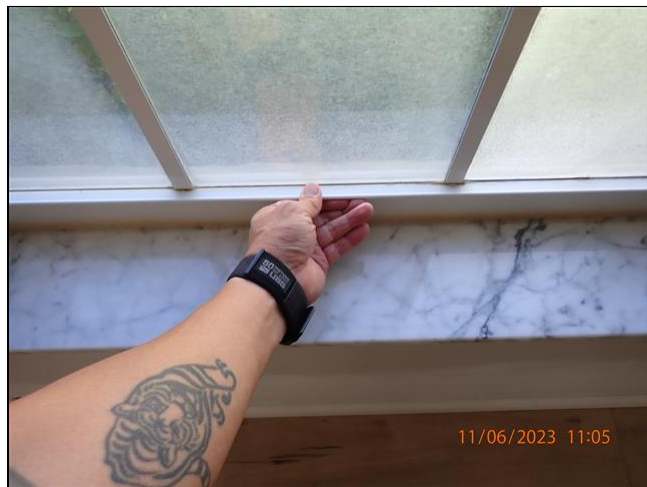
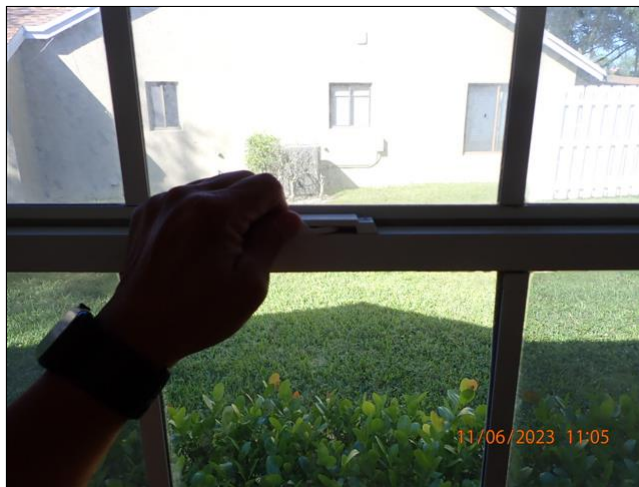
4.9 (1) All accessible windows were inspected and tested. At the time of the inspection, these windows were functioning as designed but some were slightly more difficult to open and close than others. Windows that were obstructed or otherwise not safely accessible were not operated. *Note: Window dressings and window treatments such as screens, drapes, blinds etc are not tested or operated and are beyond the scope of this home inspection*

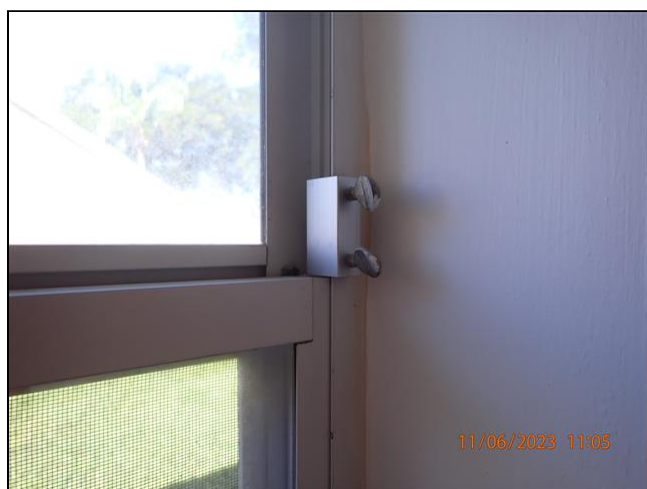
4.9 (3) There are thumbscrew operated locking devices installed at one or more windows. While these types of devices may add a layer of perceived security, they can seriously compromise the ability of an occupant to escape an untenable situation in the event of an emergency. Because windows and doors may serve as a secondary means of emergency egress, they must be maintained clear and free of any obstructions leading to and in front of the openings. Additionally, these emergency egress openings cannot be secured in a manner that requires the occupant to have to use any excessive force or energy, keys, tools or special knowledge to unlock and remove. Windows and sliders which have these or other types of locking devices installed were not tested. The functionality of those windows is unknown. Recommend removing these devices as a means of safety and operating any affected windows/sliders for acceptable functionality prior to the end of your inspection contingency period.

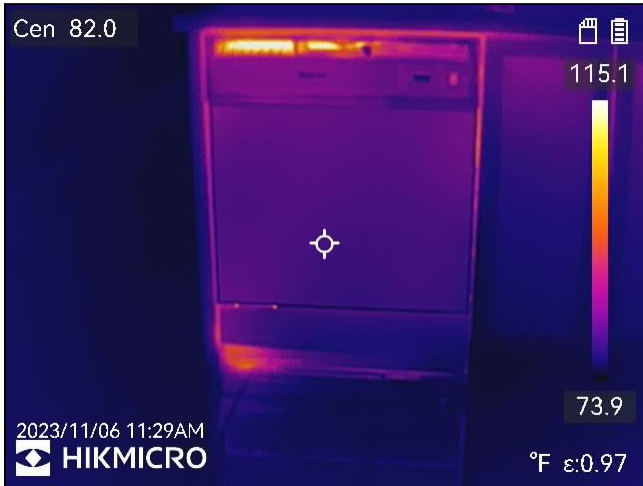
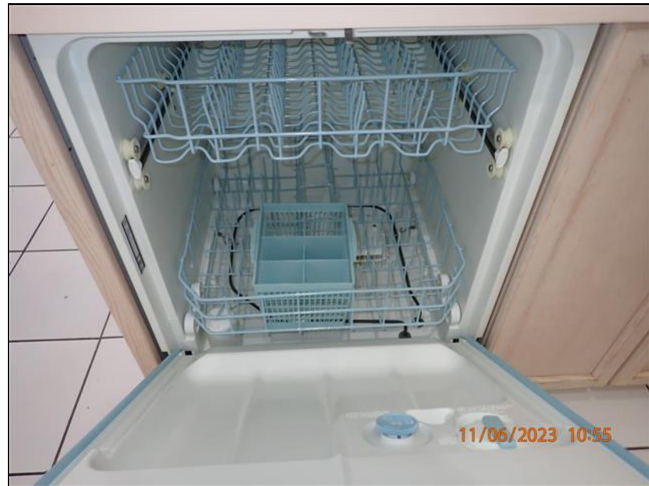
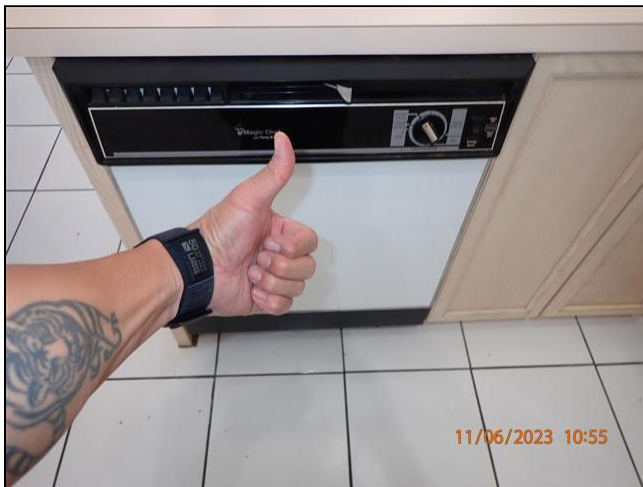
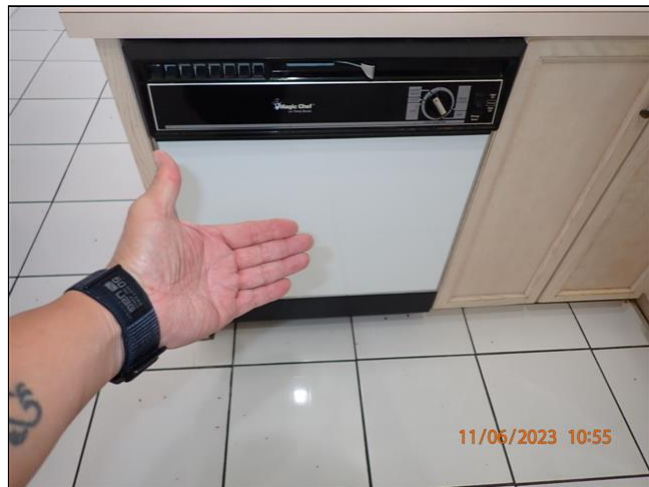
5.0 The dishwasher operated and cycled through to the end with no visible leaking but did make some elevated noise during operation. Note that the appliance is older.

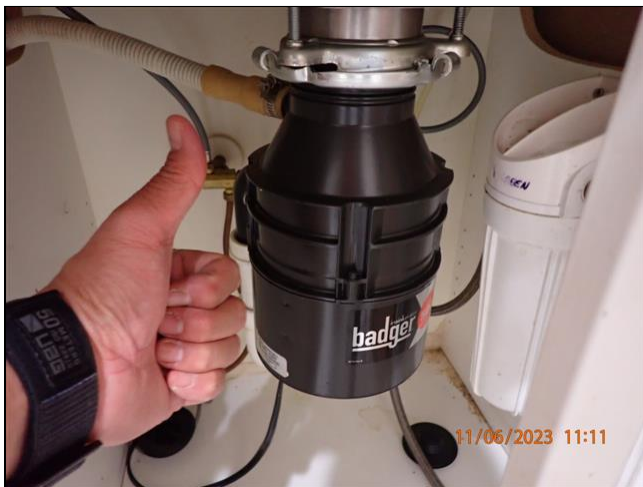
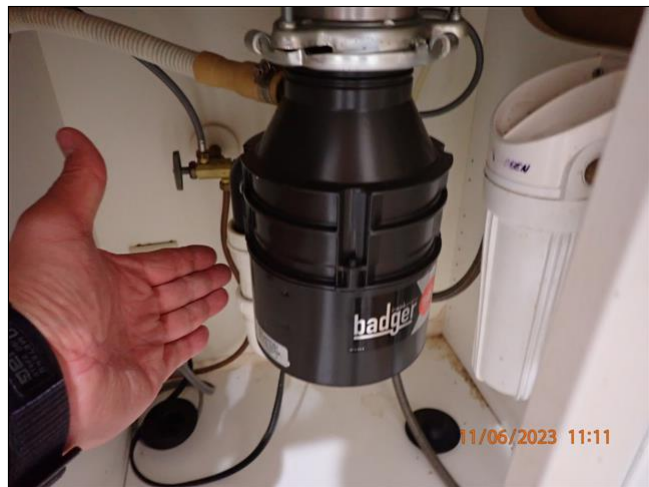
5.1 The food waste disposal unit operated as expected. There was an elevated noise level which may be that particular model and design from that manufacturer or have something caught inside. Note: disposals use blades rotating at high speeds and will cause serious injury if any objects or hands are put or reached inside. Always ensure power is turned off before attempting any servicing.

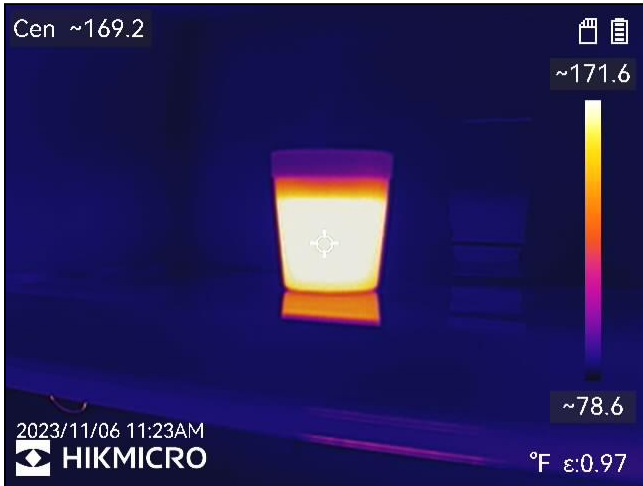
5.2 Microwave oven operated normally as expected. After 60 seconds, the microwave heated a cup with water to acceptable temperatures.

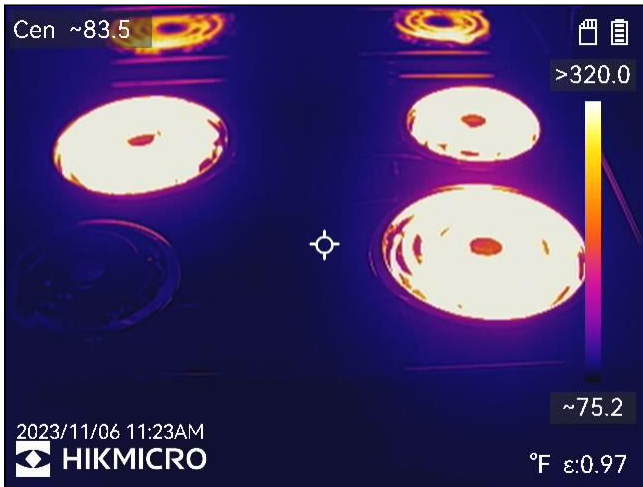
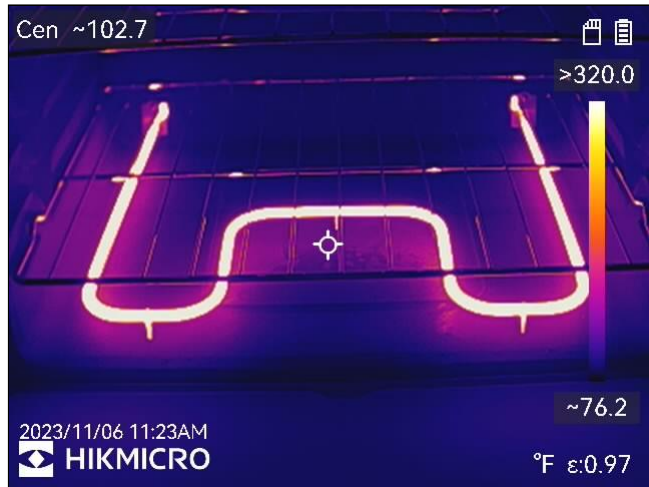
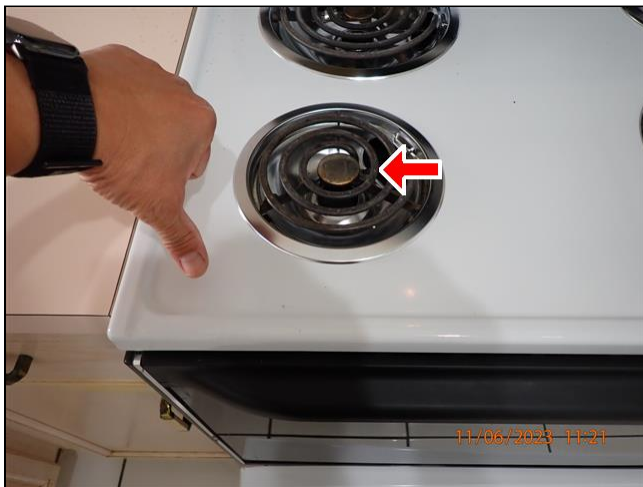
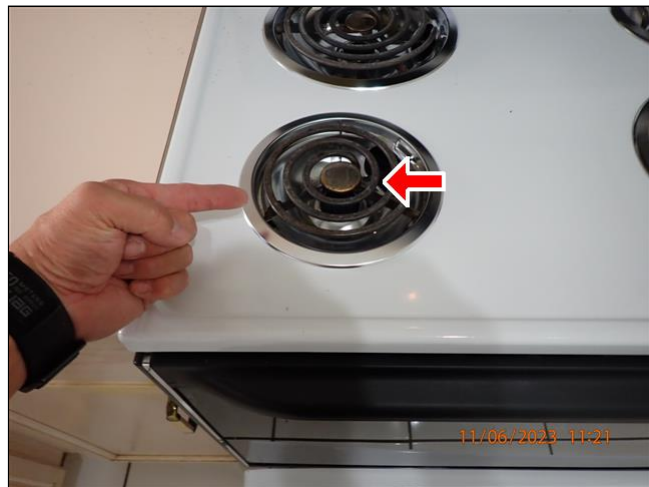
5.3 (1) Range burners all worked as expected except for the front, left burner. The oven operated normally and produced heat. The oven is turned on to ensure it is working, but it is not kept on to achieve any particular temperature thresholds for any length of time.

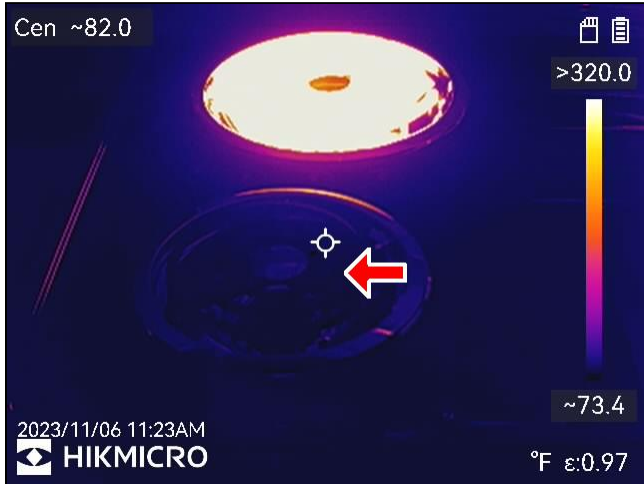
🏠 5.3 (3) Front, left burner did not work.

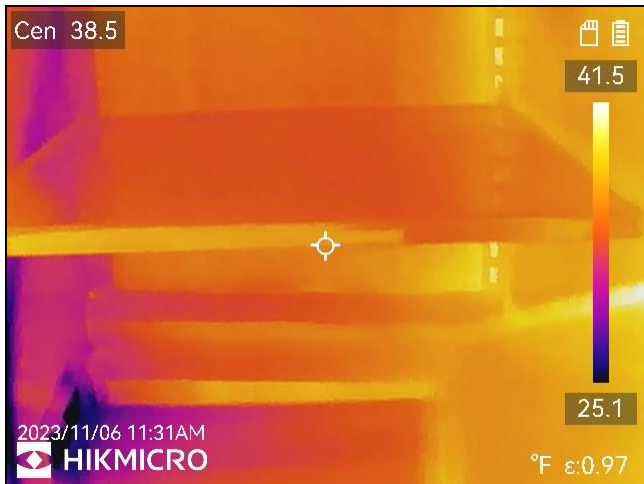
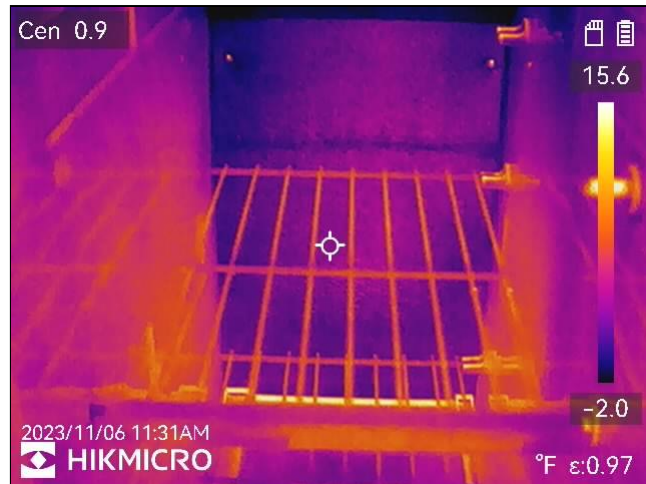
5.4 (1) The refrigerator and freezer were on and appears to be operating and has adequate temperature readings as set by the built-in temperature controls. Note: Refrigerators are not pulled out in order to inspect behind or under them.

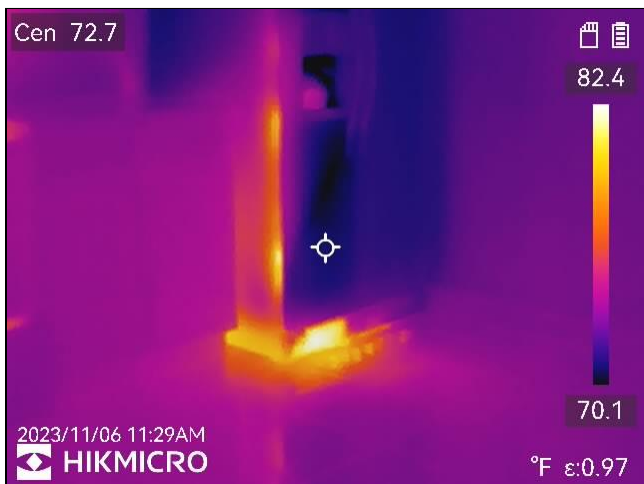
5.4 (2) The refrigerator did NOT have any leaks at the time of the inspection. Note: We do not pull out any appliances from their installed positions.

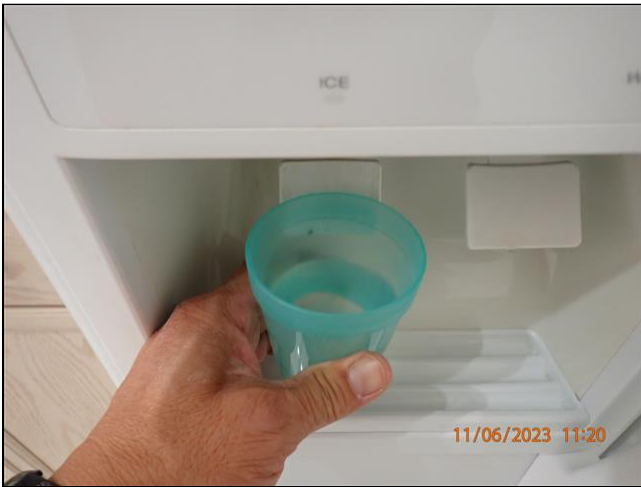
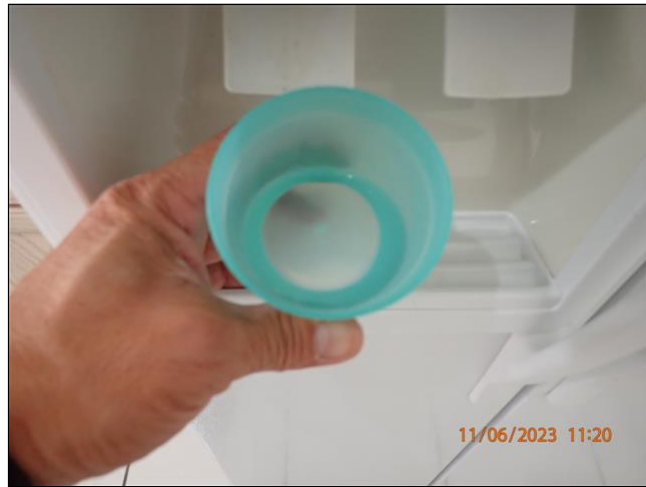
5.4 (3) The ice maker did not dispense any ice.

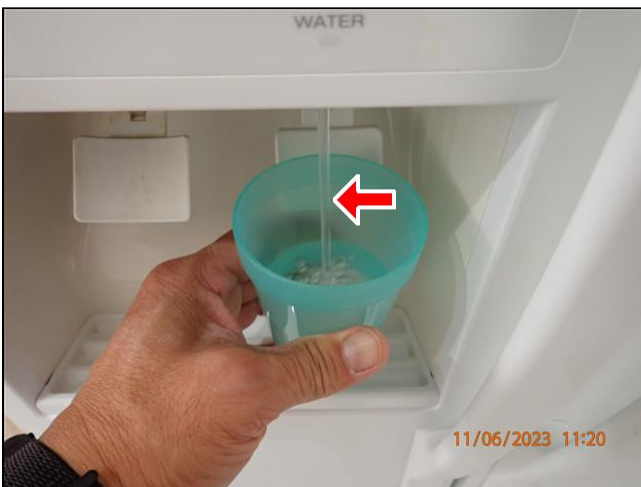
5.4 (4) The water dispenser at the refrigerator operated as expected

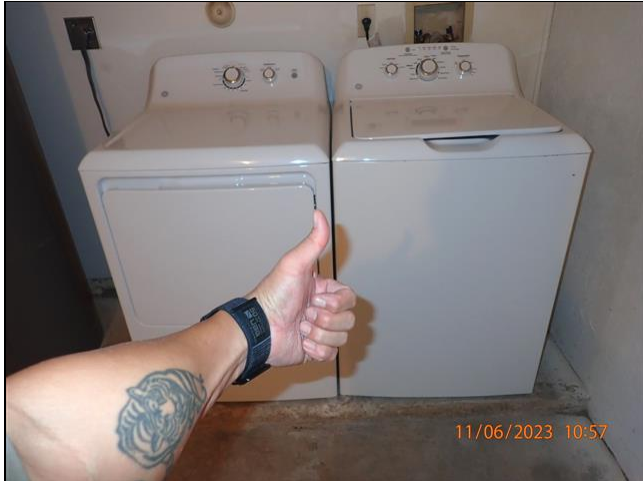
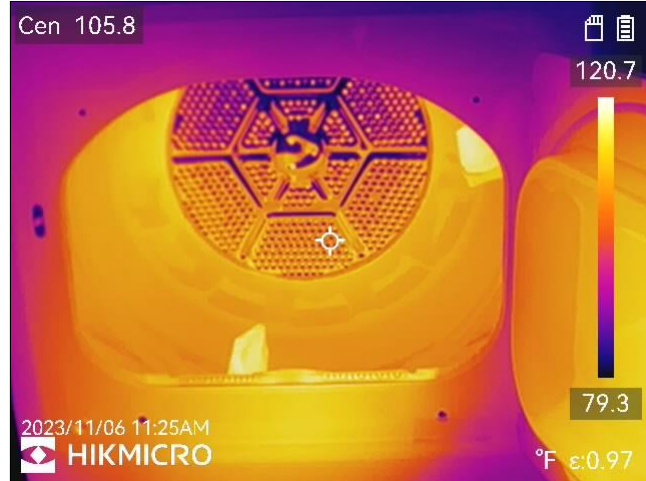
5.5 (1) The washer and dryer worked at the time of the inspection. Note: We normally operate washers and dryers without a clothing load. *(This only gives us an idea of the unit's functionality; a fully loaded washer could perform differently)*

The areas around the visible supply piping and valves are checked for the presence of any leaks and moisture and appeared dry. Leaks which may be present behind or in between walls are not visible and cannot be detected during the course of a home inspection. No reportable deficiencies were observed unless otherwise noted in this report.

Dryer vents are recommended to be cleaned periodically to remove and lint accumulations. Clothes dryer vents are not inspected and are beyond the scope of a home inspection.

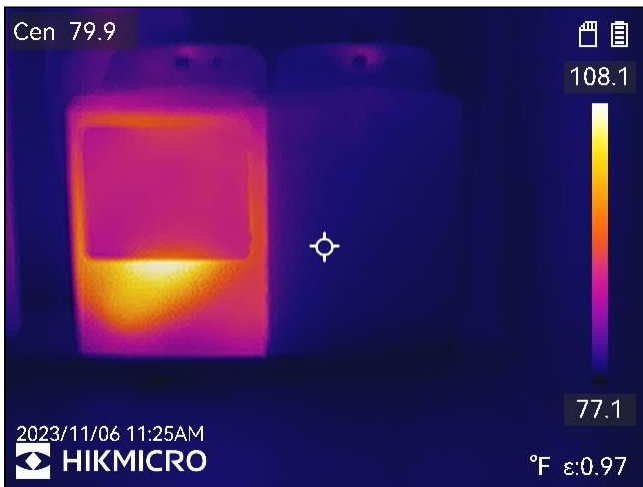
5.5 (2) The washer completed it's wash cycle with no visible leaks.

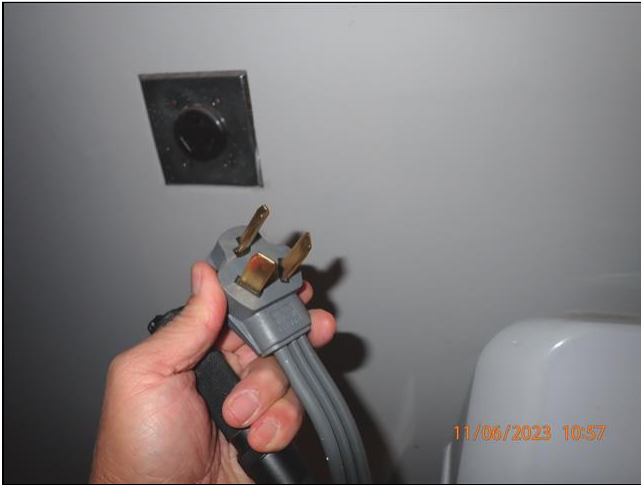
5.5 (3) Older 3-prong receptacle is installed in the home. This type of 220V receptacle is not tested. It should be noted that this is an older and obsolete 3-prong receptacle which should no longer be used. This should be replaced with the newer and approved 4-prong receptacle which has a provision for the appliance to be properly grounded.

(This style of receptacle contains two 120V "hot" conductors, with the third conductor being a neutral and no provision for a ground. This could potentially allow for current to energize the metal housing of the appliance that is powered by this three prong receptacle. A newer style "four prong" receptacle is recommended for safety and may be required by code since the property has been renovated)

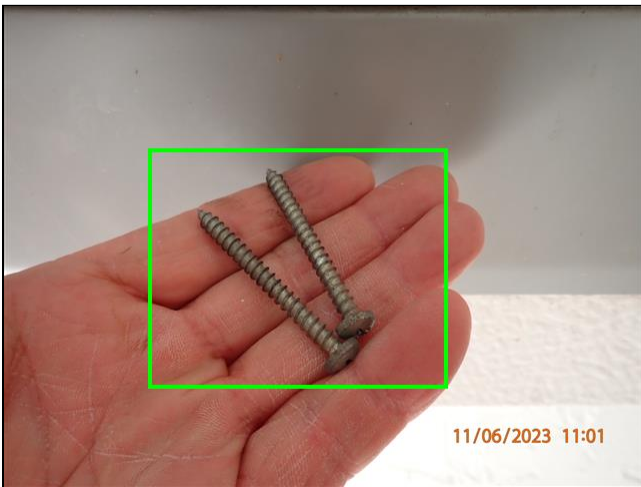
6.2 (2) Improper distribution panel screws. Correct screws have a flat tip so they would not accidentally penetrate a wire inside the panel. Recommend replacing any improper screws with the correct panel screw types.
