Inspection Report

Mr Sample Report

Property Address:
1234 Sample Report
Sample City FL 33444

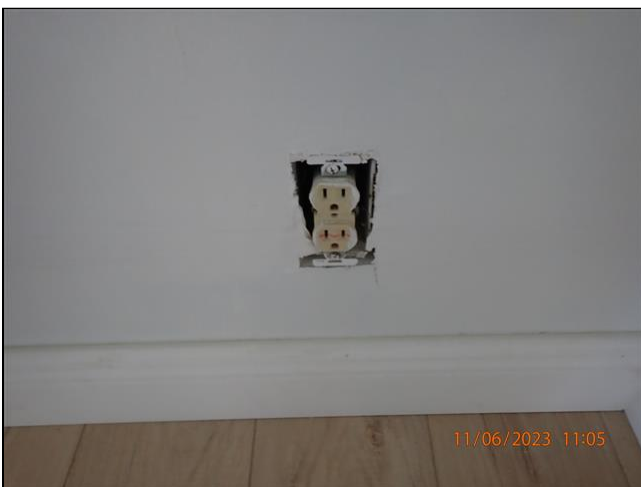
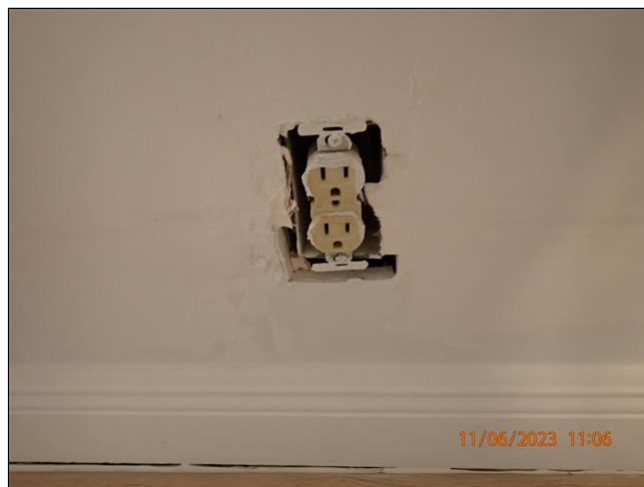
6.3 Loose or missing electrical box covers are noted. They should be replaced with the proper cover to prevent electrical hazards

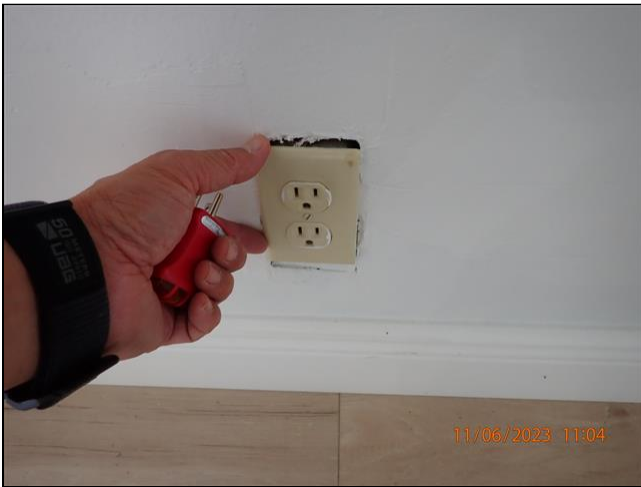
6.5 (1) Loose receptacle(s) should be properly secured to prevent movement

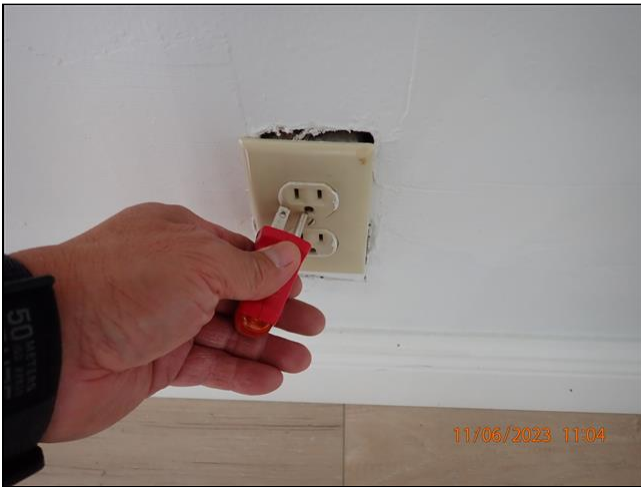
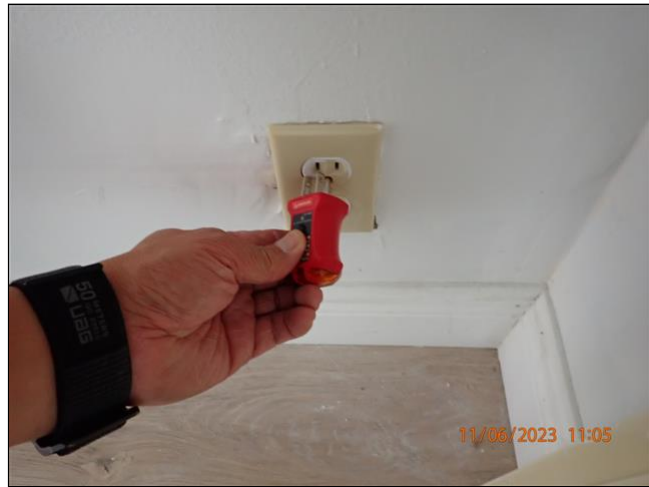
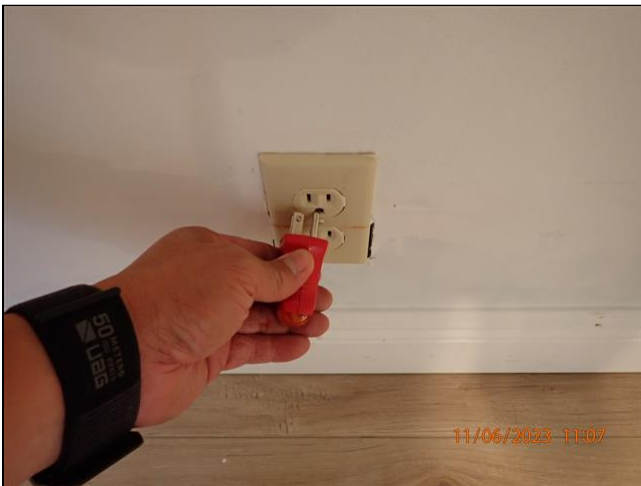
6.5 (2) One or more receptacles are painted or otherwise has openings restricted and the tester could not be inserted in order to test the outlet. The functionality of the outlet is not known. The polarity and grounding of that outlet is not known.

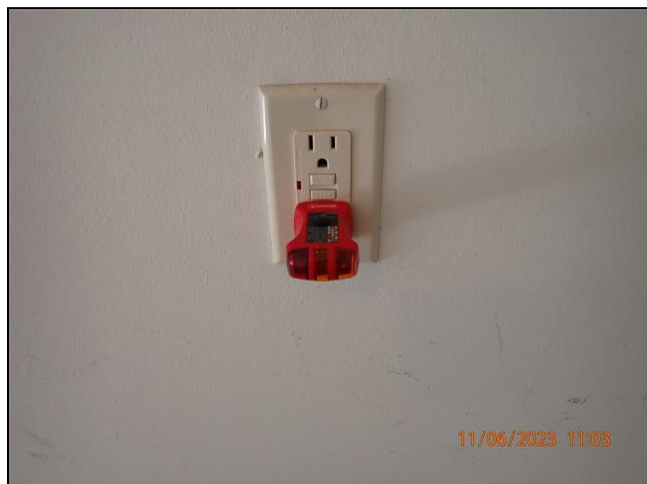
6.5 (3) One or more interior receptacle did not have power. The electrical system will require further evaluation and correction.

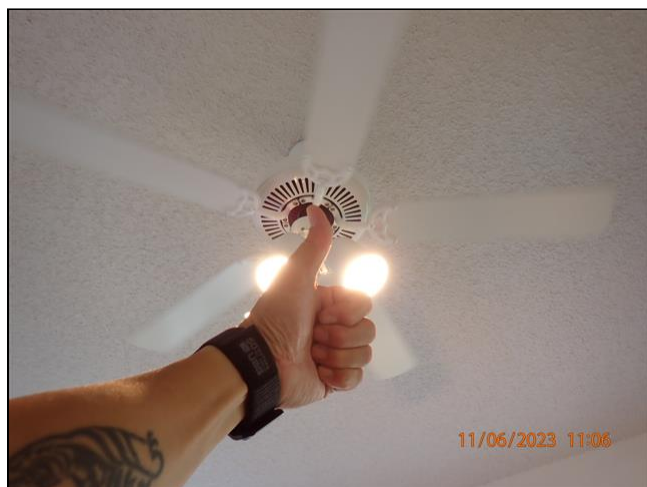
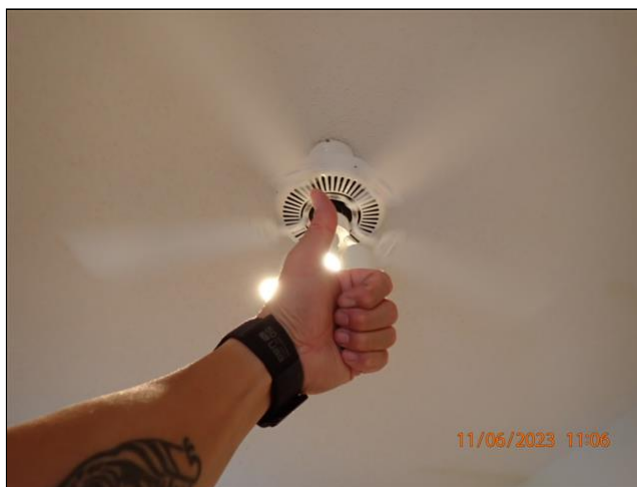
6.5 (4) All installed ceiling fans were tested and all worked as expected. Note: Some ceiling fans may have a wobble which is caused by an imbalance of the fan blades. This is something that should have been checked and balanced during the installation of the fan.

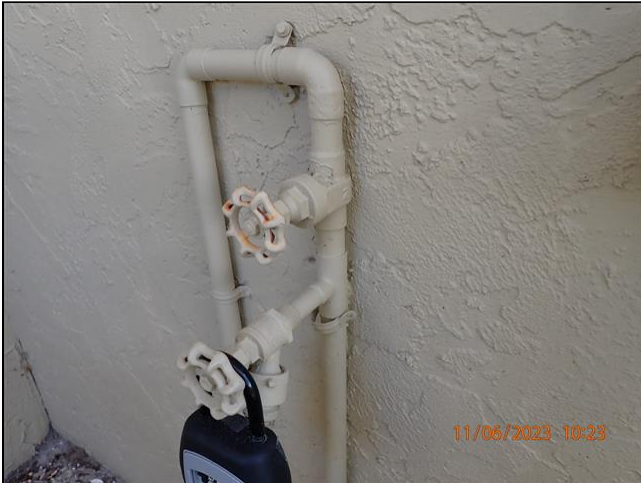
7.0 (1) The main water shut off is located at the exterior of the building and at the utility closet.

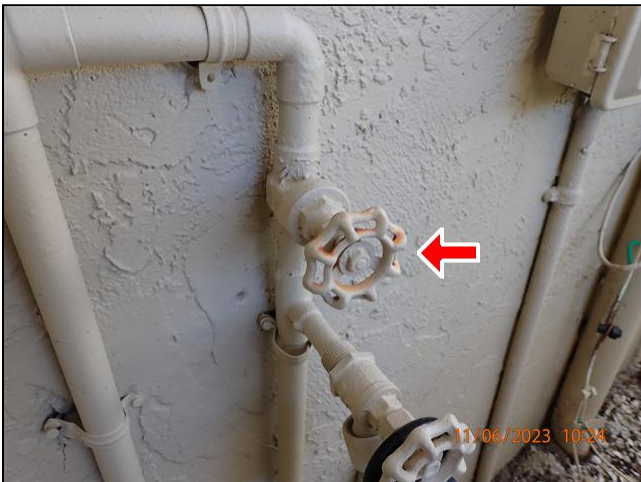
7.0 (2) The main water shut off is a gate valve design. These are not tested as part of the inspection due to potential failure. It is recommended that at your convenience this valve be replaced with a quarter turn ball valve design

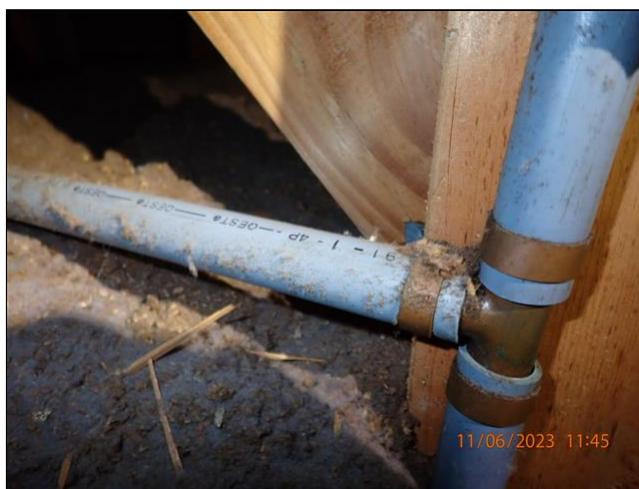
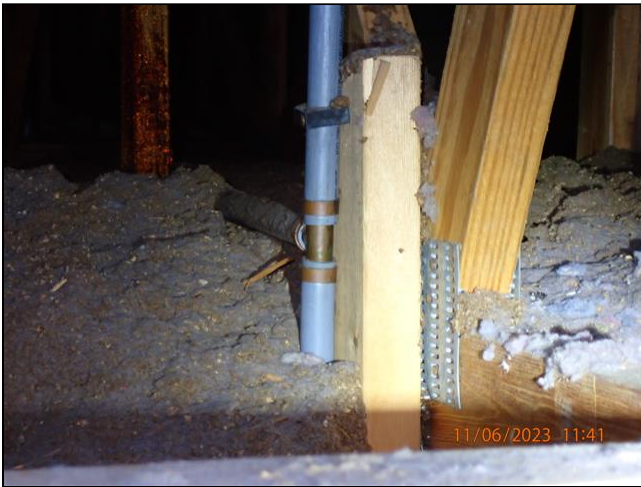
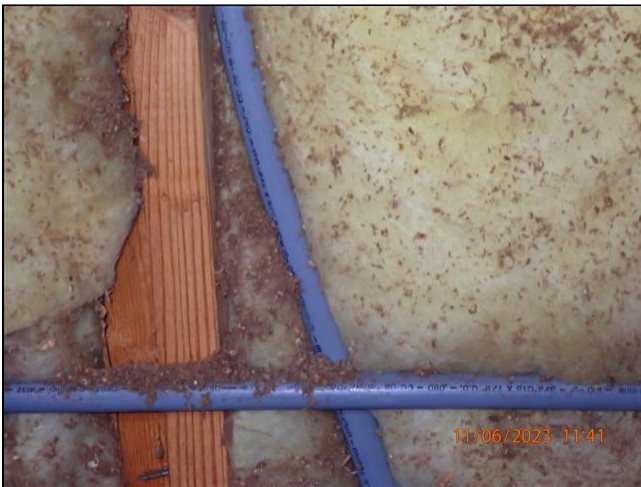
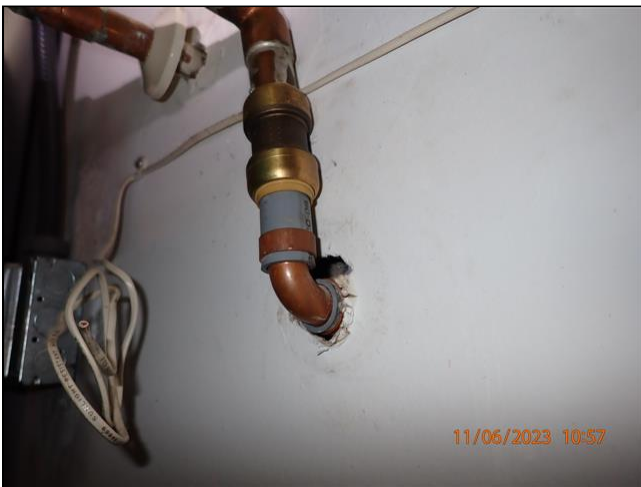
7.2 (1) **The home is equipped with polybutylene type plumbing water pipes. The extent of the amount of piping is not known.** This type of water supply piping is known to have a higher rate of failure and was the subject of a class action lawsuit for this problem. Recently there have been issues with obtaining homeowners insurance on properties equipped with this material. There is the possibility that the piping and or it's connections can begin to leak behind walls and cause damages including supporting mold growth. We advise you to consult with your insurance carrier to ascertain whether there will be any insurance consequences. **WE RECOMMEND REPLACING ALL OF THE WATER SUPPLY PIPING IN THE HOUSE**

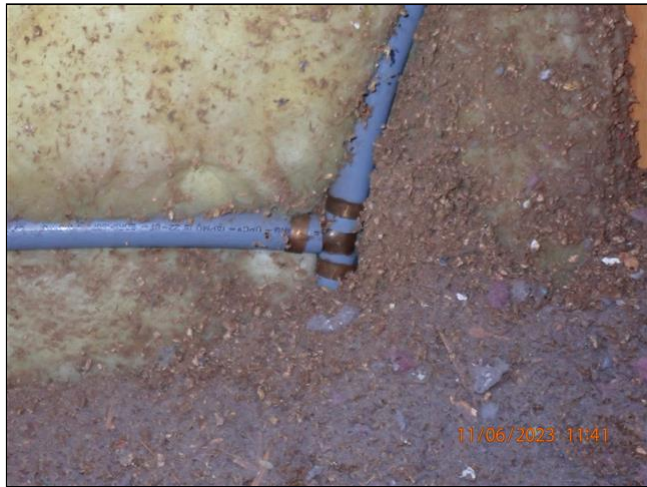
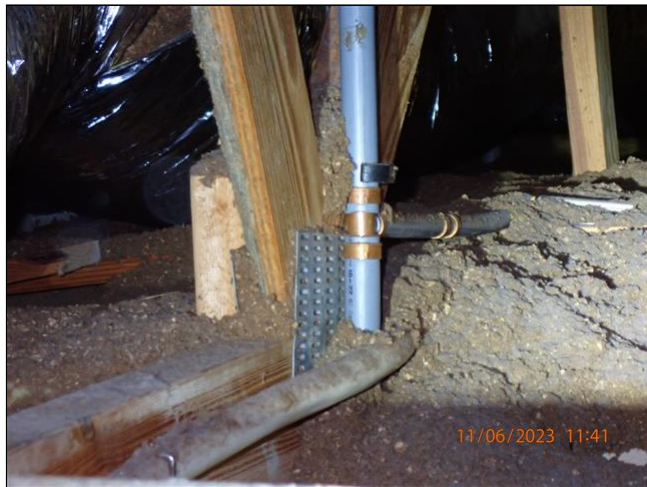
7.2 (2) Note: The polybutylene is actively in use.

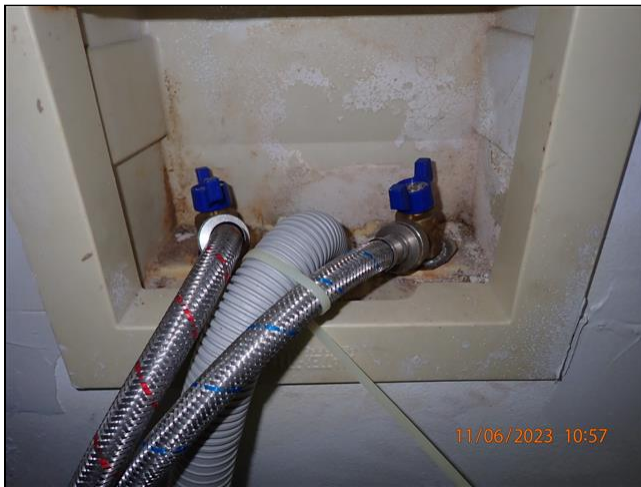
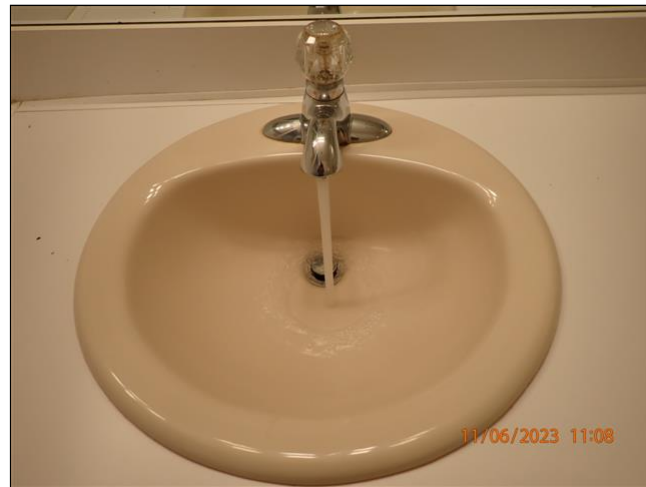
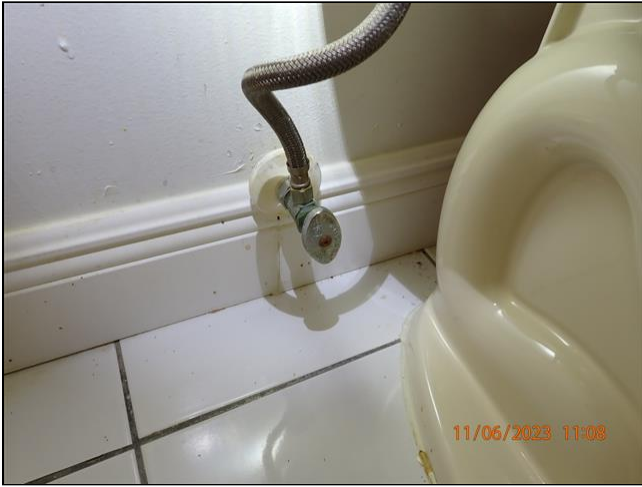
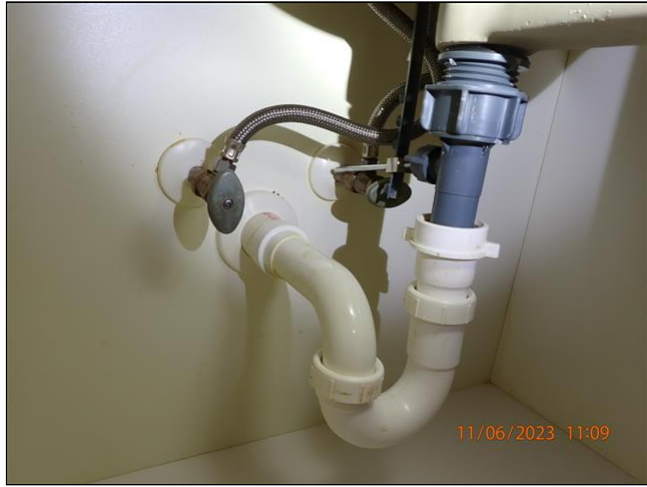
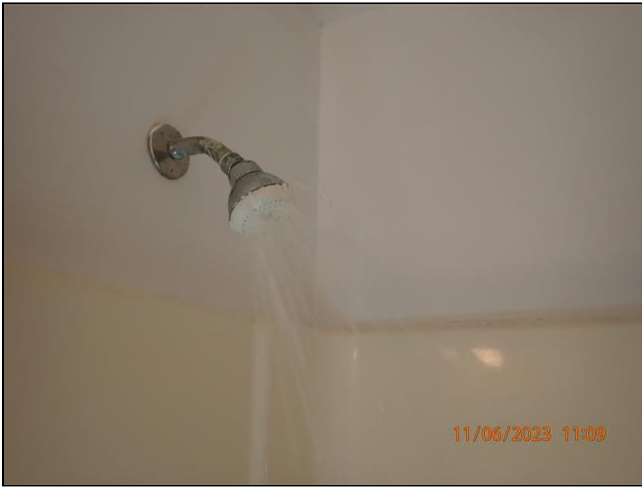
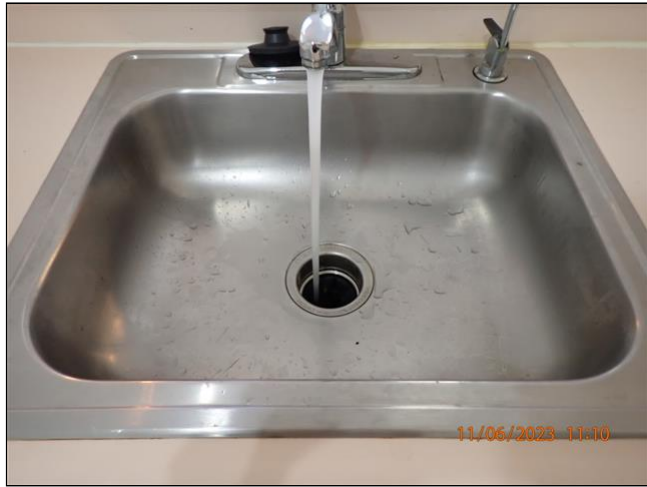
7.3 All accessible sinks, vanity faucets and showers are turned on for water flow presence and adequate pressure. Toilets are flushed a minimum of 2 times. The areas around the visible supply piping and valves are checked for the presence of any leaks and moisture or elevated moisture with an infrared thermal camera and moisture meters and were non resultant for any visible leaks at the time of the inspection **unless noted elsewhere in this report**. Leaks which may be present behind or in between walls are not visible and cannot be detected during the course of a home inspection. Leaks can develop at any time.

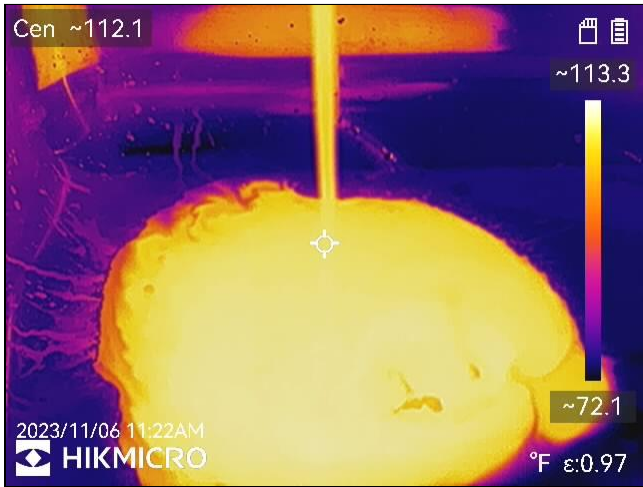
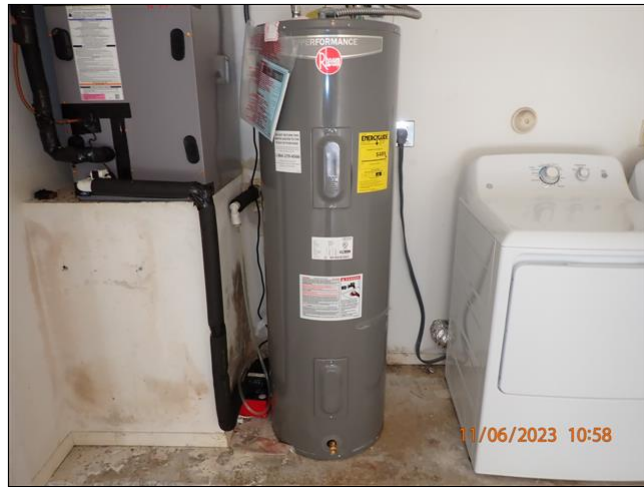
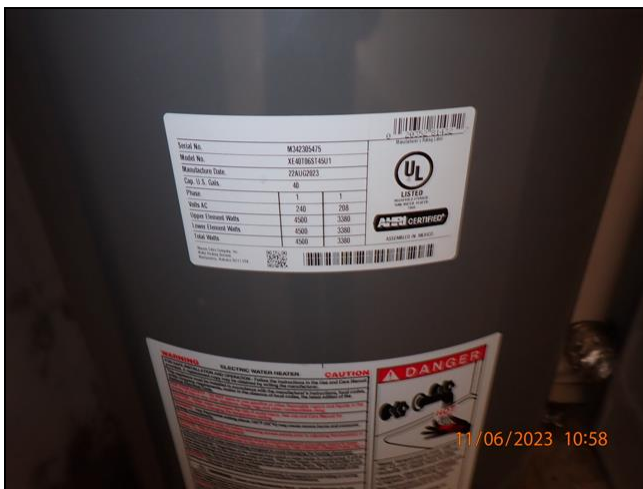
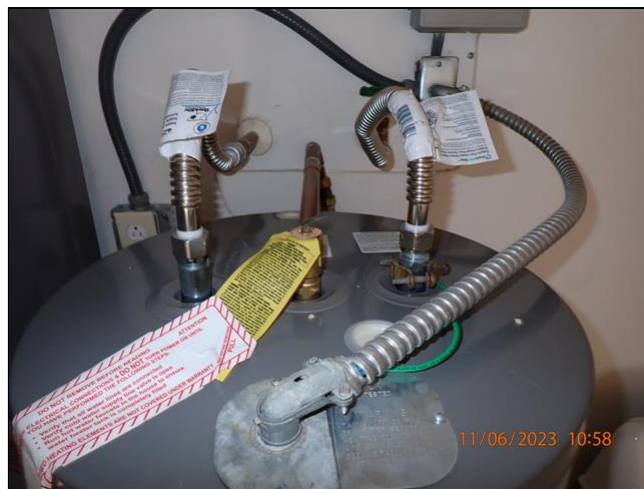
7.4 (1) The water heater is currently producing hot water and is in good overall condition with no visible corrosion. These types of appliances typically last about 10-15 years. These appliances have a greater risk of failure as they approach or exceed life expectancy and can fail at anytime. If there is intermittent hot water or no hot water or visible leaks developing from the water heater, it should be evaluated for replacement. The water heater was manufactured in 2023

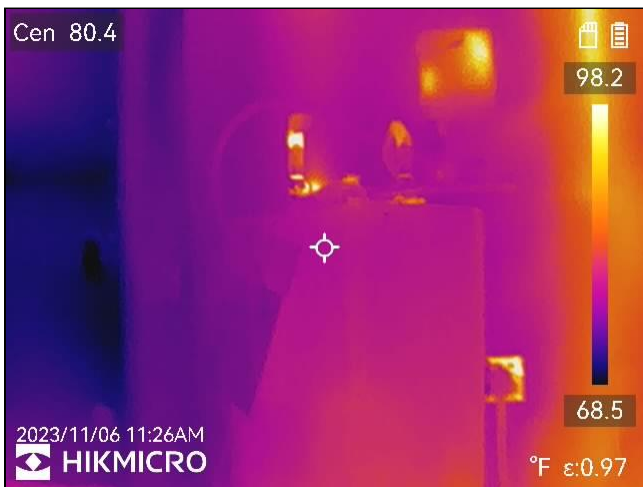
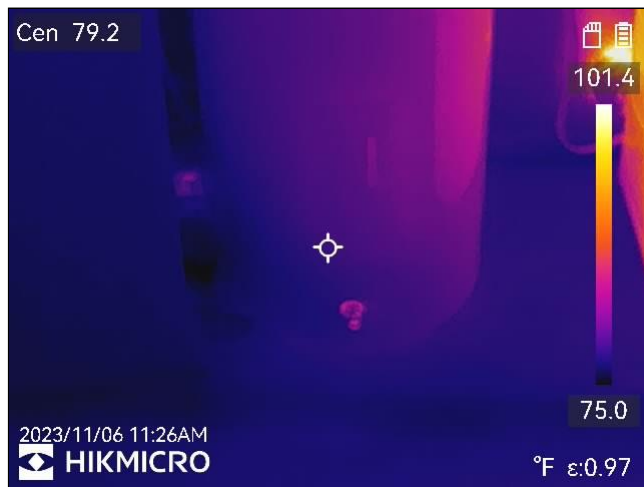
7.4 (2) Water heater was inspected and scanned with a thermal camera and was not leaking at the time of the inspection.

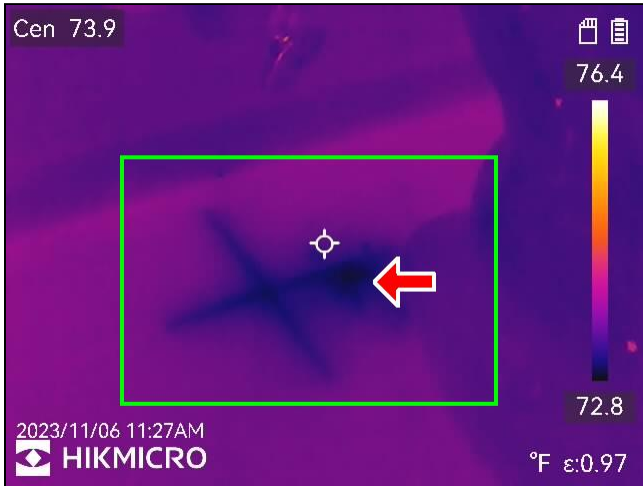
7.5 (1) One or more areas of active leaks noted. The leak could be from the drain or the supply lines. All leaks should be addressed expeditiously in order to avoid moisture damage and mold growth.

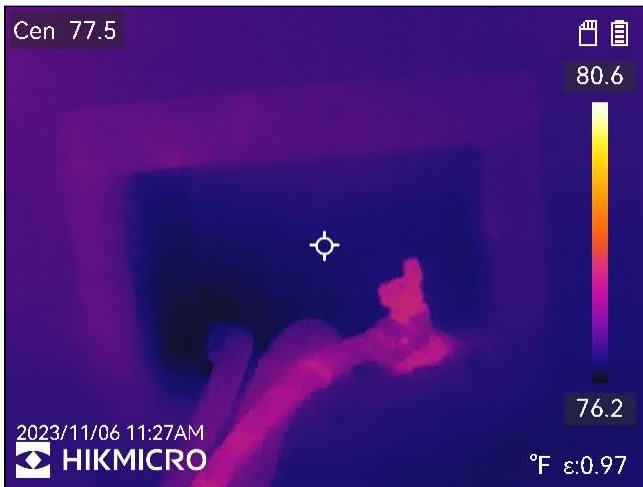
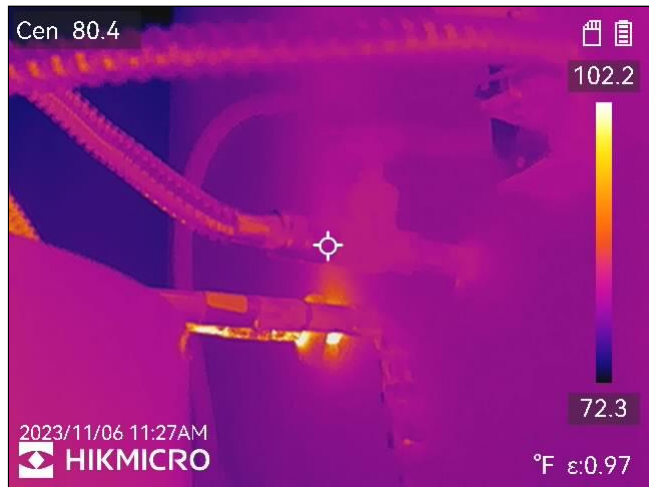
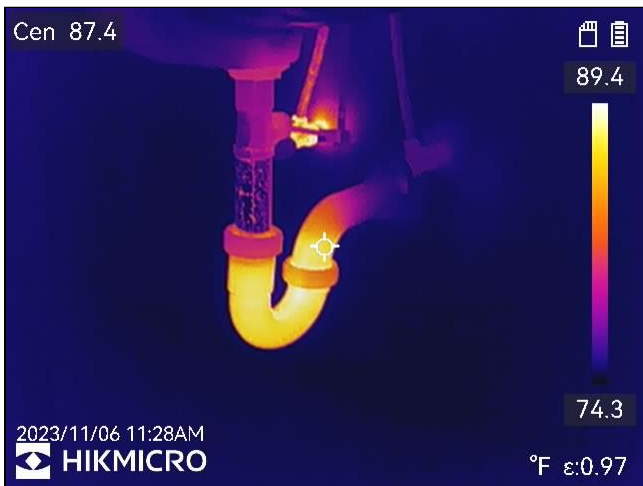
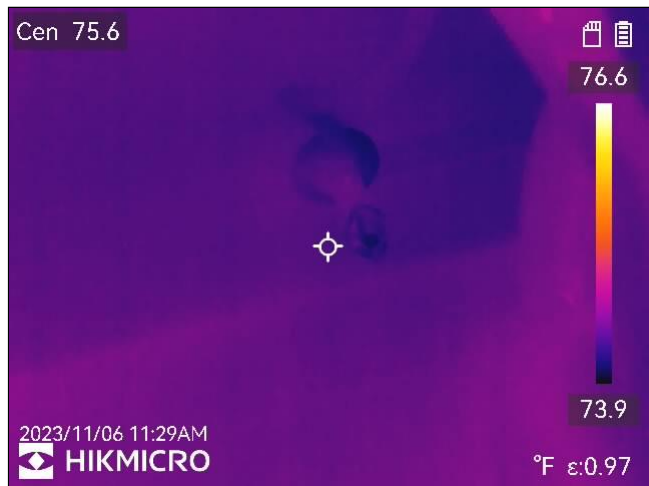
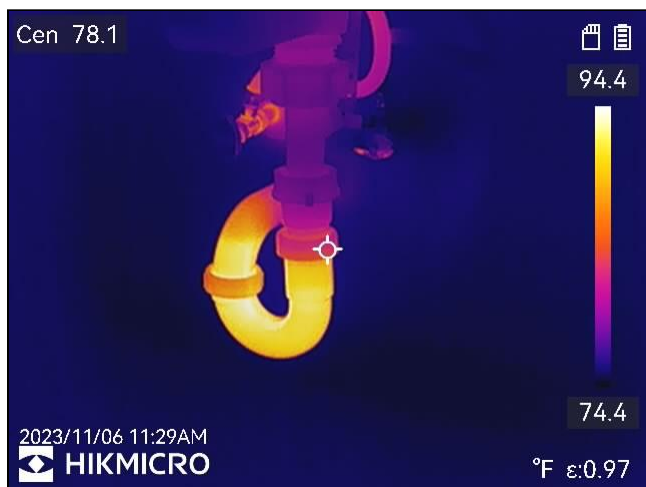
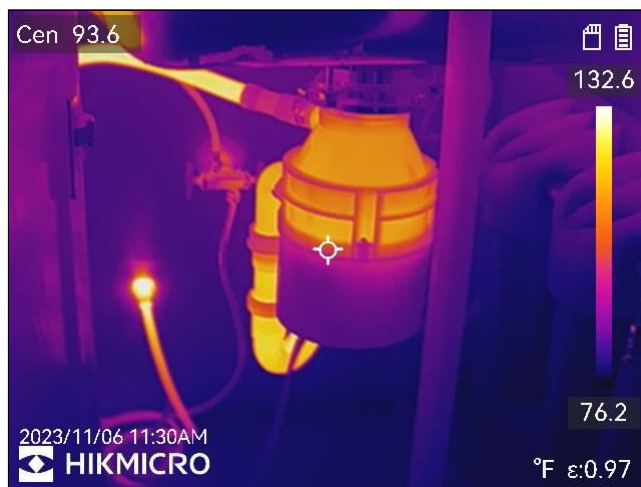
7.5 (2) The other valves and connections did not have any detectable leaks at the time of the inspection.

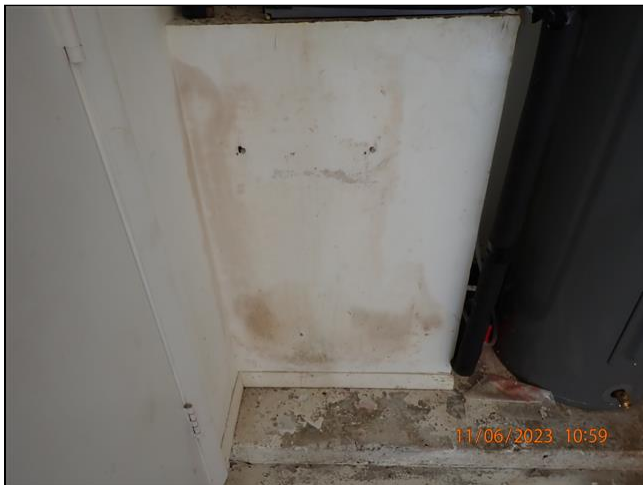
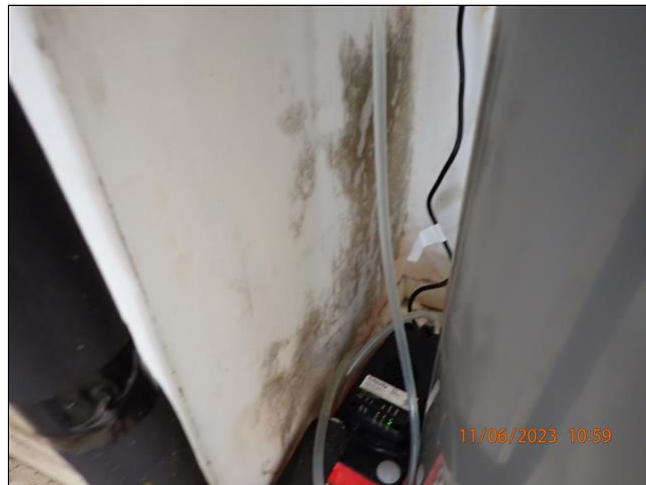
8.1 There is evidence of previous moisture staining on the walls/ceiling/floors of the air handler utility closet. These areas were tested and are non-resultant for active or elevated moisture levels.

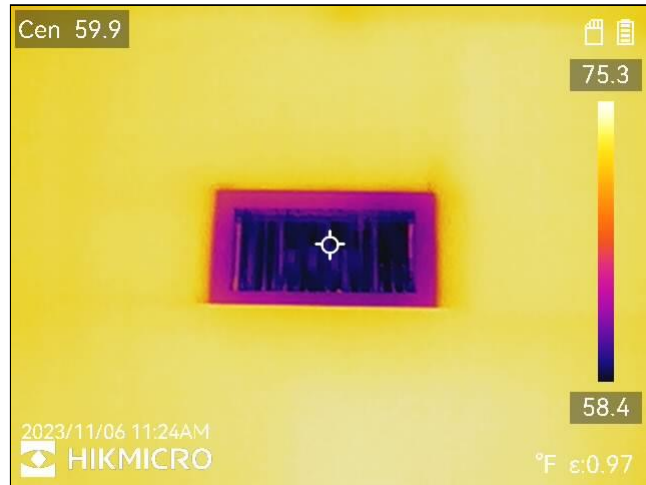
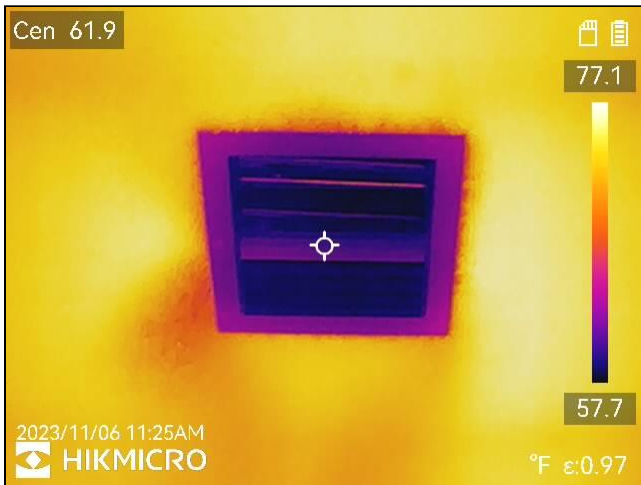
8.2 The AC system is producing acceptable conditioned air at the time of the inspection. HVAC systems require periodic maintenance such as regular filter replacements and inspecting the coils. HVAC systems and or their components, just like any other mechanical system can fail at any time. There is no way to predict the lifespan of these systems. Note: We do not use the Delta-T differential which is an efficiency indicator. If there are issues with the temperatures of the conditioned air being produced, we recommend having the HVAC system serviced.

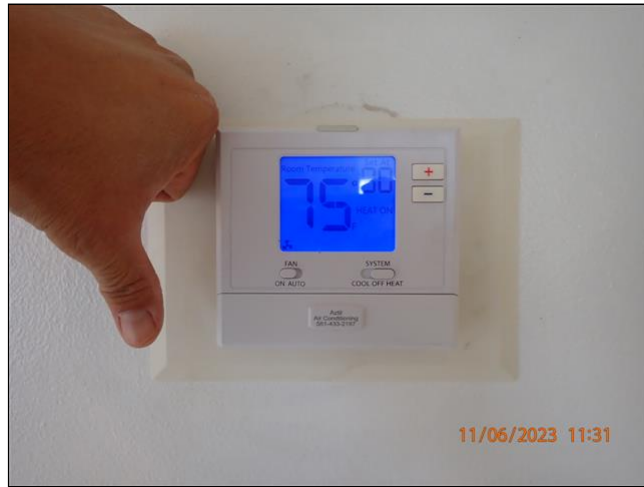
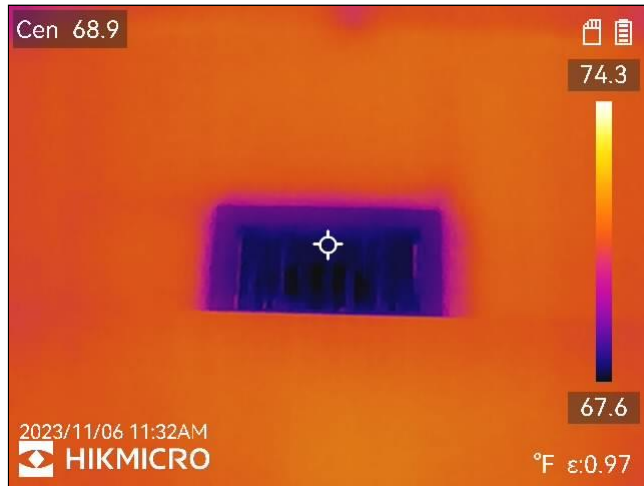
8.3 The HVAC system did NOT produce heat using the installed operating controls. The thermostat was set to HEAT and the setting was raised to the upper limit in order to call for heat. After a few minutes the heat was not adequate. It is possible that there is no heat kit installed. Recommend further evaluation by a qualified HVAC contractor.

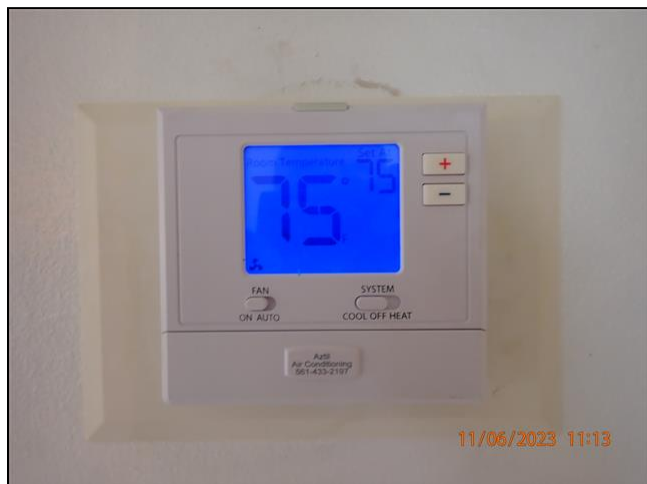
8.4 Note: there is a modern thermostat installed to control the HVAC system and appears to be functioning properly. Thermostats may require periodic replacement of internal batteries in order to continue to operate effectively.

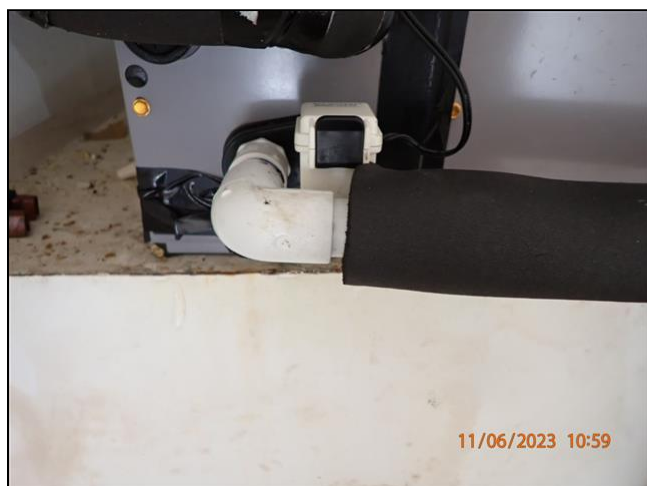
8.5 An in-line switch installed at the condensate drain line is a safety device that helps to prevent water damage due to an obstructed condensate line by acting to shut down the HVAC system in the event an obstructed condensate line is not letting the water drain out. These safety devices mechanical switches and are NOT tested as part of this home inspection. Recommend having the HVAC system periodically serviced as part of a maintenance program to keep the condensate line clear and free of obstructions.

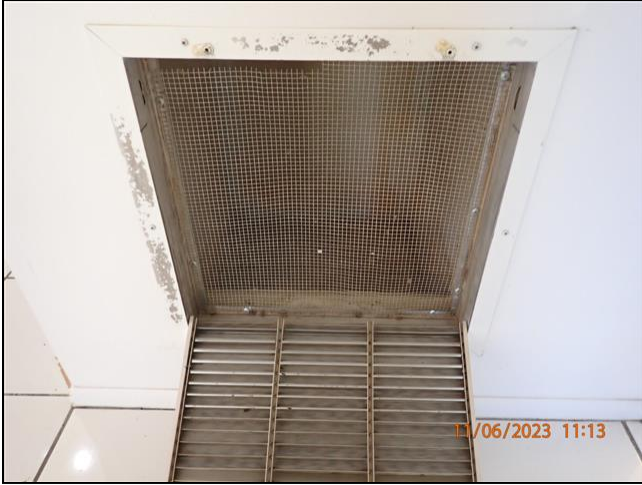
8.6 (1) For reference only: The air handler filter should be checked and replaced as a matter of routine maintenance in accordance to manufacturers recommended guidelines. Additionally, we recommend the use of high quality, high MERV rated filters whenever possible. Note: The washable mesh filters which are include with the HVAC system are not adequate and can allow particulate matter to bypass and obstruct the coils. No filter installed.

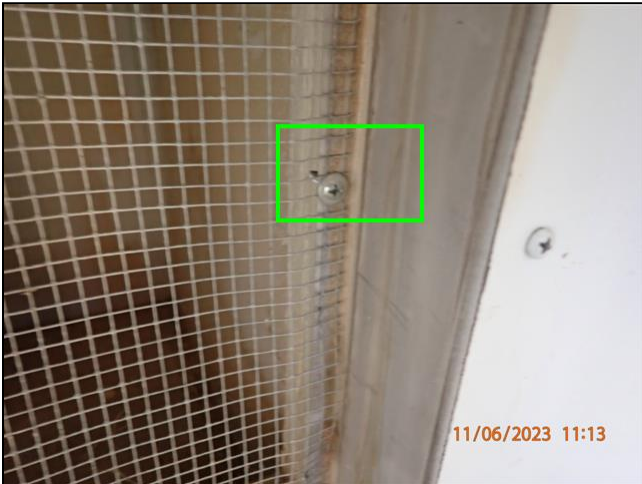
8.6 (3) Filter guard is screwed into place. Coils not accessible

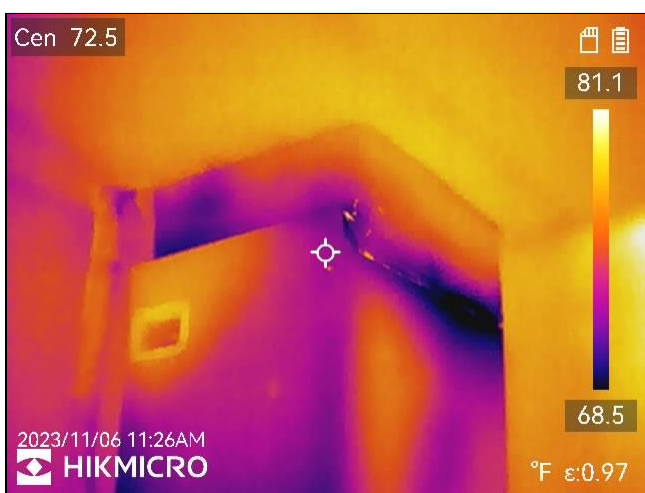
8.9 (1) Thermal imaging shows areas of possible minor conditioned air loss at the level of the supply plenums in the HVAC air handler utility closet any open gaps or compromise in mastic HVAC tape should be sealed to prevent conditioned air loss and subsequent condensation formation

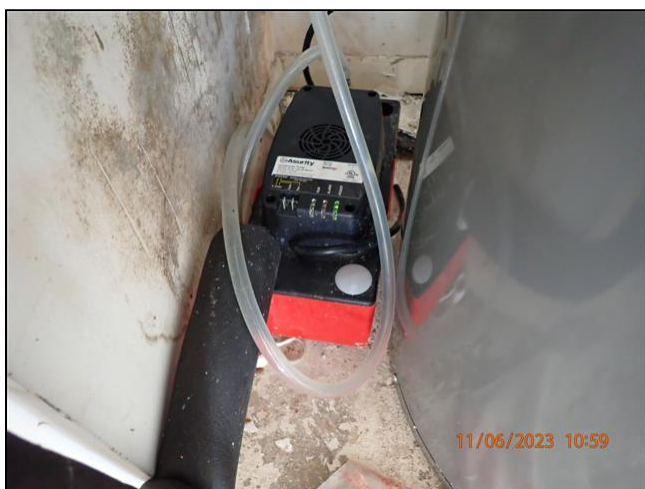
8.9 (2) Note: There is a condensate pump installed. This pump takes the condensate water produced by the HVAC system and manually pumps it out through the condensate line. These pumps can fail unexpectedly and can result in water stoppage and overflowing. It is currently operating as designed.

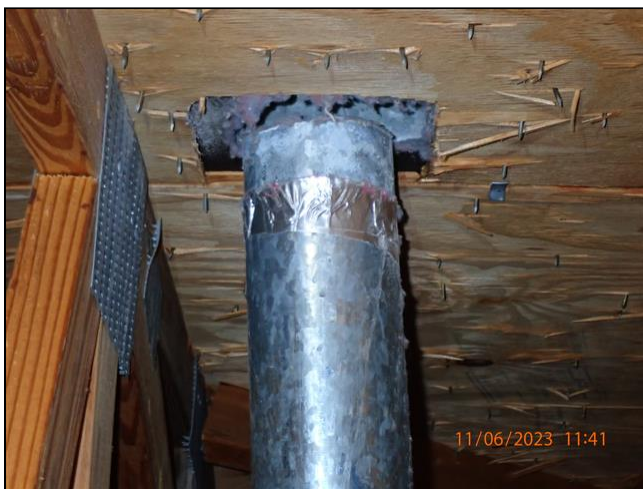
9.2 There is visible dryer lint accumulations in and around the adjacent areas where the dryer vent goes up and out through the roof. This is an indication that the vent housing, and or the dryer vent ducting may be partially obstructed. We recommend having the dryer ducting cleaned to ensure air can move freely to the outside.

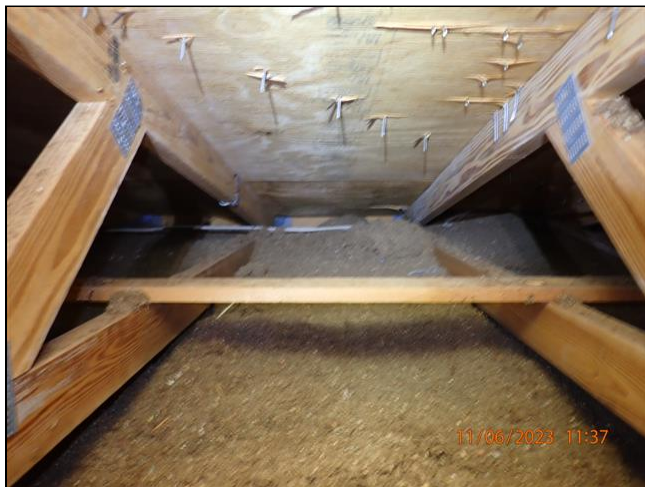
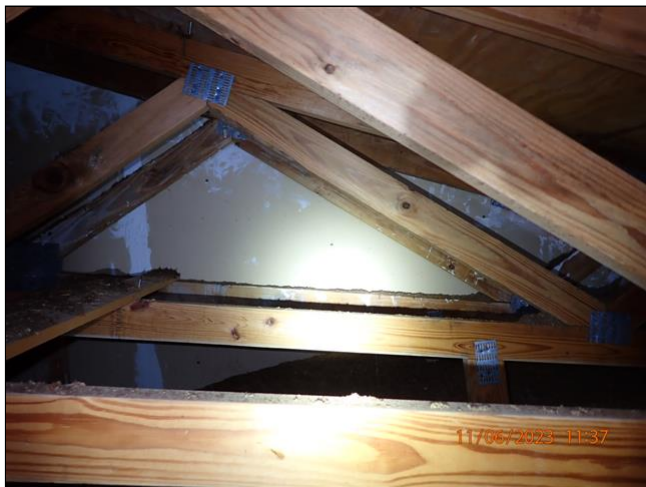
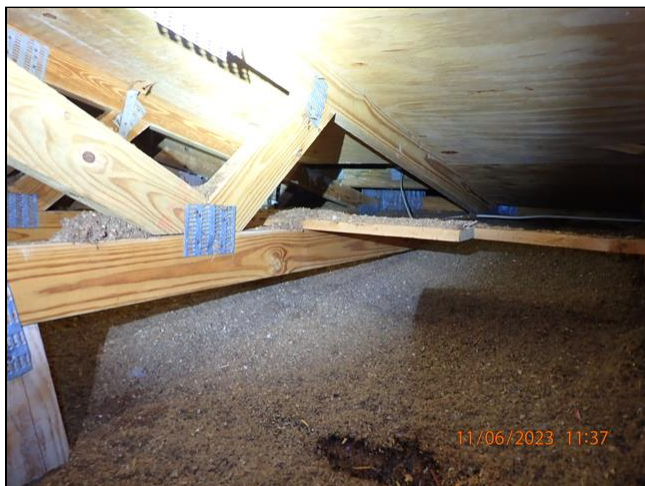
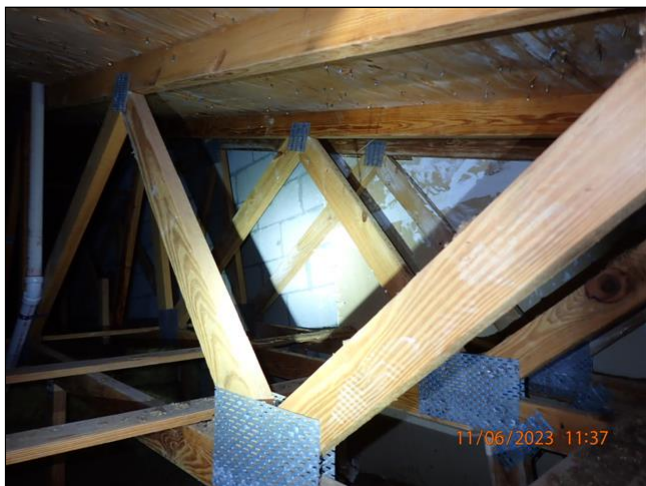
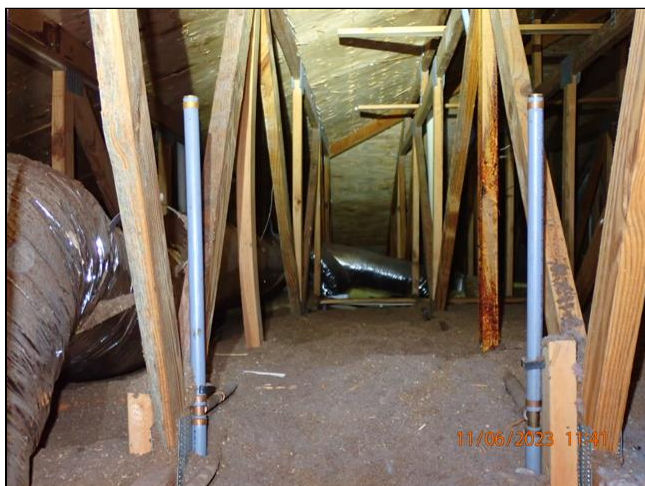
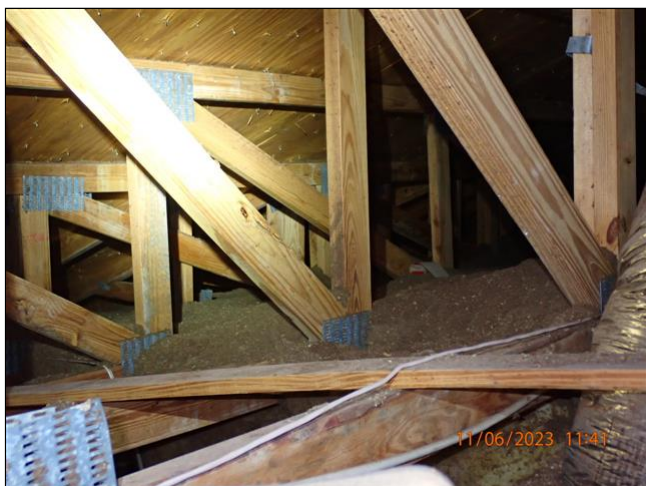
10.0 There were areas of the attic that were not accessible or visible at the time of this inspection. The conditions in those areas to the building components such as but are not limited to the sheathing, exterior walls, trusses, joists,

gussett plates, insulation etc are not known. There could be concealed damaged not accessible or visible at the time of the inspection. If there are any roofing leaks whether past or present, it can be assumed that there will be some level of damages to one or more of those attic components and to expect deterioration up to and including the need for replacement of any of those affected components. Common sense dictates that inaccessible or non-visible spaces may have concealed damages. And these damages may only be discovered if and when these areas are subsequently opened up and exposed for any reason. This does not imply that the inspector has missed any concealed damages because this is an inherent risk the buyer is taking and accepting due to lack of access to those areas. As such, any non-accessible and or not visible attic space or area are hereby disclaimed.

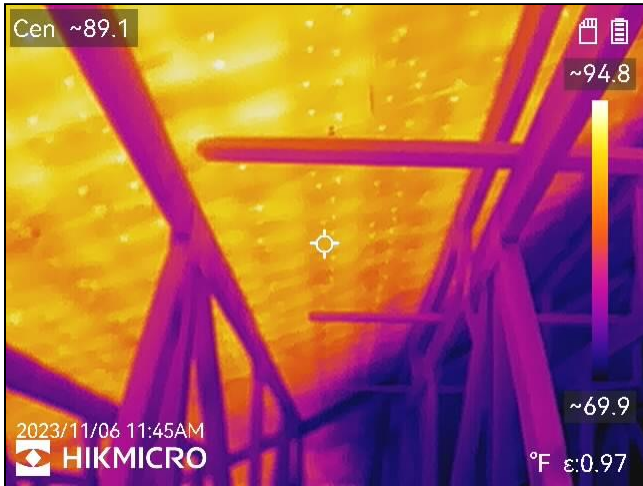
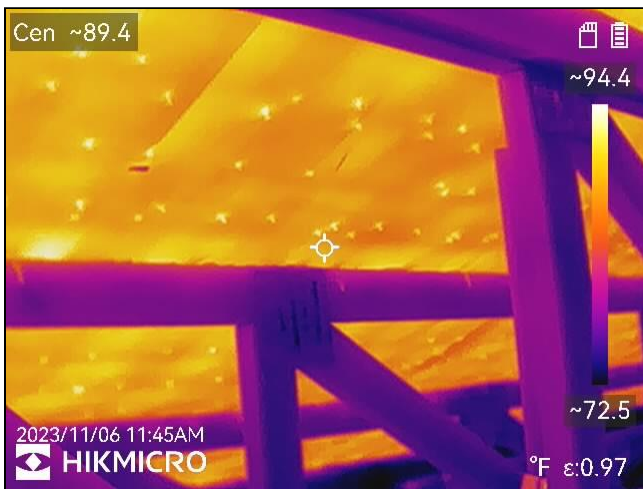
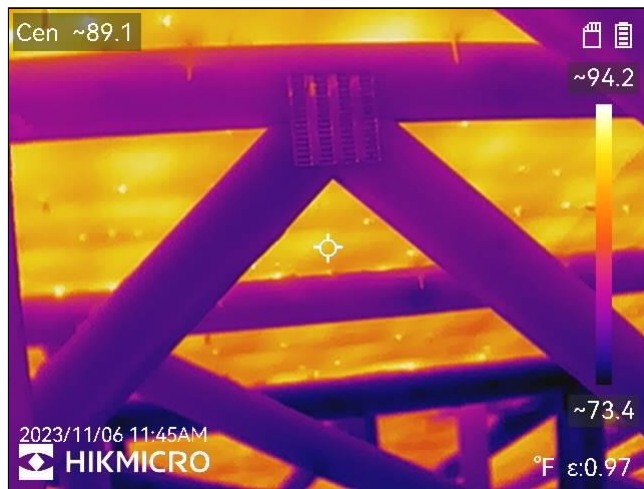
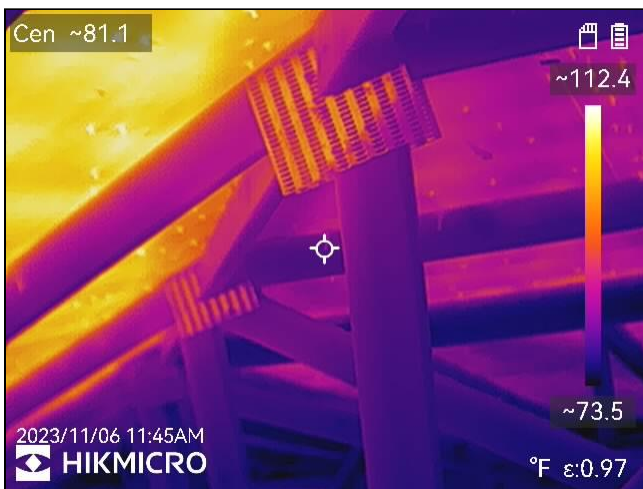
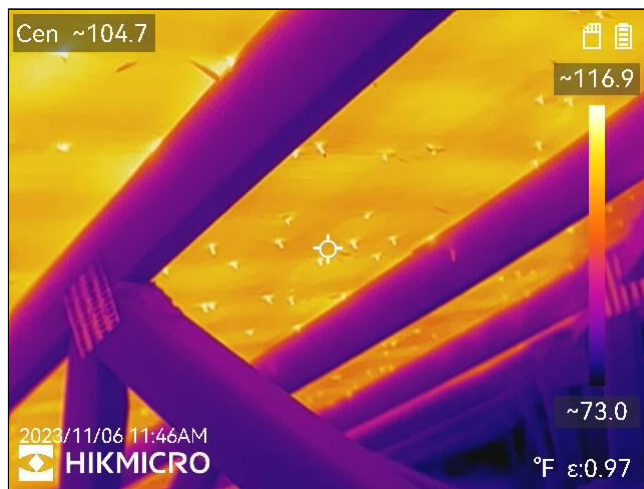
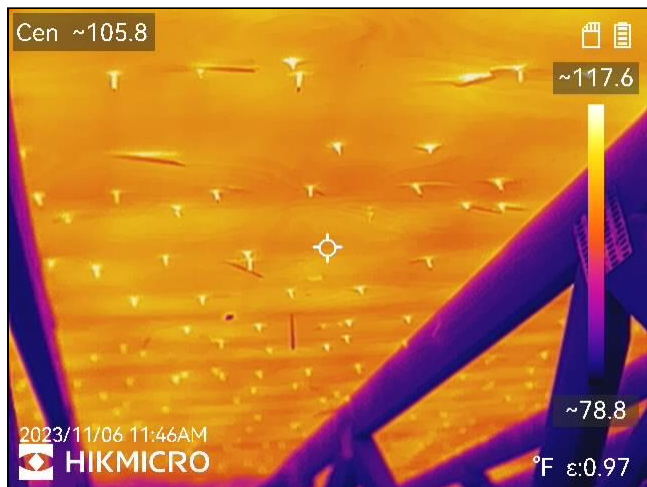
10.9 The visible and accessible areas of the attic were scanned with an infrared thermal camera. At the time of the inspection, these areas do not have elevated moisture levels **unless noted elsewhere in this report**. Thermal imaging tools aid in helping to find leaks and moist areas, but is not a guarantee there are no leaks since infrared thermography measures energy levels stored and given off by the materials being scanned. If the energy levels released are all the same, a moist area can appear to be the same temperature as it's surrounding areas and may not show up in the thermal scans. Previous

leaks which have not be corrected will likely still leak. Unfortunately, under favorable weather conditions, discovering a leak is not possible due to the lack of necessary precipitation.

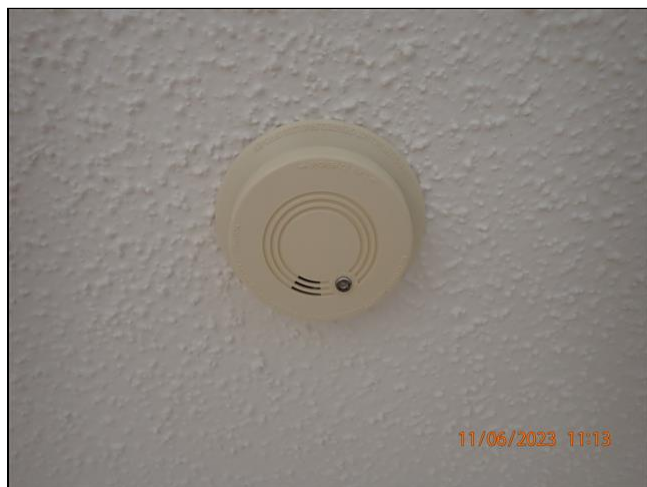
11.3 We recommend replacing all of the smoke/CO detectors as a matter of precautionary safety. They are low voltage devices which are items not tested as part of a home inspection. Note that testing detectors by depressing the "test" button only tests the speaker itself and does not test or confirm it is actually working. If the building has hard-wired systems, batteries should be replaced at the recommended interval. If this is a new or renovated property, we recommend having the builder and or contractor provide documentation they are new detectors.

Install smoke alarms/CO detectors inside each bedroom, outside each sleeping area and on every level of the home, including the basement. On levels without bedrooms, install alarms in the living room (or den or family room) or near the stairway to the upper level, or in both location or in accordance to manufacture recommendations. They should be replaced at least every 10 years and batteries annually if they are removable batteries.

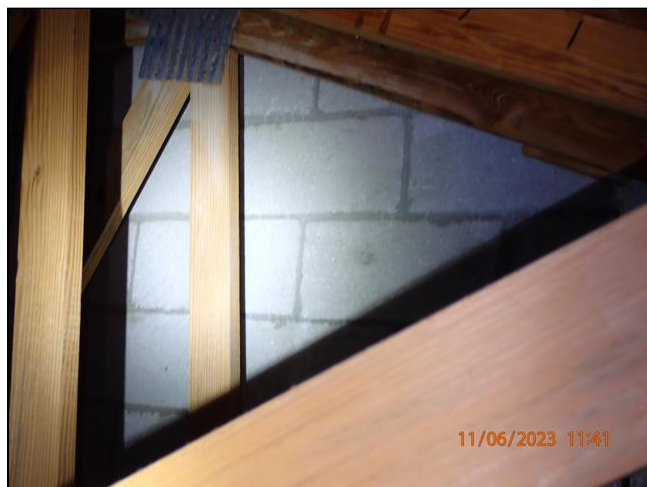
11.5 Notation only: The building has multiple units under a common roof. This condition/design is referred to as a common cockloft. In a fire service point of view, a fire in a cockloft/attic can spread easily and often times undetected. Resulting in total loss of the roofing structure. More modern building designs of this type of structure now mandate firewall separations to compartmentalize the attic spaces to limit fire spread. This structure has concrete block walls separating the units. This will act to help compartmentalize the units to isolate fire and smoke in the event of an emergency.
