Inspection Report

Sample Report

Property Address: 12345 Sample Drive West Palm Beach Florida 33411

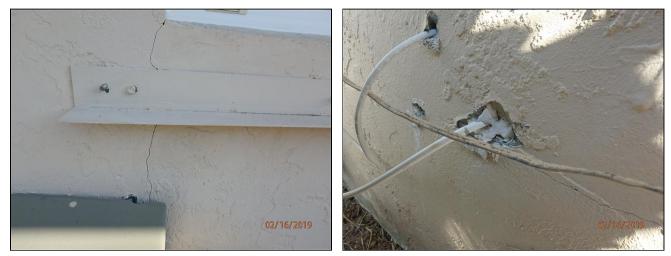
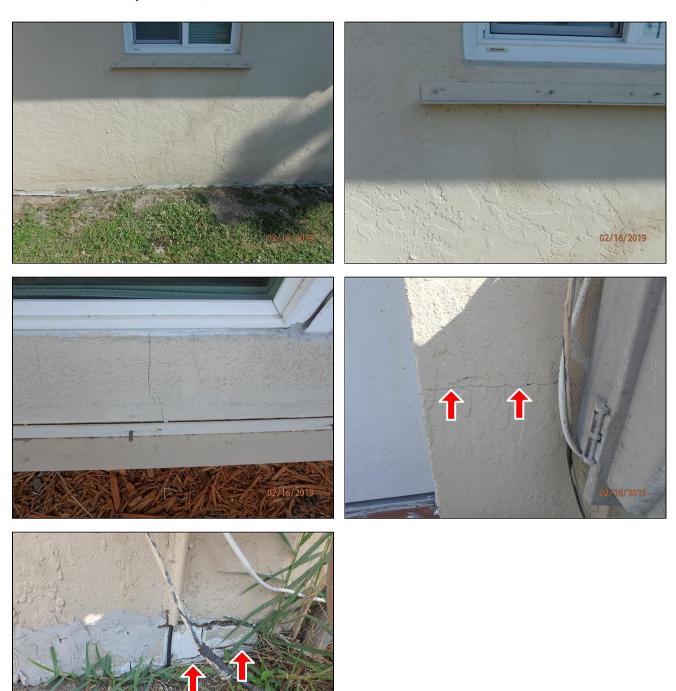
1.0 (2) Multiple cracks/openings were noted in the exterior walls, these cracks/openings are typically settlement/ expansion cracks and are considered cosmetic. All exterior cracks should be sealed to prevent water intrusion and possible further damage due to moisture intrusion. They should be monitored over time to ensure they are not expanding, which would require the recommendation of a structural engineer for evaluation.

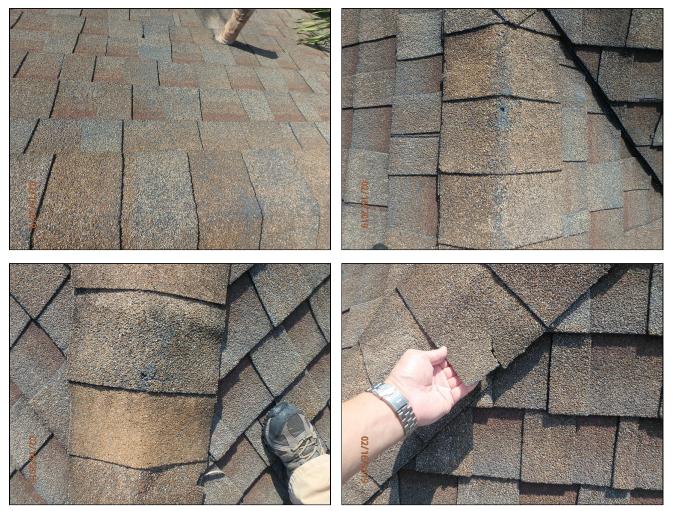
2.0 (1) There are multiple cracked/broken/brittle tiles as well as un-bonded tiles and visible nail pops. There is degranulation with visible asphalt and fiberglass fibers. The roof is past normal life expectancy and requires replacement.

The roof is aged and has granular loss, visible asphalt and fibers showing. It is expected that the roof will require replacement.

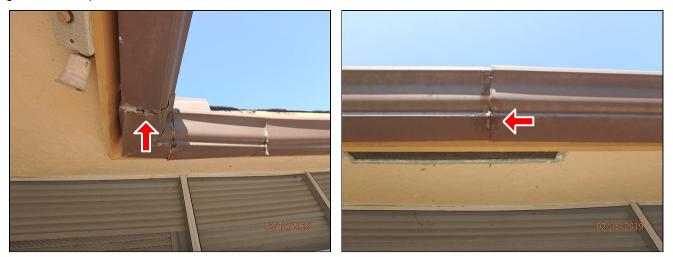
2.3 (3) The gutters will need service in several areas, there are leaks at seams/end stops, water retention and debris in gutters/downspouts

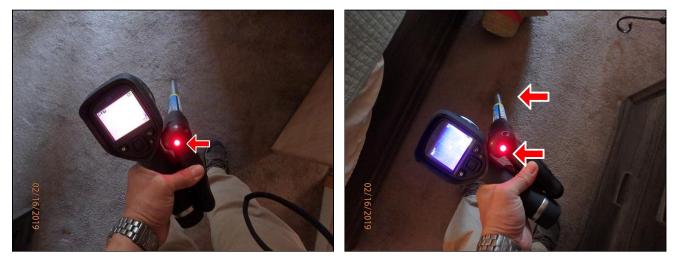
4.7 (1) There is elevated moisture in the carpeting at numerous areas. Note: there are 2 dogs currently living at the residence

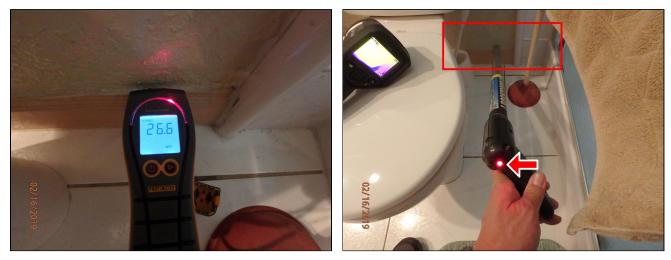
4.7 (2) There are elevated moisture levels (moisture content above 17%) at the wall behind a toilet. Unknown reason as to why or the moisture content is elevated. This area should be monitored.

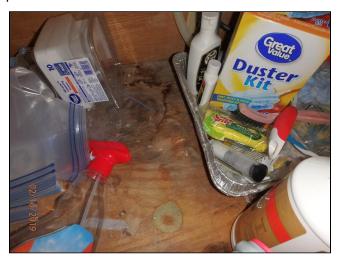
4.8 Area(s) of previous water intrusion/staining. The area(s) were scanned with an infrared thermal camera and checked with a moisture meter and found non-resultant for active moisture at the time of the inspection. These areas should be painted.

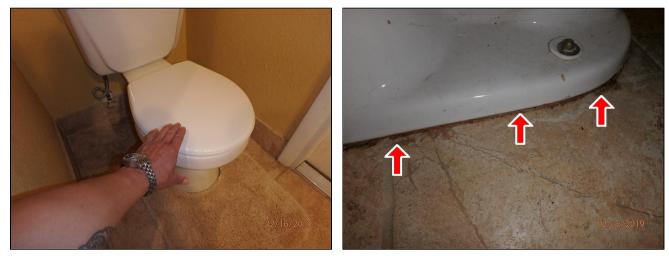
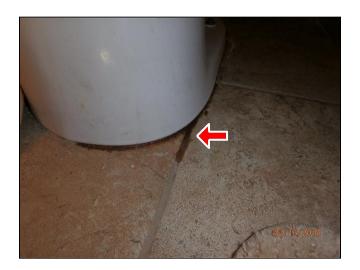
6.3 (1) Toilet is not properly secured to the floor. This results in some movement and shifting and is causing water leak to form at the wax seal. Recommend re-installing and properly securing the bowl attachment bolts. The toilet water supply was turned off. I turned it on to test the toilet and then turned if back off. There is visible water leaking from the base of the toilet.

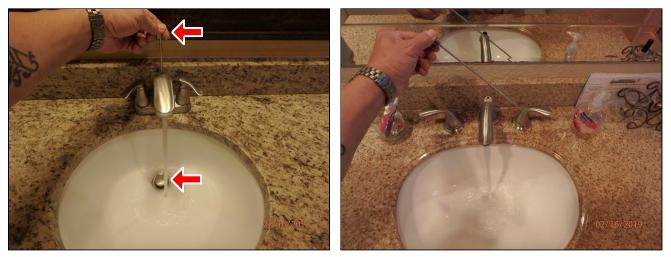
6.3 (3) Drain stopper(s) not working or is damaged or missing

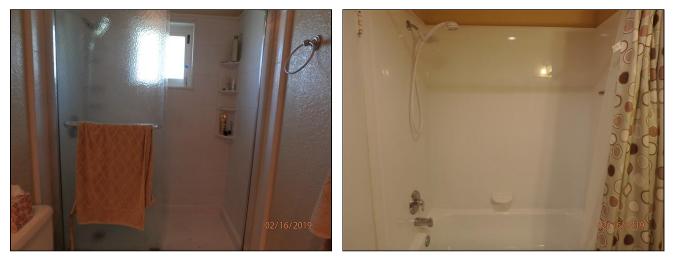
6.3 (4) Note: There are one-piece plastic tub and shower enclosure units in the bathrooms. The condition of the wall and floors behind and under these enclosures are unknown. These types of shower retrofit enclosures tend to be a "quick fix" for bathrooms.

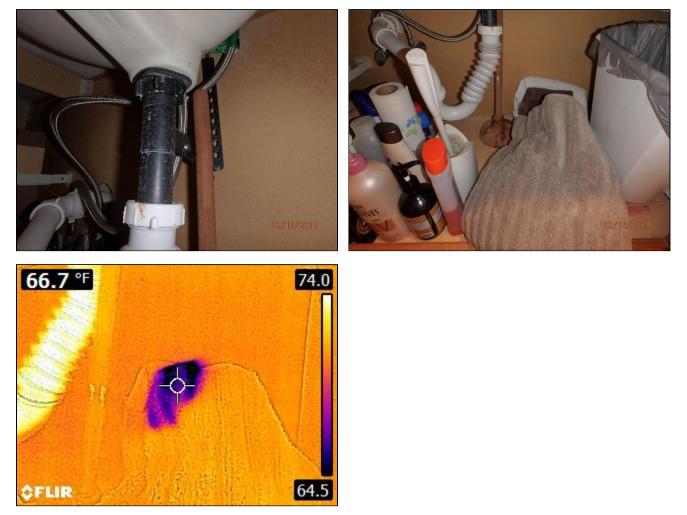
6.6 Small leak at the tailpipe of the drain line at a bathroom vanity

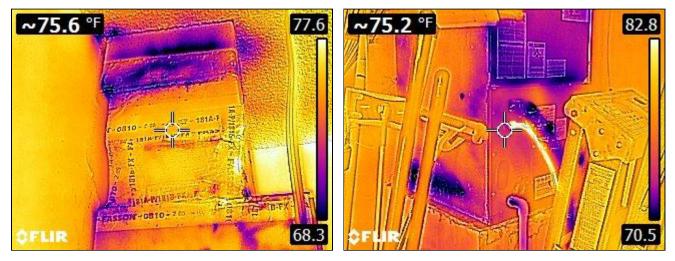
7.0 There is some conditioned air loss at the air handler. Specifically, at the supply plenum. This area has visible dirt covered mildew as a result of condensation over time. It should be cleaned, sanitized and properly sealed to increase efficiency

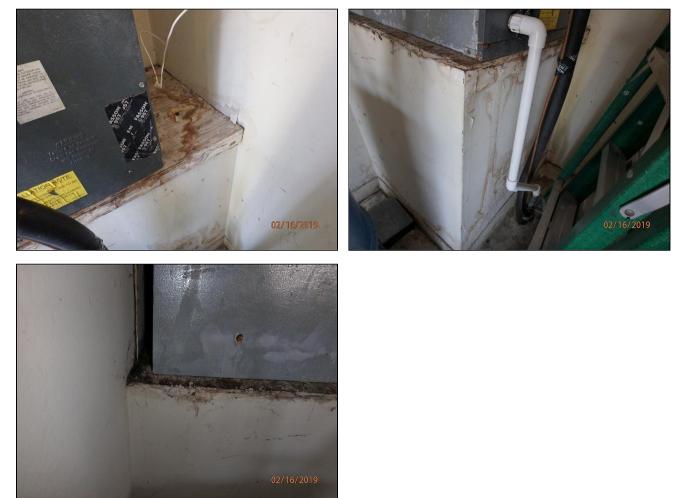
7.1 (2) There is evidence of previous moisture staining on the walls/ceiling/floors of the air handler utility closet. These areas were tested and are non-resultant for active or elevated moisture levels.

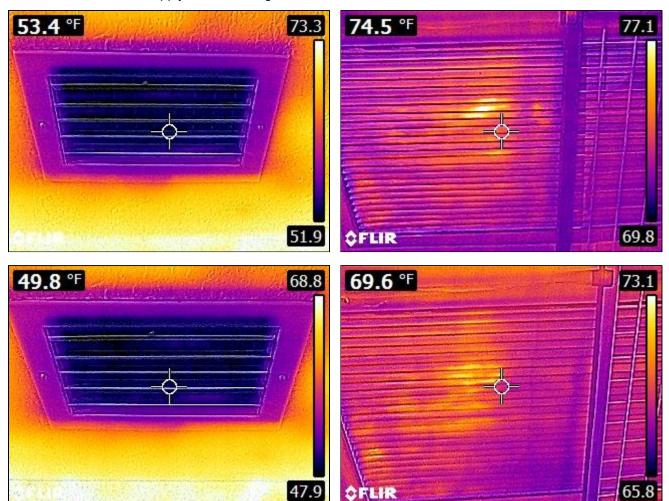
7.2 (1) The AC system temperature differential test shows normal performance with a minimum of 14 degrees temperature differential between the supply and return registers

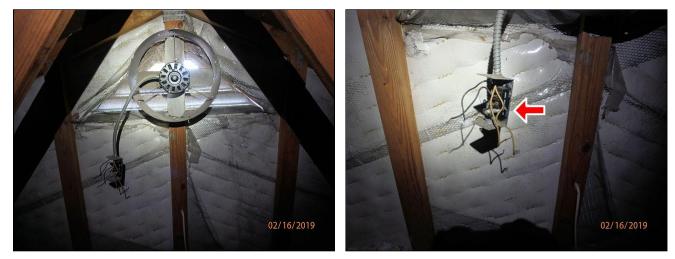
8.3 There is a gable mounted electric exhaust fan but it is not connected. It is not known whether it works or not. It could not be tested.

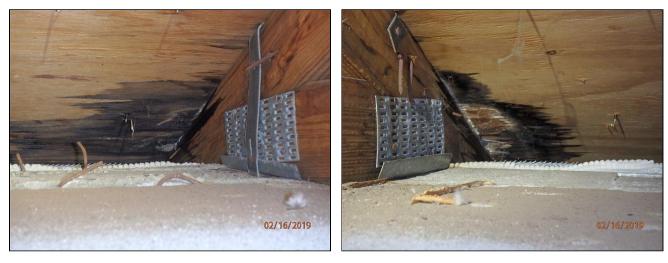
9.6 There is evidence of previous water leaks/water intrusion found in the attic at areas underneath the roof sheathing. These water stains appear to be from previous leaks/water intrusion. They are located near the edge of the roof and are physically not accessible to check for current moisture level content. These areas MAY LEAK during a rain event.

2.6 There is evidence of previous leaks from the attic. Please see section 9

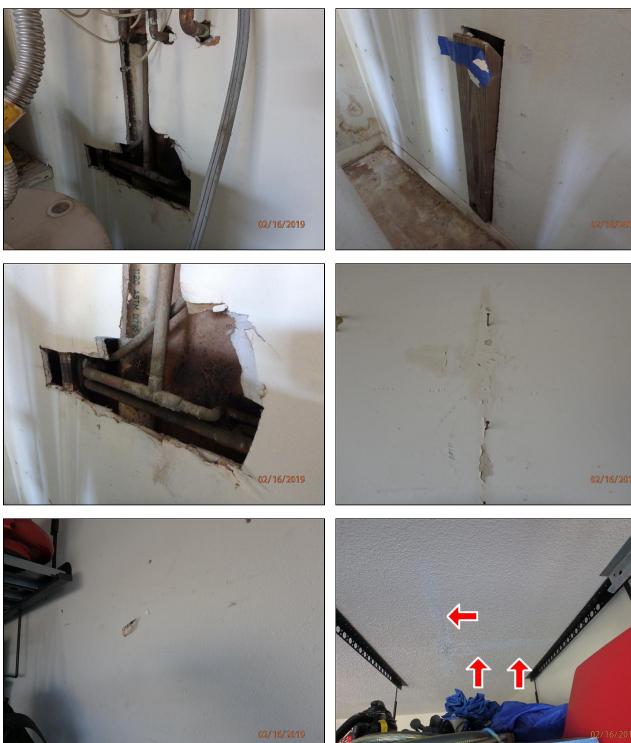
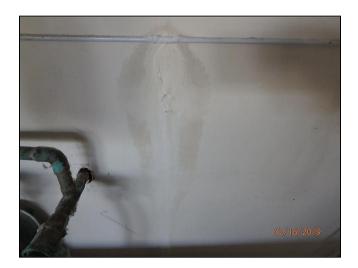
10.0 Open area at wall penetration should be properly sealed and finished to prevent attic and wall cavity air from entering into the garage. There are other minor wall imperfections which are considered cosmetic but should be sealed and finished as well.

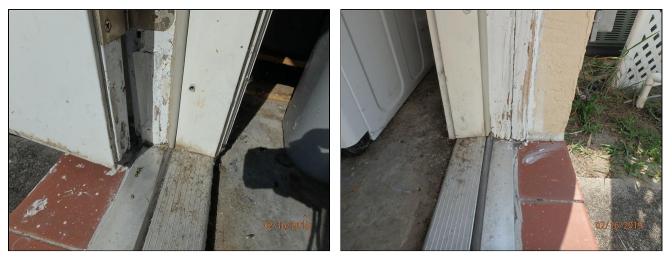
10.5 Some wood rot/deterioration at the bottom of the lower portion of the door frame. This is typical for exterior doors subject to exposure to rain.
