Inspection Report

Sample Report

Property Address:
12345 S Sample Road
Jupiter Florida 33478

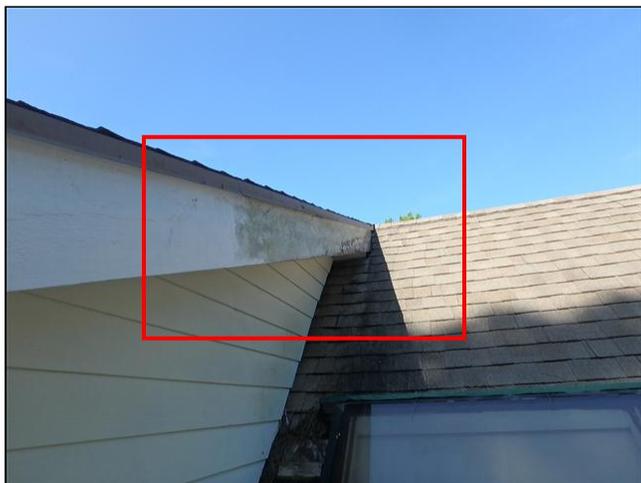
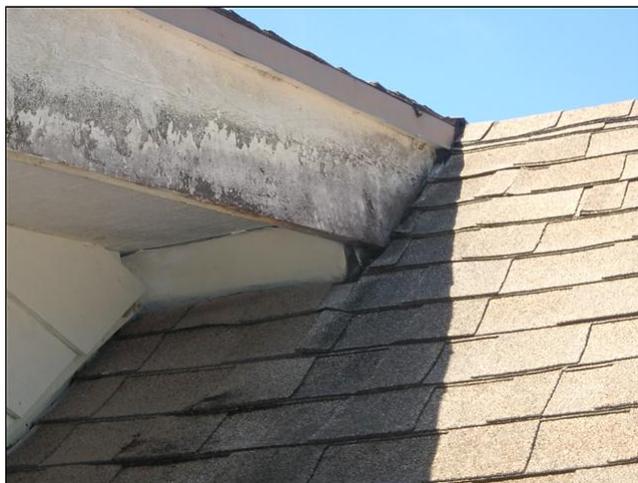
1.2 Fascia requiring sealant/painting. Observed section which could have some deterioration/moisture damage. Not accessible due to pitch of roof. This should be monitored and any deteriorated sections of fascia should be replaced as necessary. Other areas of possible fascia repair but not definitive due to being painted over. Note: This section of the house has a high pitched roof with no attic access. The conditions behind and under this roofing section is not accessible and conditions are unknown.

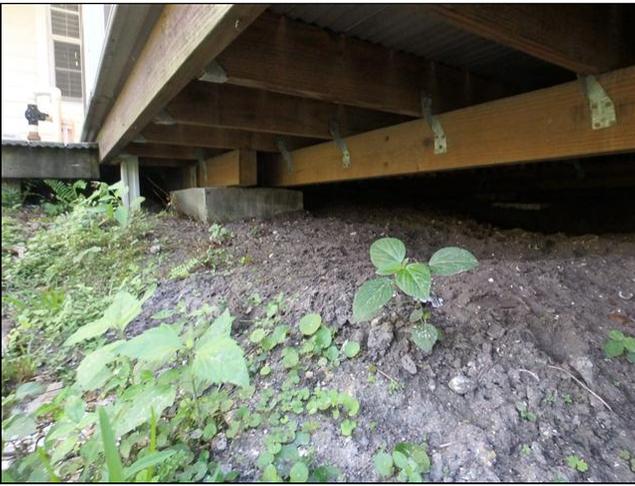
1.5 (1) Decking appears in good overall condition. Visible areas underneath the decking appear in good overall condition.

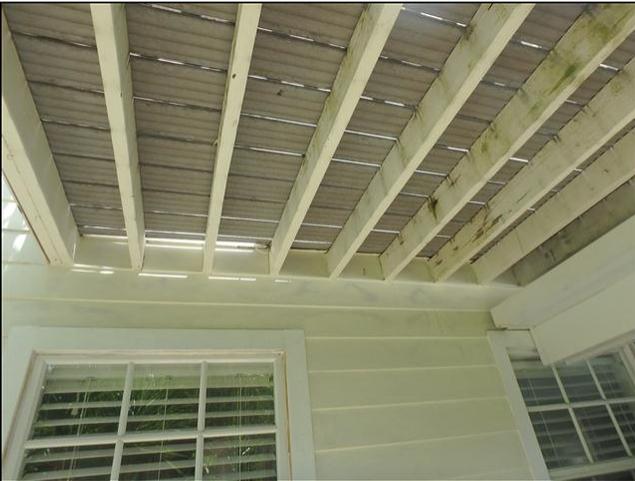
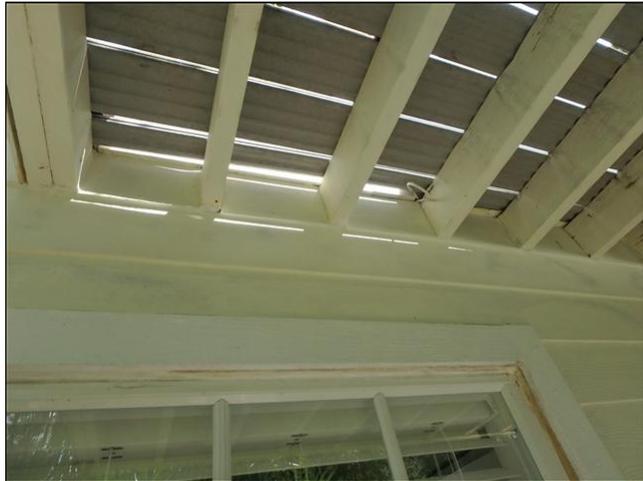
1.5 (2) The second floor deck does not appear to have flashing along the full length of the deck. Flashing helps to push water away from the structure. If there is no flashing or the flashing is deficient, water can possibly work its way underneath the siding and cause unseen water intrusion damage. The method of attachment to the structure is also not visible. This area should be monitored for signs of leakage and corrected if found.

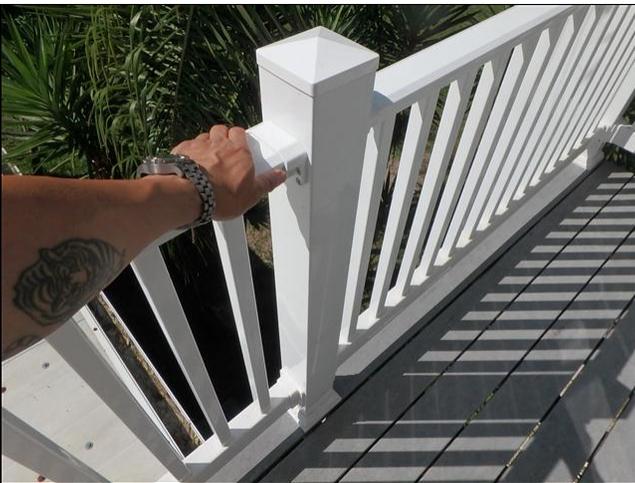
📍 1.5 (3) Second floor handrail has lateral movement. It should be properly/fully secured.

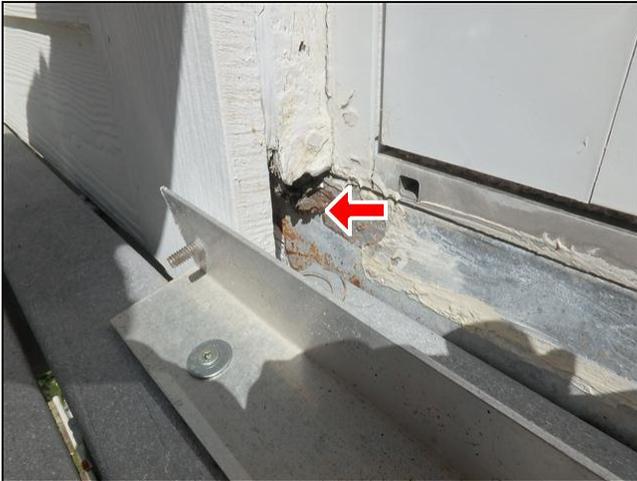
🏠 1.5 (4) There are open gaps at the lower sides of the rear deck/patio doors. This can allow water to intrude behind the siding. Recommend sealing.

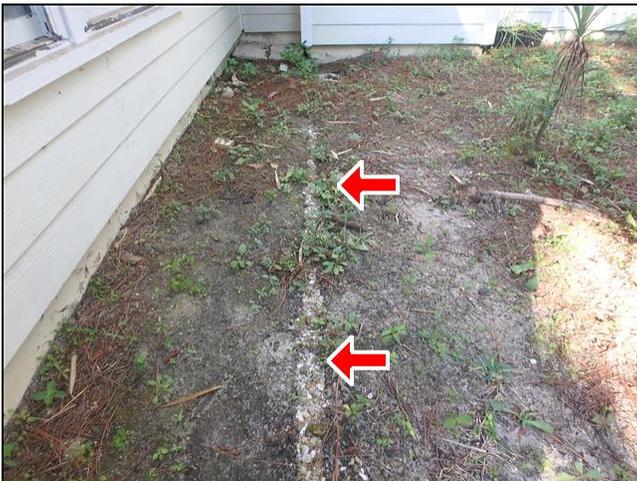
🏠 1.6 (1) Multiple areas of ground and soil erosion adjacent to the building structure around the perimeter. It is recommended to grade these areas using aggregate or other means to allow water to drain away from building.

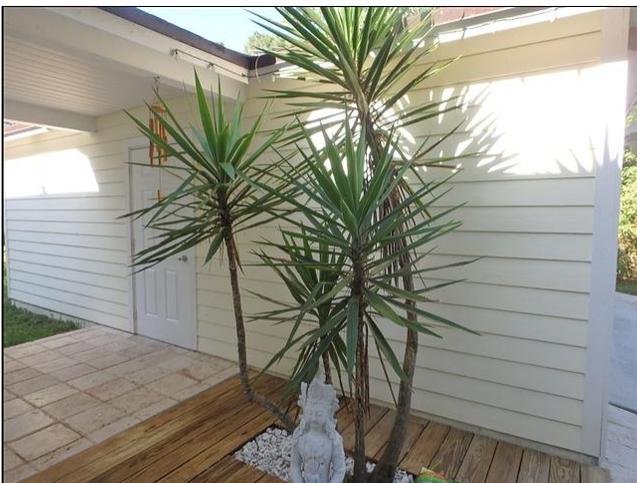
🏠 1.6 (2) Vegetation in contact with the structure should be trimmed back or removed. Vegetation in contact with the structure can allow moisture and pest entry into the home.

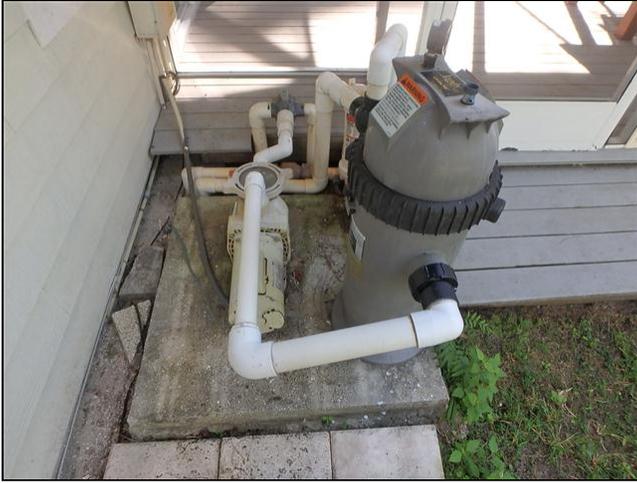
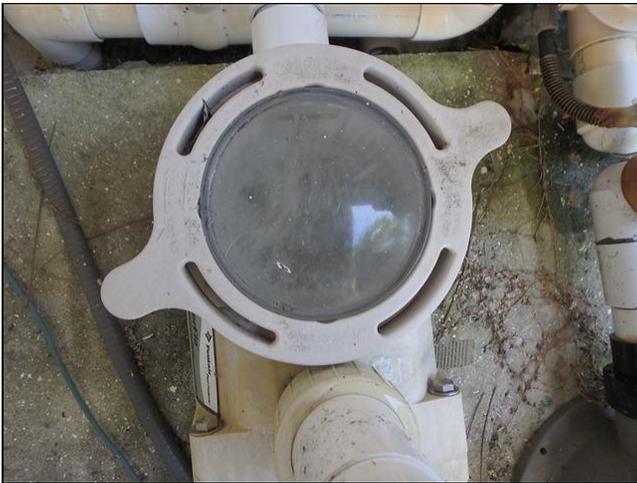
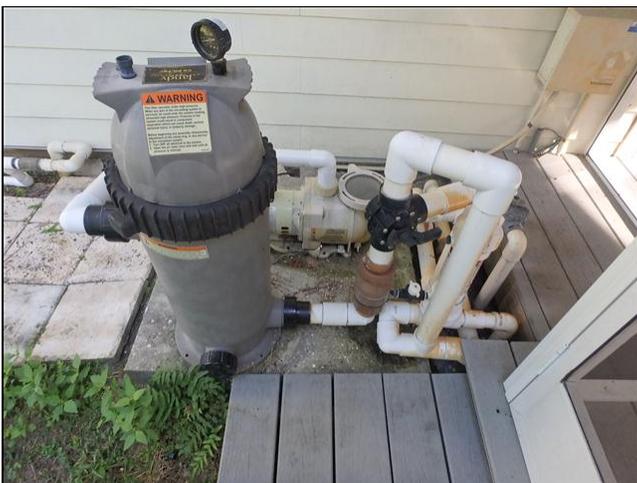
1.7 (1) There is an above-ground pool installed at the rear of the property. Pool inspection is not part of a home inspection. Only a courtesy visual for overall condition is offered. The pool, pool surface, pump, filter and visible piping appear in overall good condition. The pump is operational and water is flowing through the system as designed. The filter is not opened for inspection. As a matter of general maintenance, recommend having the pool serviced. The filter should be checked and replaced if necessary, and the water should be tested for ph and chlorine levels. As a new owner, it is recommended to have the pool serviced and put on a maintenance program.

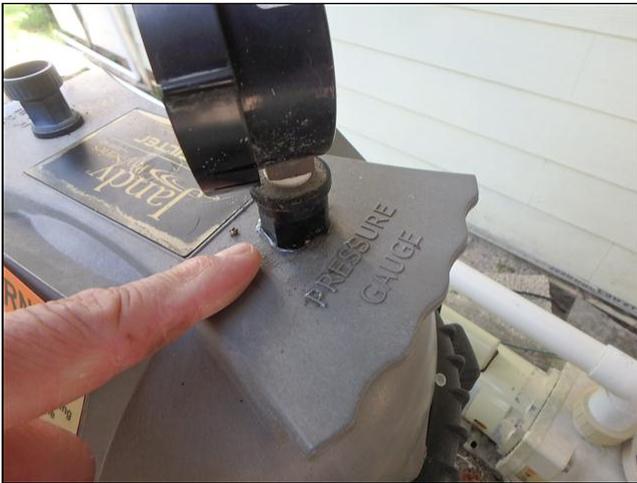
1.7 (2) Area of filter with a leak

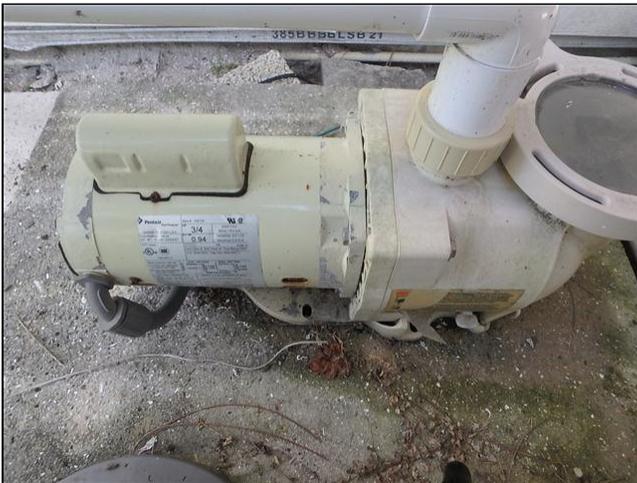
1.7 (3) There does not appear to be a bonding wire to the pool pump. Bonding wires properly bond/ground the pool system to prevent electrical hazards.

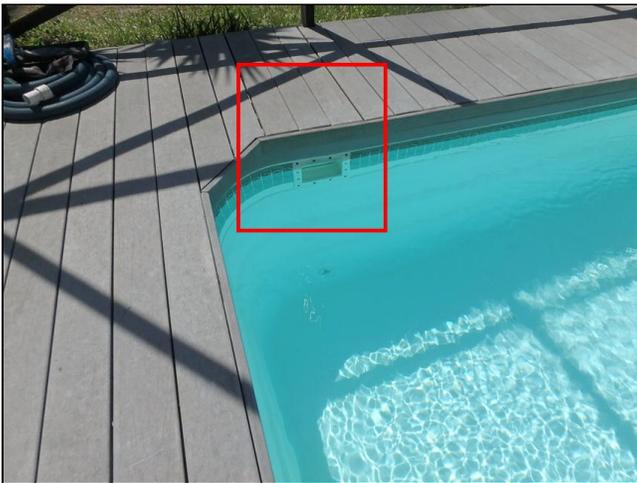
1.7 (4) There does not appear to be access or presence of a skimmer. No attempt to search below the decking. No further action was taken.

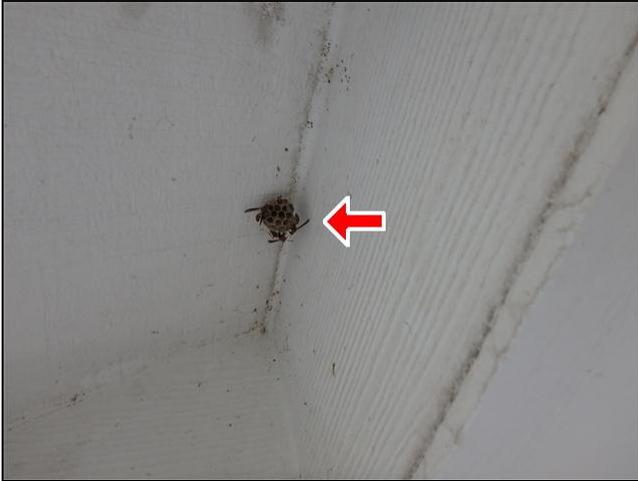
1.9 There are a few visible bees/bee hives around the property.

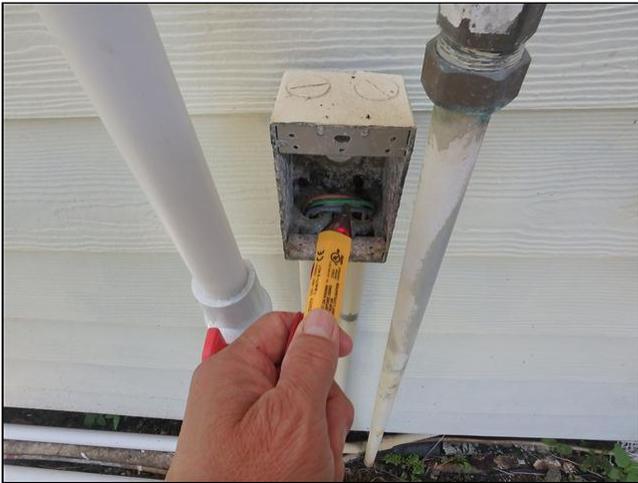
📍 1.10 (1) Uncovered box with live wiring

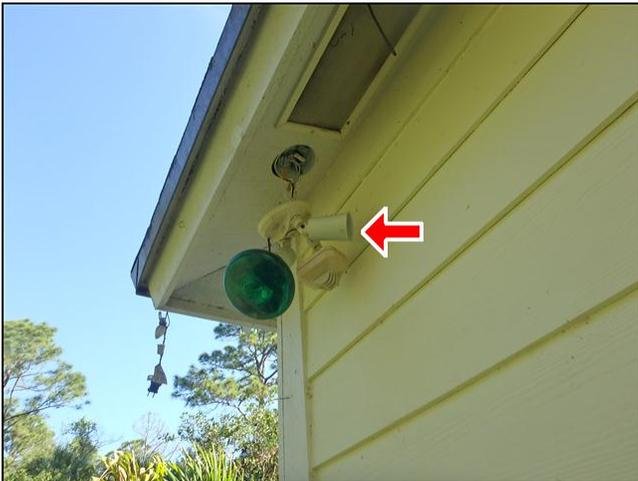
📍 1.10 (2) Loose, detaching exterior light fixture

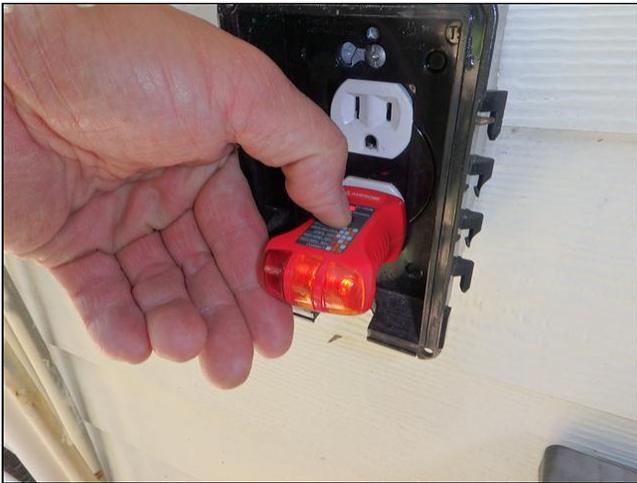
🏠 1.10 (3) The exterior electrical receptacle did not have GFCI protection. The GFCI receptacle should be replaced.

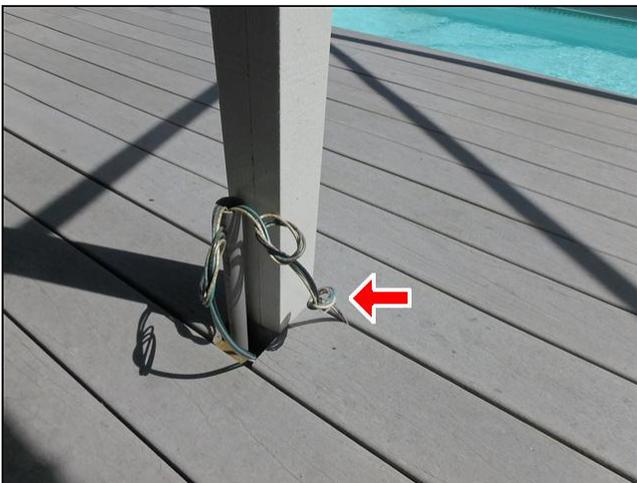
🏠 1.10 (4) Open visible wiring at the rear deck should be properly housed or removed

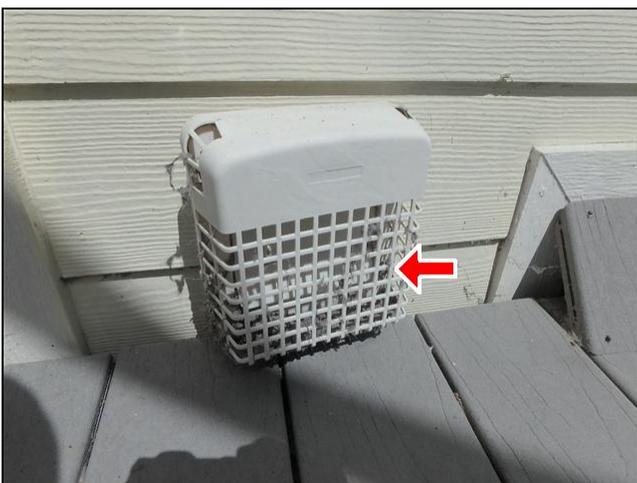
🏠 1.11 Dryer vent should not be screened otherwise it will accumulate lint and cause reduced air flow and increase risk of fire

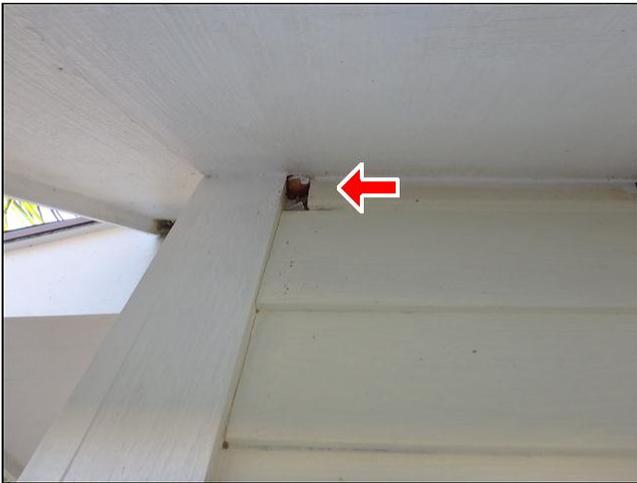
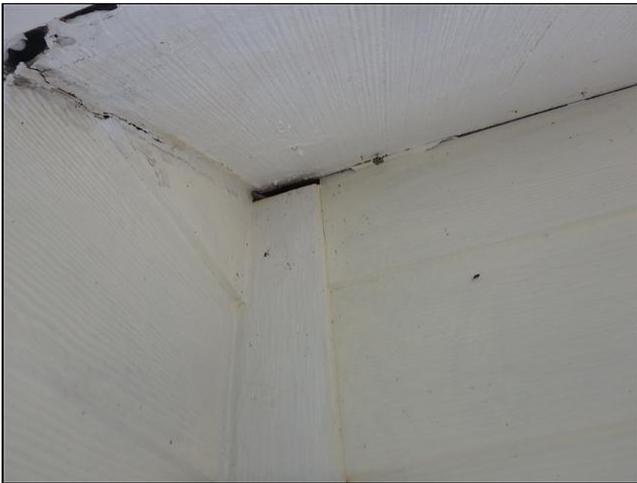
🏠 1.12 Open gaps in exterior walls should be sealed and finished to prevent moisture and pest entry.

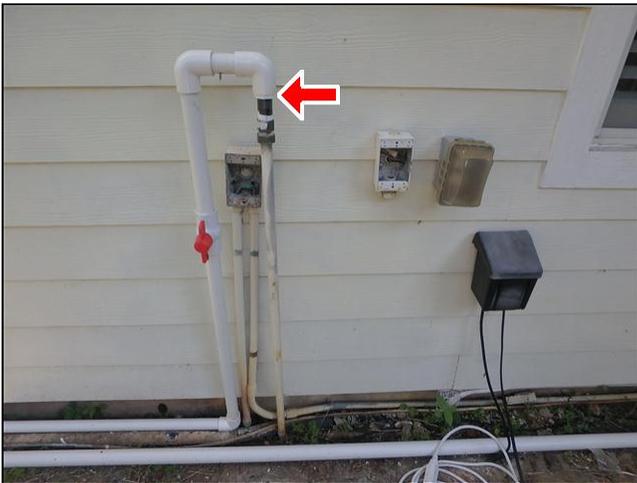
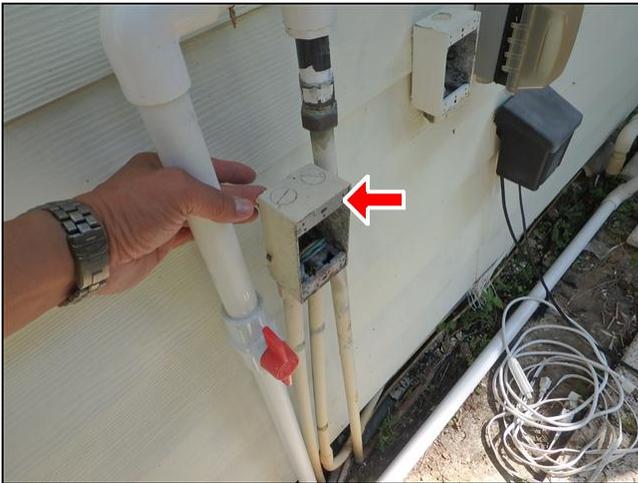
🏠 1.13 (1) Unsecured water line

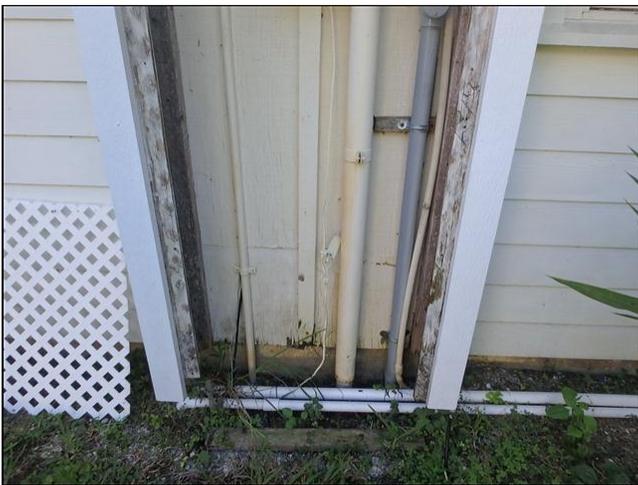
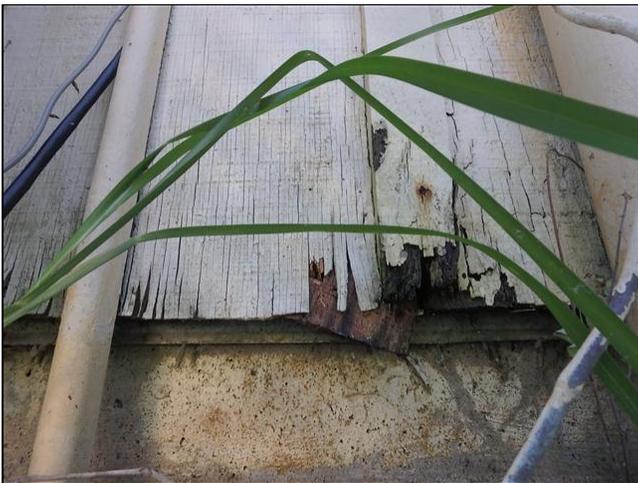
1.13 (2) Exterior electrical meter housing is deteriorated. The condition behind this area is not known.

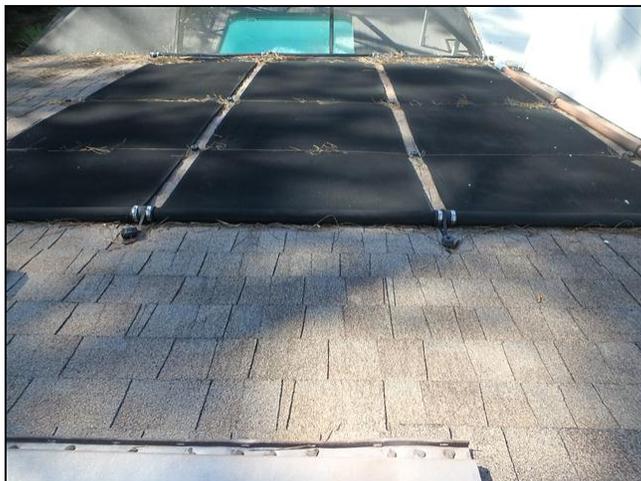
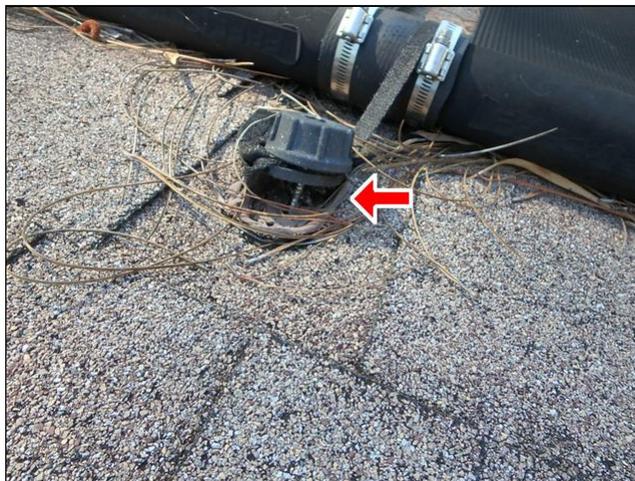
1.13 (3) There is a solar heating system installed on the roof. It was conveyed to me by the seller that the system does not work and has a leak. This system is not within the scope of an inspection and is disclaimed and not inspected or tested.

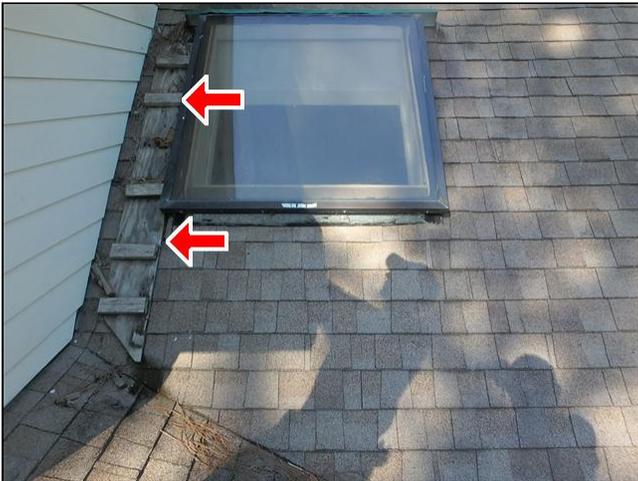
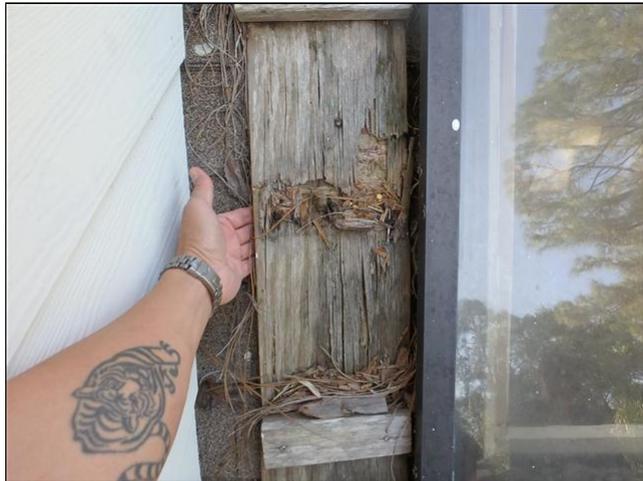
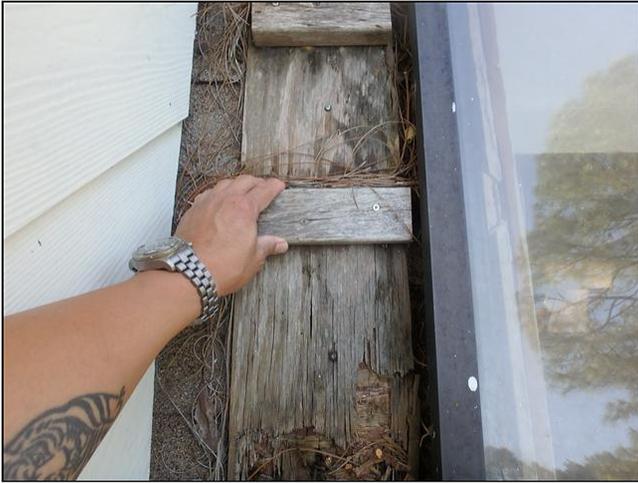
📍 2.0 (2) There is a home made "ladder" at the roof adjacent to the skylight. It is deteriorated and is not safe to use. The attachment screws through the roofing can cause leaks. It should be removed and any attachment holes properly sealed.

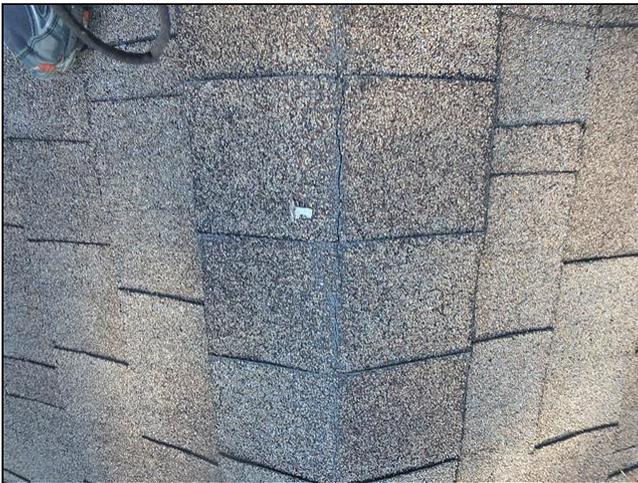
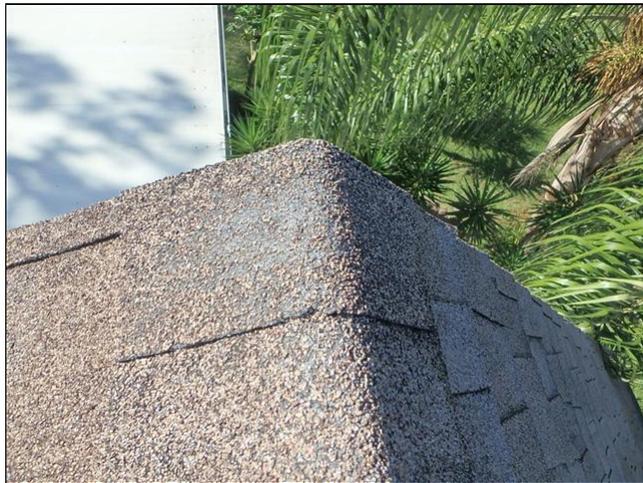
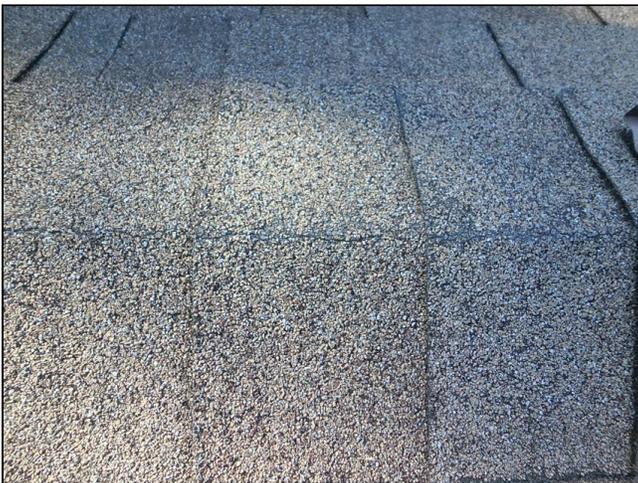
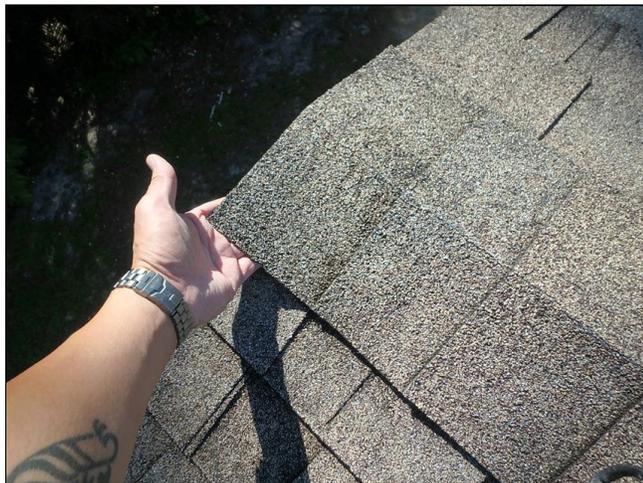
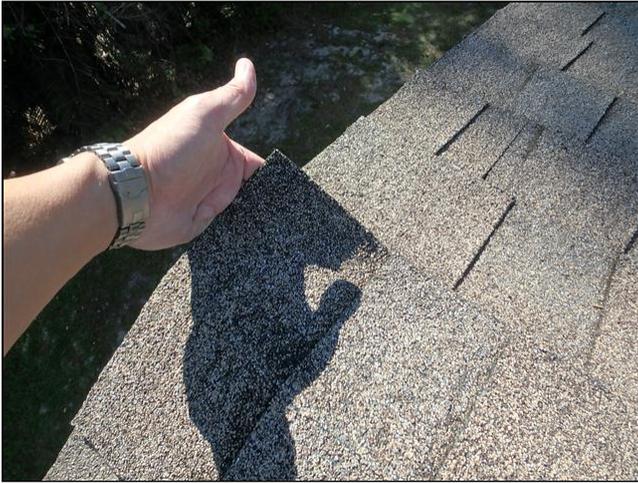
**2.0** (3) Visible evidence of shingle degranulation and unbonded tiles. As roof coverings age and weather, they start to lose their granules and become less effective as they approach life expectancy.

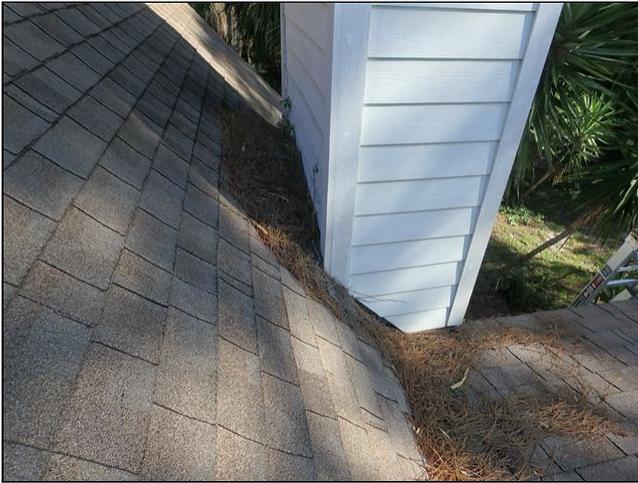
📍 2.0 (4) The chimney has soil and vegetation type debris accumulation. This area is highly susceptible to water intrusion. This area should be maintained clear and clean of debris. Due to the soil and debris, it is not known if there is the presence of a cricket/flashing installed. This area should be monitored.

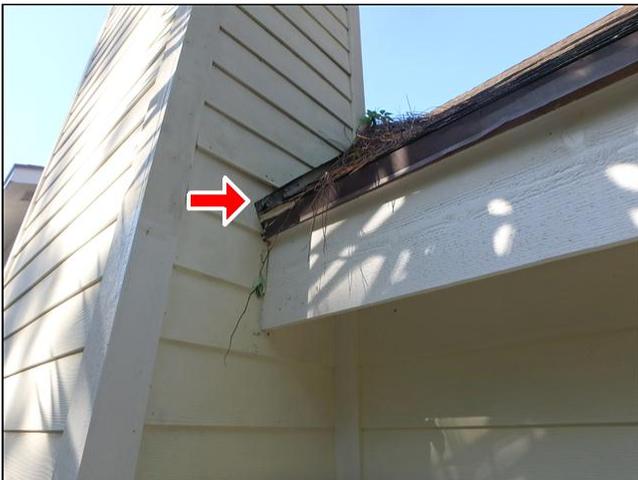
📍 2.2 (1) This area of the chimney should be monitored. It is ideal to have kick flashing installed in order to divert rainwater away from the chimney. These areas could be possible areas of water intrusion.

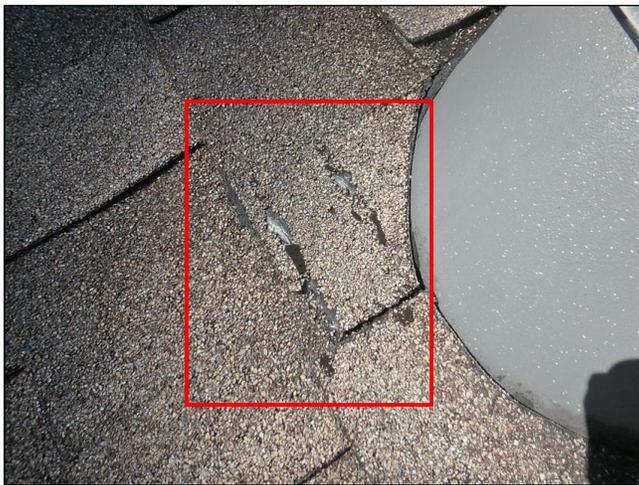
2.2 (2) Damaged shingle/flashing at a roof penetration. This could be an area of potential leakage

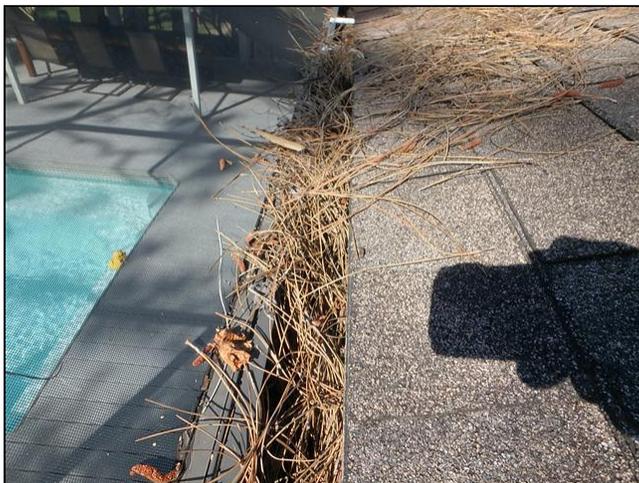
2.3 The gutters should be serviced and cleaned to prevent buildup of debris and obstruction of downspouts

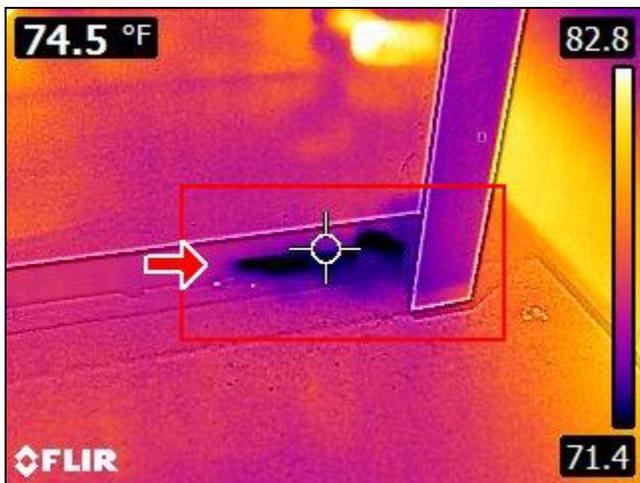
**3.0** There is a leak at the right side of the front of the dishwasher. Water/moisture was noted using the thermal imaging camera.

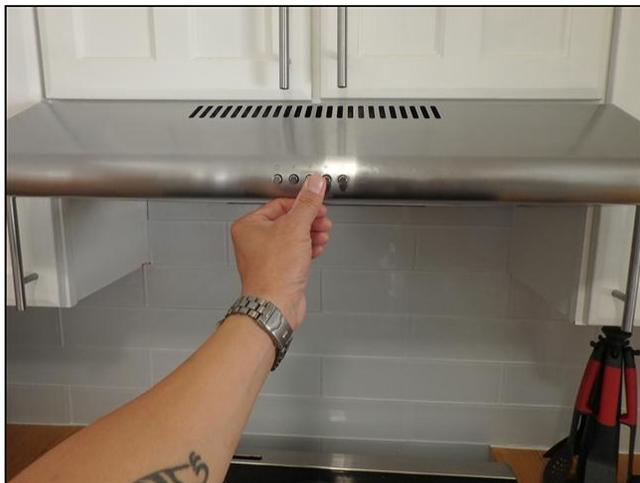
3.1 (2) The range hood vent fan is noisy on the higher settings but is normal on the low setting.

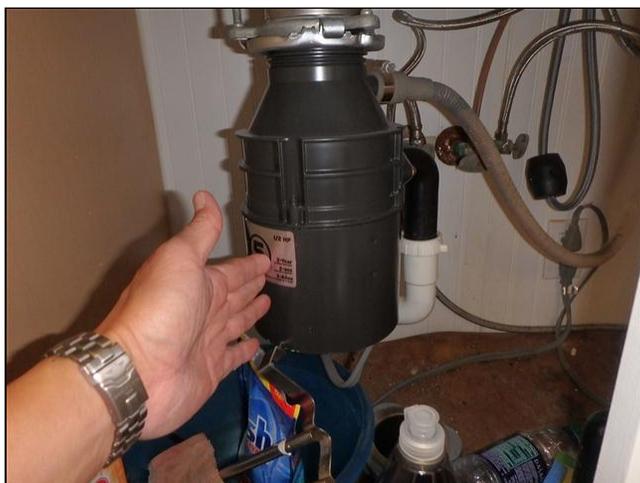
3.2 Waste disposal is operating but makes excessive noise.

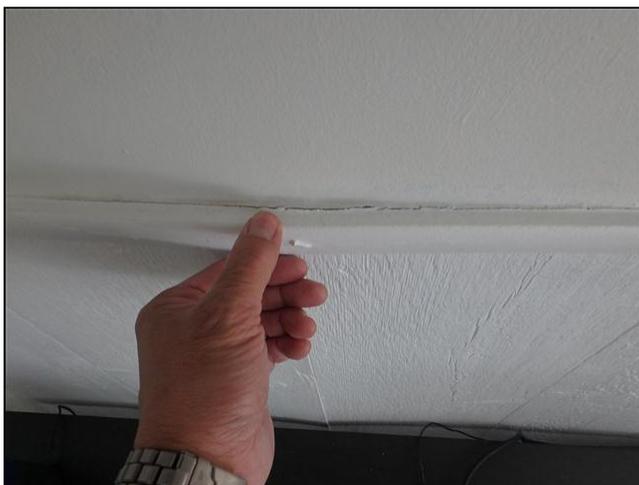
**4.0** (2) There are minor surface type imperfections to the finished drywall of the walls or ceilings. These are considered cosmetic in nature but noteworthy since they were not originally designed that way. They should be repaired and finished.

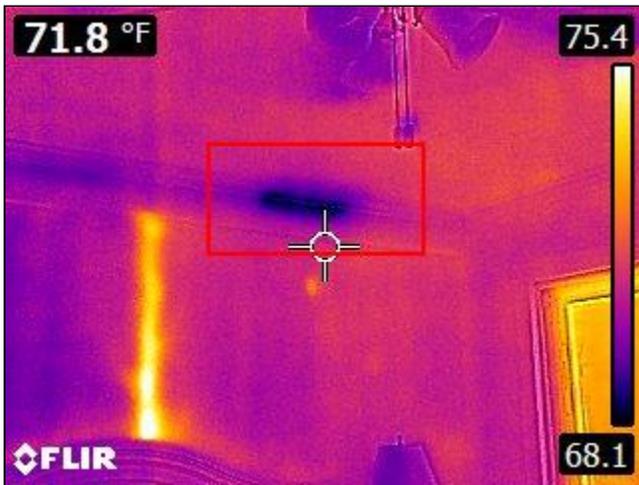
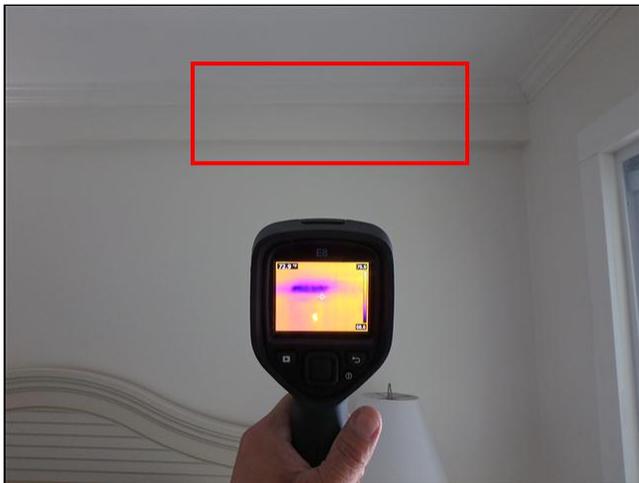
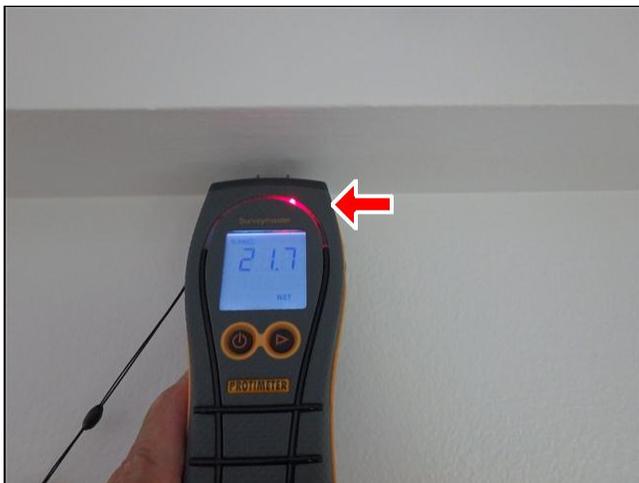
4.7 (2) This appears to be an anomaly. The area was tested with a moisture sensor and moisture meter and were no resultant for moisture. It is not know why the difference in temperatures are present at that specific section of ceiling. Monitor this area for further signs of moisture.

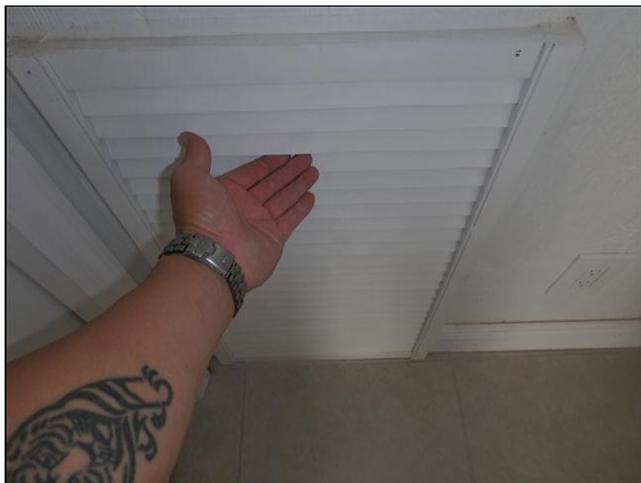
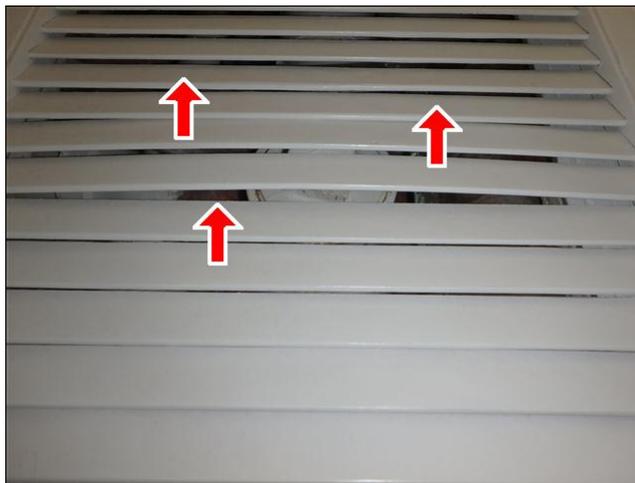
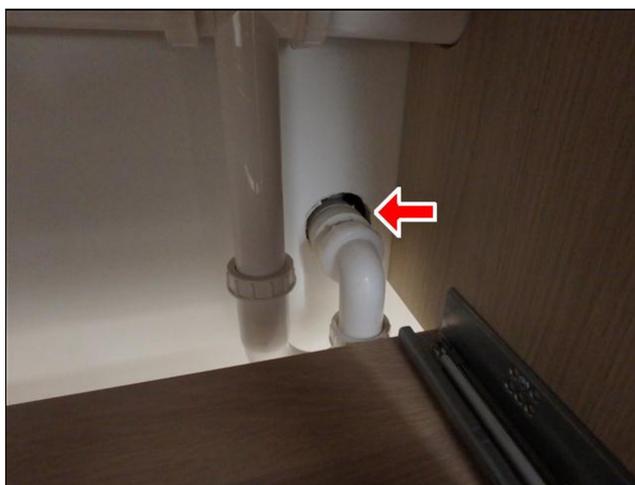
4.11 There is a louver installed at the wall adjacent to the washer and dryer. It appears to be covering a section of wall that has been opened up. There may have been previous plumbing work performed at this area. This louver is open to the wall cavity and can possibly be open to the attic. Air flow can potentially draw hot, moist attic air into the living spaces and vice versa. Recommend replacing this louver with a solid cover.

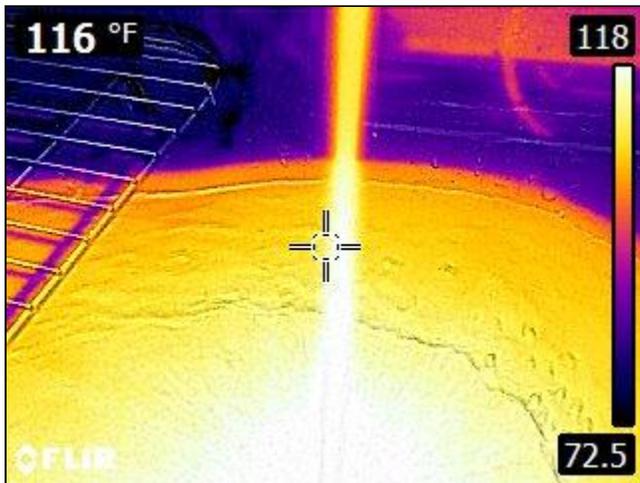
6.4 (1) The hot water temperature was 116 degrees fahrenheit at the time of the inspection.

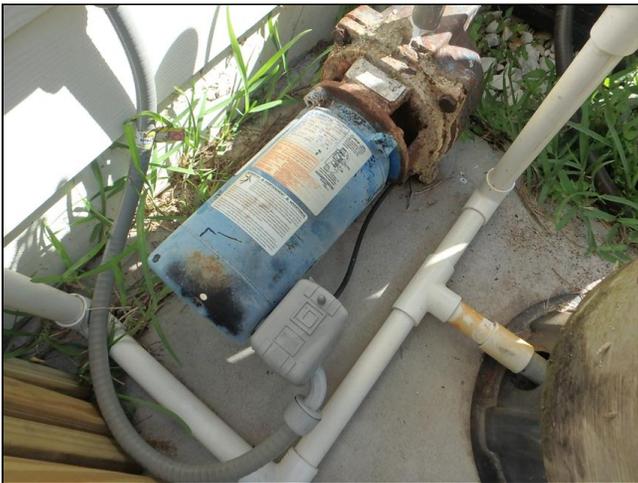
6.5 (2) There are no bonding wires to the well pump. This can be a electrical safety hazard

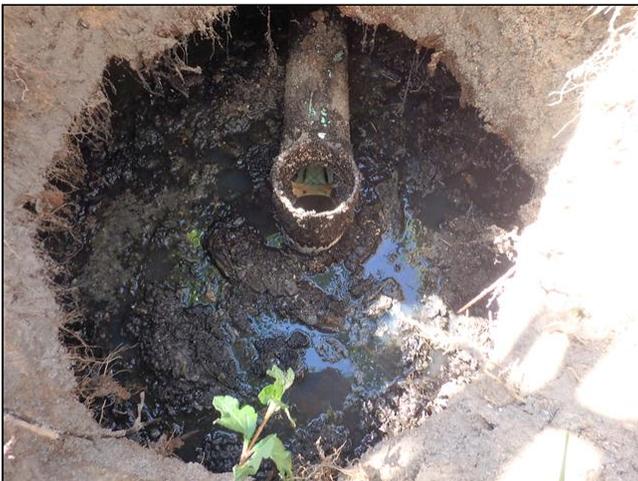
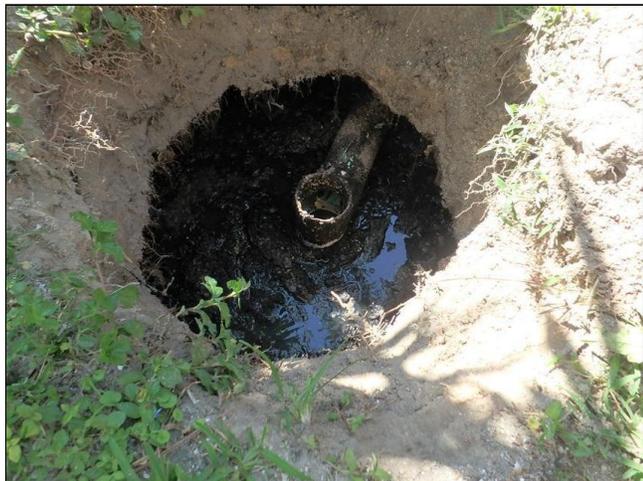
6.7 There is a septic system installed on the property. The septic system inspection was outsourced to a third party septic company. Their report will be made available in addition to this report

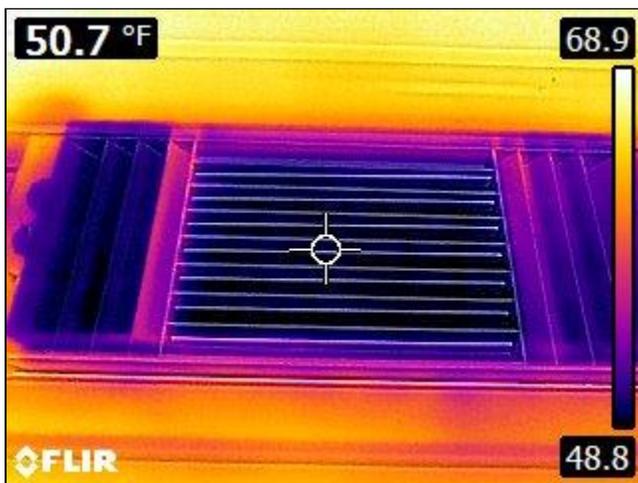
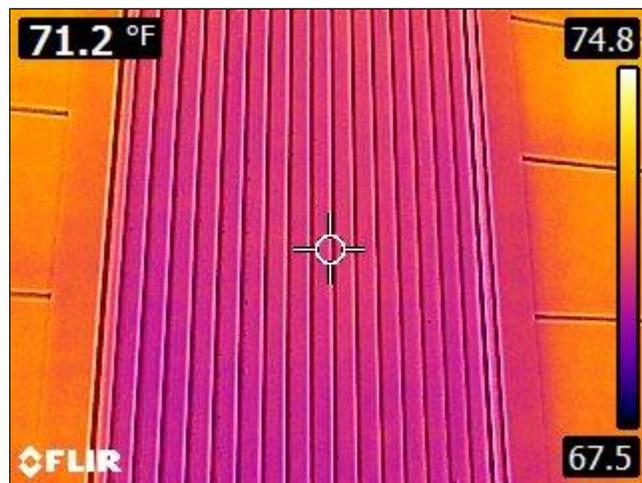
7.2 The AC system temperature differential test shows normal performance with a minimum of 14 degrees temperature differential between the supply and return registers

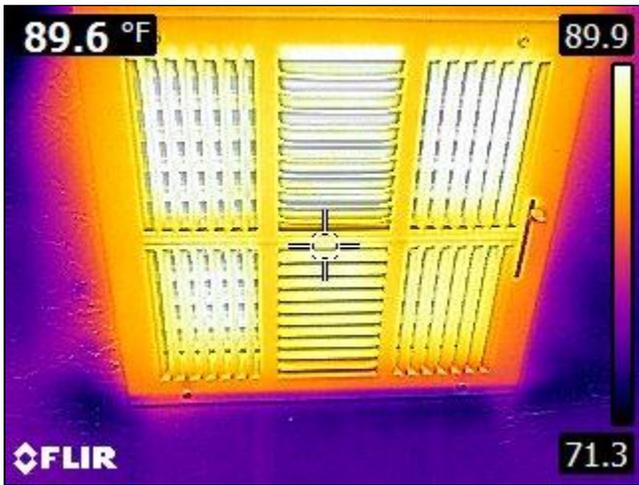
7.3 Heat was working as expected using normal controls

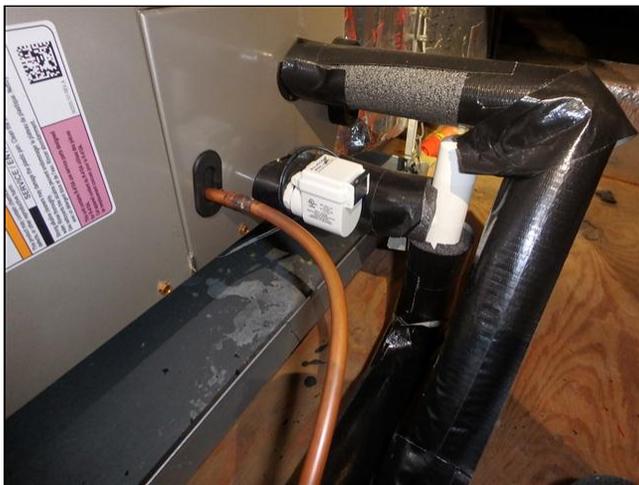
7.5 In line condensate overflow switch is present and installed. This is a safety device that helps to prevent damage due to an overflow of the condensate drain pan.

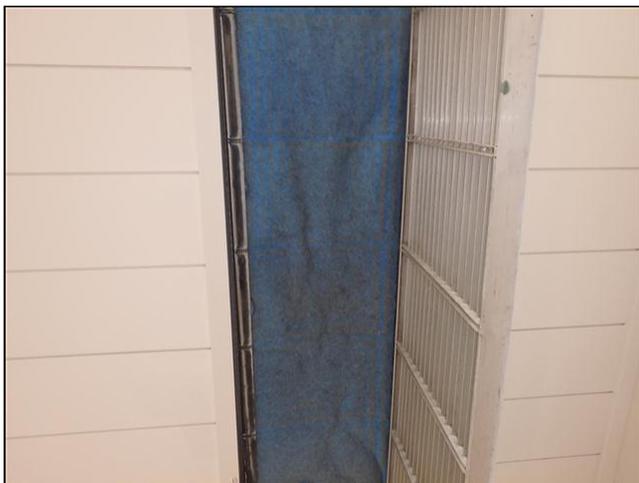
7.6 (1) The filter is dirty but can be used a little while longer. Recommend following manufacturers recommendation for filter replacement.

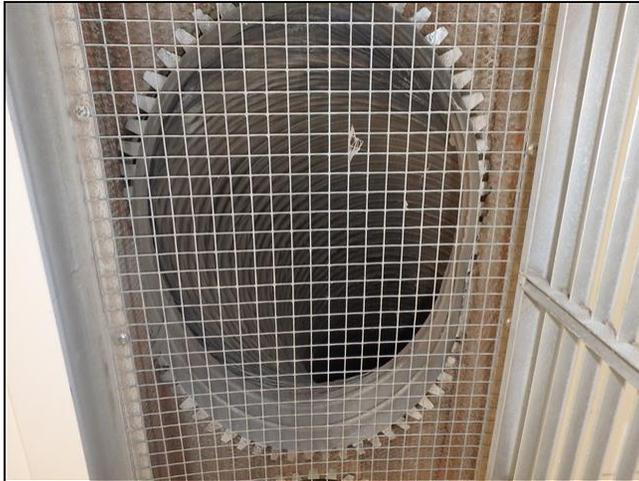
7.6 (2) The return plenum is in good overall condition. There are no condensation leaks or other moisture issues at the time of the inspection,

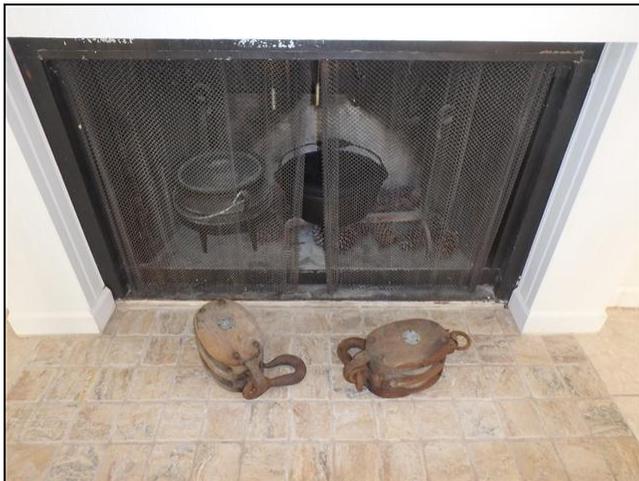
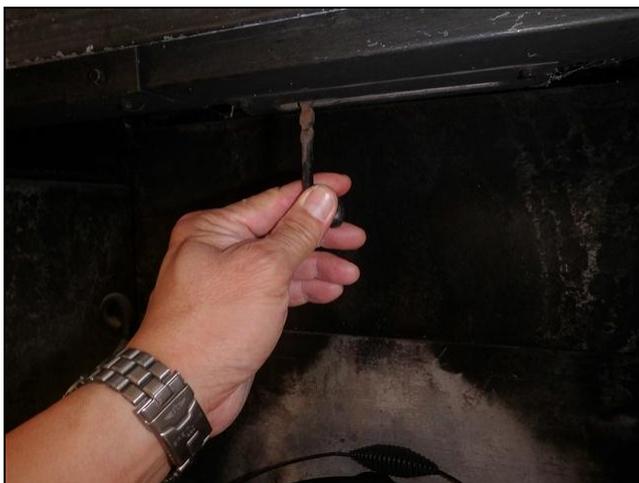
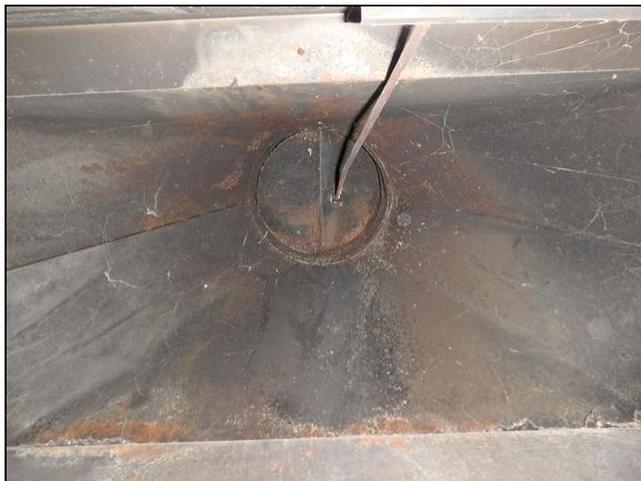
7.8 The fireplace is in good overall condition. However, before attempting to use it, it is recommended that a qualified chimney contractor perform a specific chimney inspection and evaluate the flue and other aspects to ensure it is safe to use.

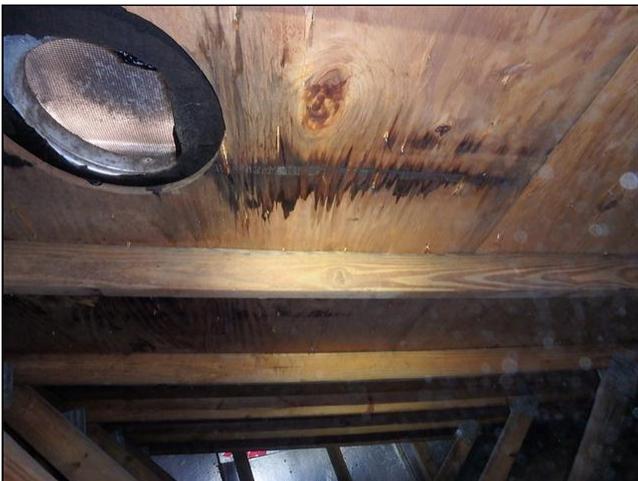
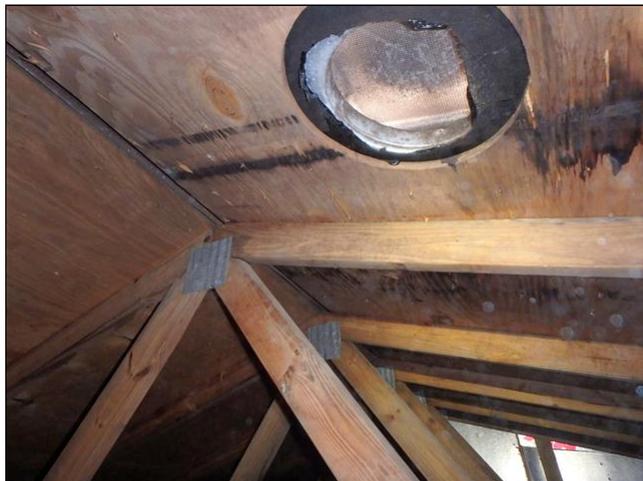
9.6 There is evidence of previous water leaks/water intrusion found in the attic at areas underneath the roof sheathing. These water stains appear to be from previous leaks/water intrusion. They are located near the edge of the roof and are not currently moist. But this should be monitored because the age of the previous staining is not known. This area could potentially leak during a rain event.

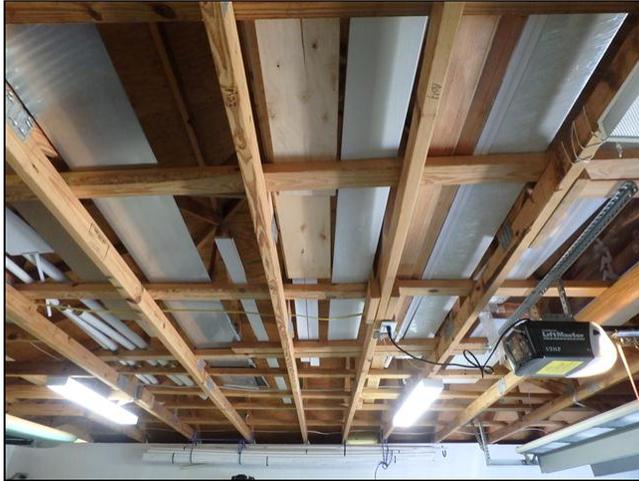
10.0 The garage was built on site in 2012 according to permits on file. The ceiling/roofing structure is manufactured wood truss and is open.
