Inspection Report

Sample Report

Property Address:
12345 S Sample Road
Jupiter Florida 33478

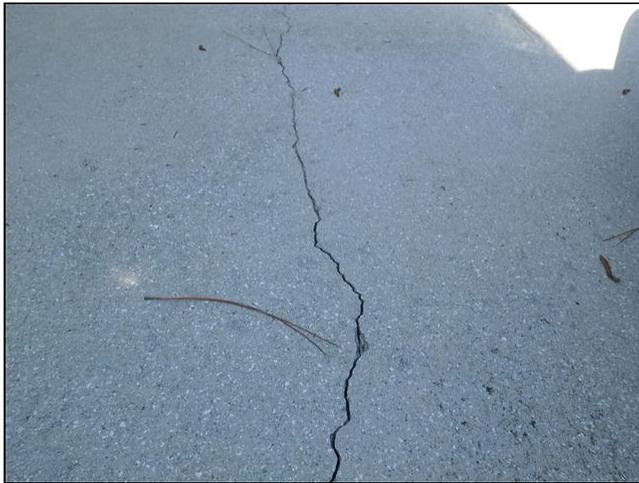
10.1 Noted cracking in the garage floor which are typical expansion/settlement type cracks.

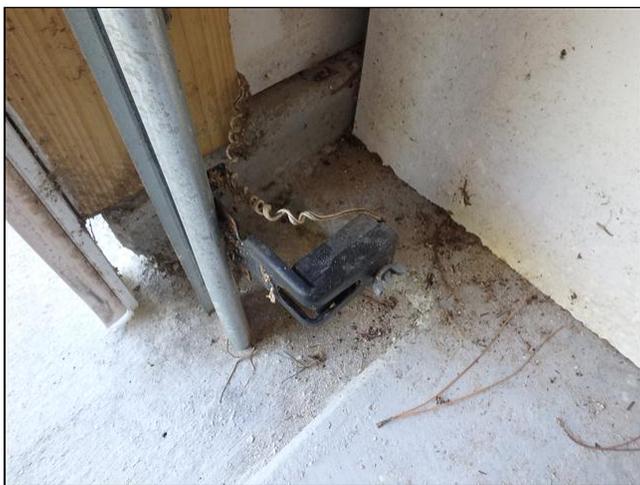
10.4 The sensors are in place for garage door(s) and will reverse the door.

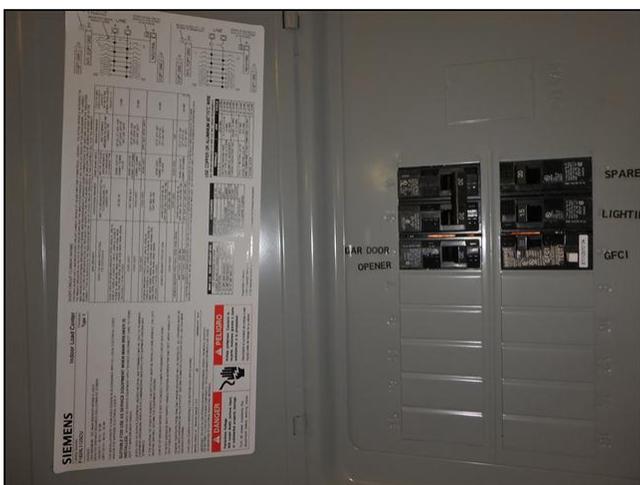
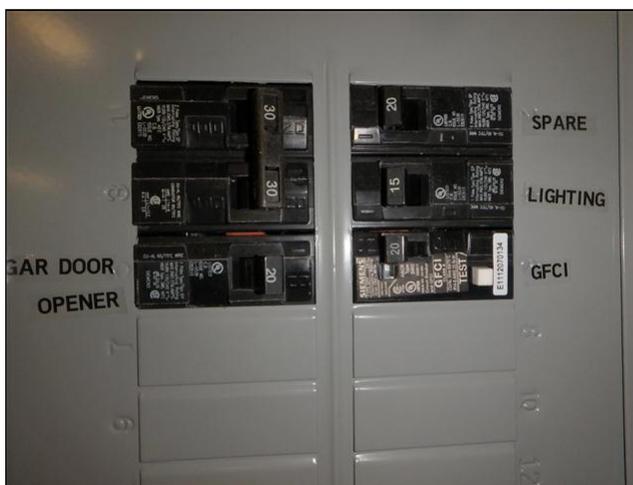
10.9 Subpanel present in the garage serving the garage
